Report A-016/2017

Accident involving a Piper PA-18-150
aircraft, registration EC-JBP, at the
Sabadell Airport (Barcelona, Spain)
on 5 August 2017

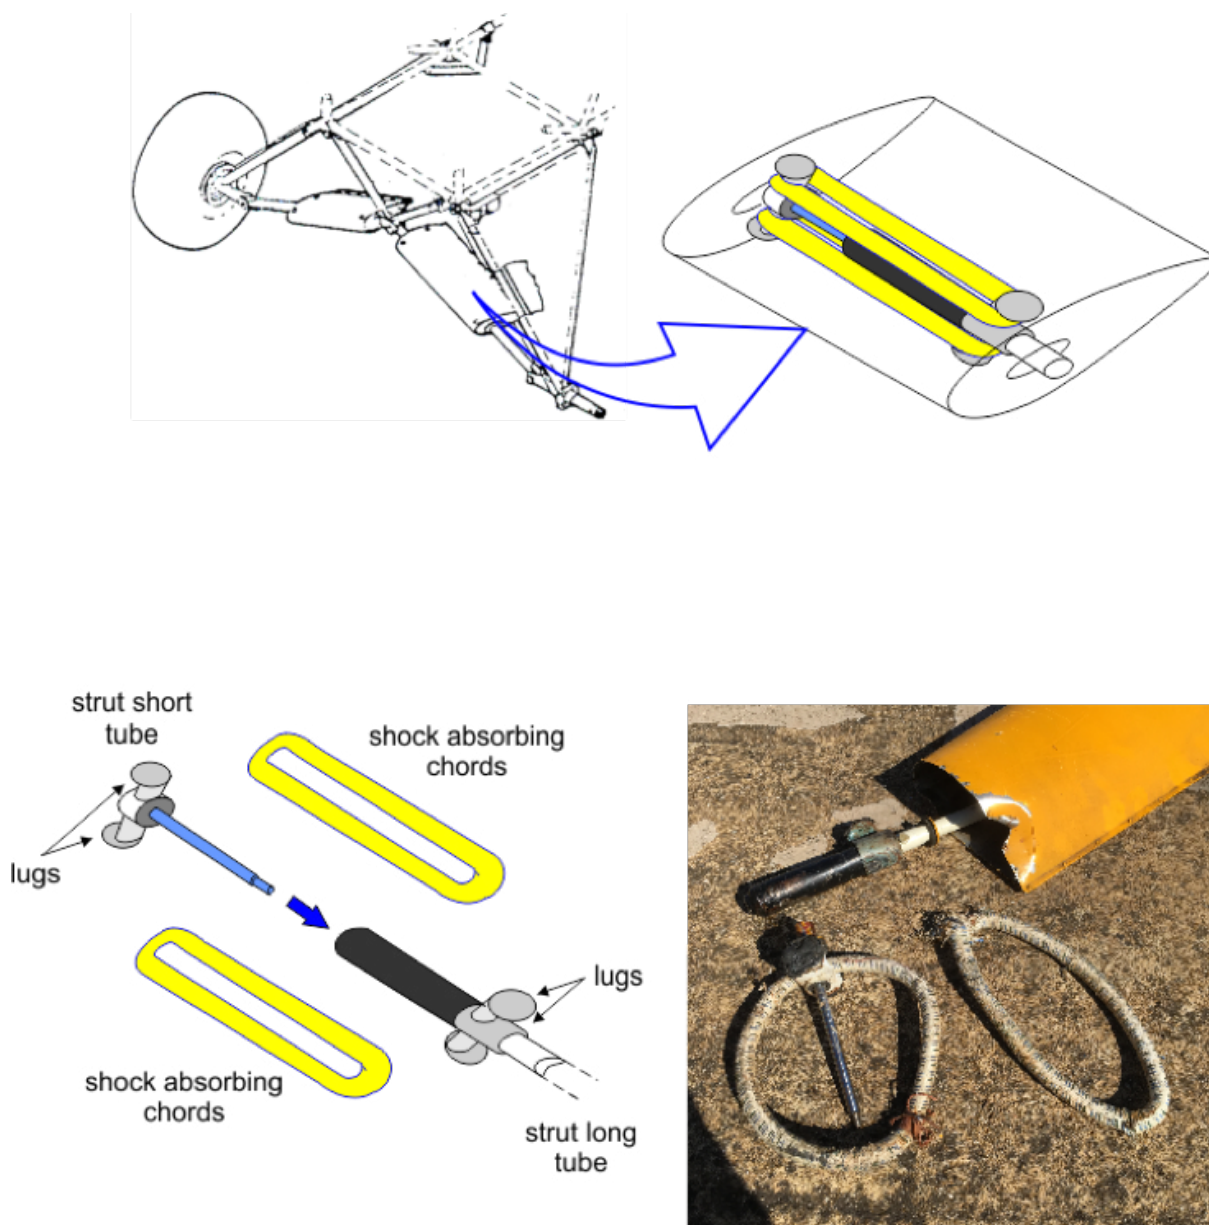
Figure 3. Diagram of landing gear

In addition to the tires, which are the first component to absorb part of this landing energy, the system has two struts (each one attached to one of the landing gear wheels), which in turn contain two lengths of tube, one short and one long. The short segment has a stem that is inserted partway into the long segment, allowing the two to move longitudinally with respect to each other. Both are joined by two cords, which are hooked on two lugs on each segment, such that when the stem is fully inserted into the long segment, the landing gear structure is kept in the retracted position (in flight or parked). When the landing gear makes contact on landing, the cords stretch, acting as a shock absorber by allowing the long segment to move over the stem, thus absorbing much of the impact energy.
