## **Report IN-013/2011**

Incident occurred on 20 April 2011, involving an Airbus A-320-211 aircraft, registration number EC-GRH, operated by Vueling, at Seville Airport (Seville-Spain)

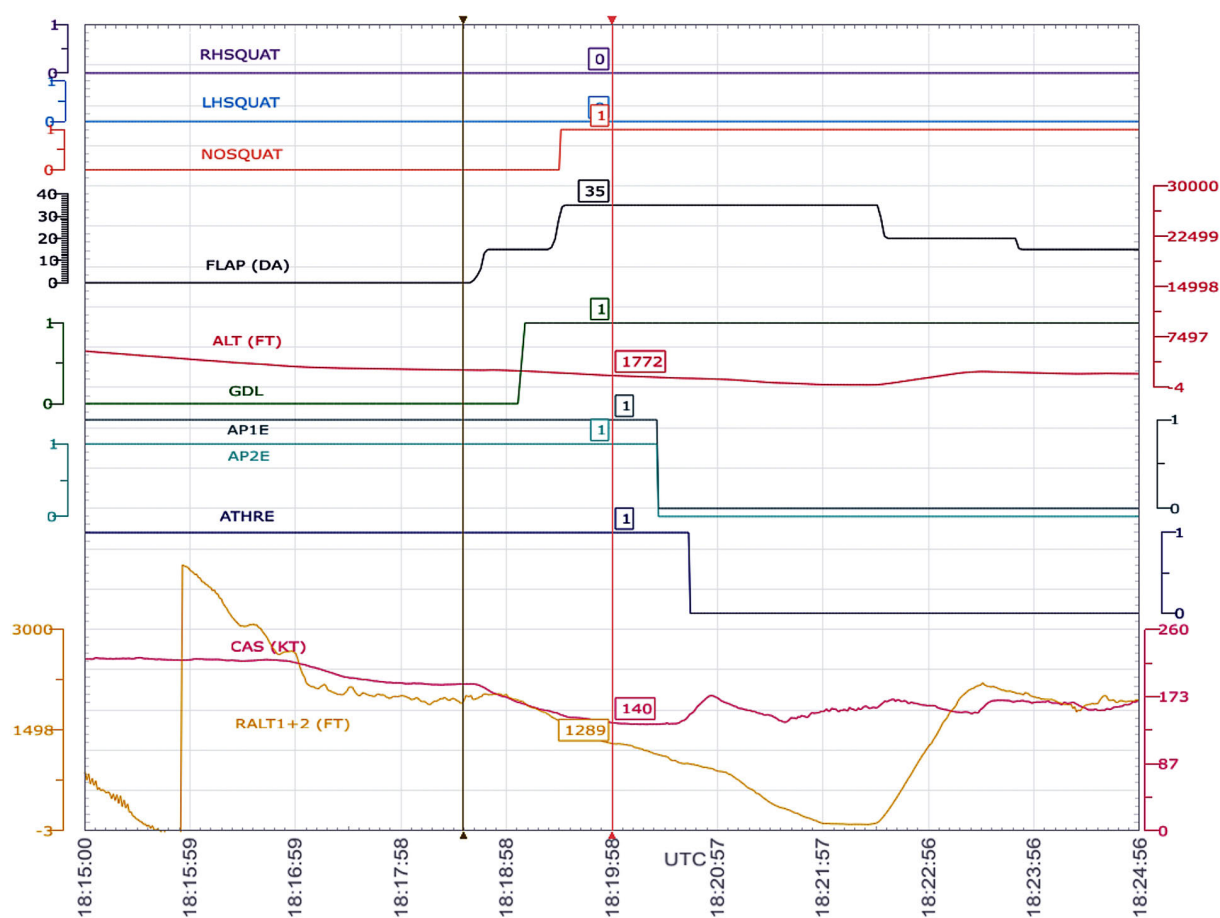
Figure 5. Graph showing SSFDR data on first approach

- The approach was performed with the two auto pilots (A/P1 and A/P2) connected, in accordance with the Airbus procedure for capturing of the ILS localiser.
- At ILS/DME 27 8NM, the flaps were actuated to CONF 2 (15° deflection).
- At 6.7 NM, the landing gear lever was actuated, indicating locking at 20:19:15.
- At 5.9 NM, the flaps were selected to CONF FULL (35° deflection).
- Almost coinciding with the deployment of the flaps to 35°, 21 seconds after the landing gear locking indication, the nose landing gear was recorded to be in the ground position (shock absorber compressed), this being identified by the turning of the wheel in the air, at 20:19:36.
- At 20:20:31, the two auto pilots disconnected, and 17 seconds later the autothrust disconnected. These were not reconnected during the remainder of the flight. At this

point the aircraft was 992 ft above the ground, 2.9 NM from the localiser and at a speed of 151 kt.

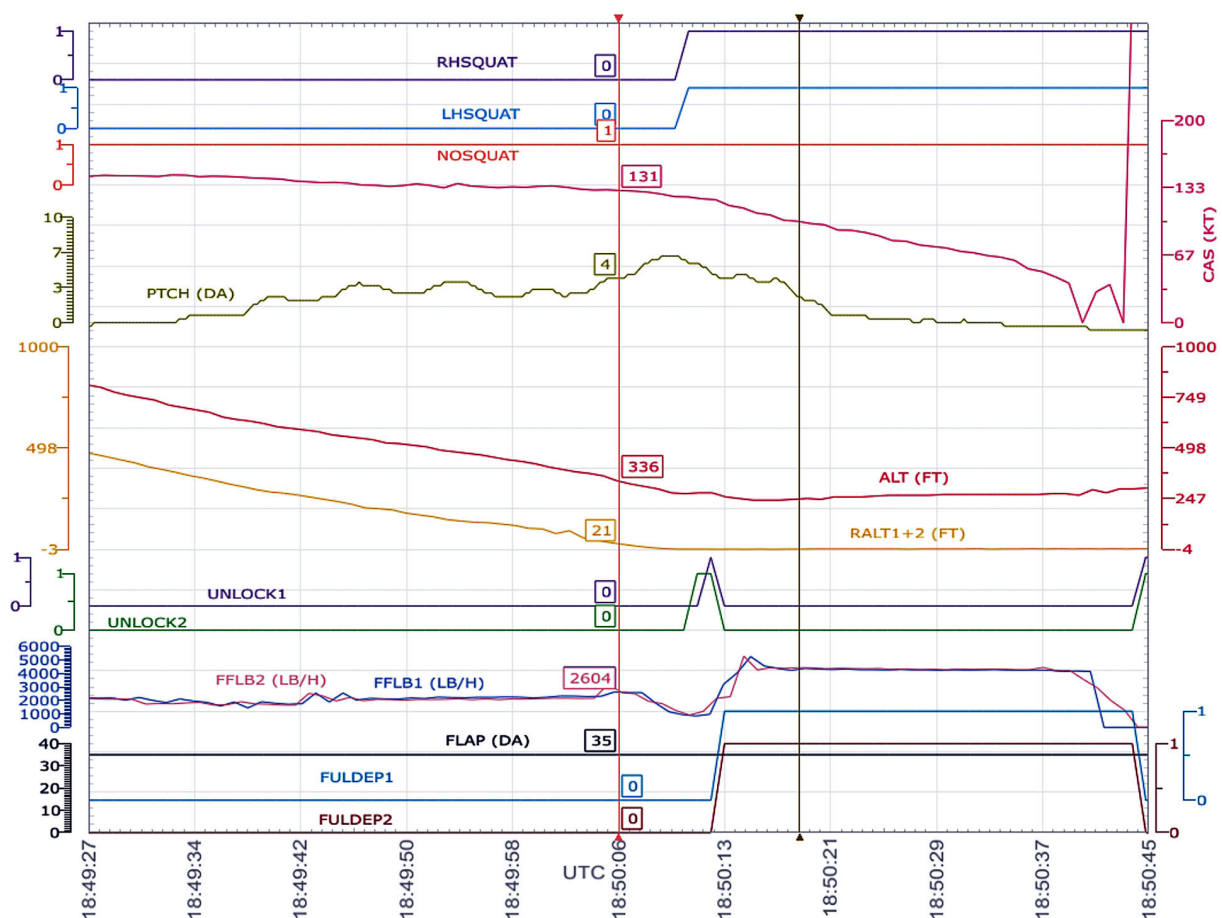
Figure 6. Graph showing SSFDR data on second approach and landing

- The final phase of the approach was performed in manual mode with the landing gear extended and the flaps in CONF FULL (35° deflection), maintaining a speed of 135 kt.
- At a height of 43 ft above the field, the flare or roundout was initiated, an angle of attack of 6° being reached.
- As soon as the main landing gear was in contact with the runway, at a speed of 123 kt, ground spoilers and reverse thrusts were deployed.
- The nose up configuration was maintained for 10 seconds.
- A time of 34 seconds passed between touchdown and the aircraft coming to a halt.
- The engines were shut down with the aircraft at a speed of 28 kt with respect to the ground, the aircraft coming to a complete halt five seconds later.
- The landing distance was 4,056 ft (1,236 m). The aircraft touched down on the runway at the aiming point sign and stopped at the junction with quick exit E3.
