## Report A-034/2011

Accident on 19 September  
2011, involving an Agusta  
AB-412 aircraft, registration  
EC-JRY, operated by FAASA  
Aviación, S. A., in the  
municipality of La Peza  
(Granada, Spain)

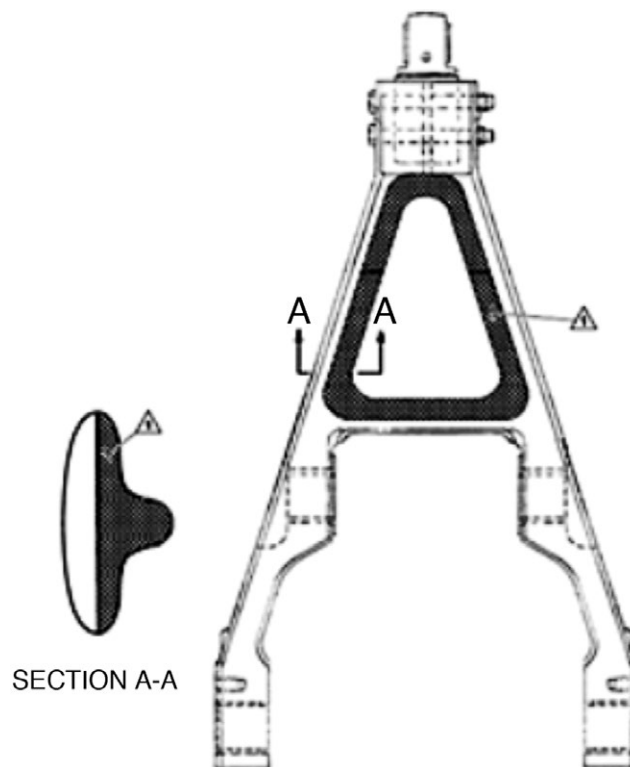
Figure 5. Collective lever

On 27/09/2011 and 12/12/2011, Bell Helicopter<sup>2</sup> issued two service bulletins, no. 412-11-148, when this part experienced fatigue fracture caused by a residual stress produced during the manufacturing process. The bulletin affects aircraft included in three groups of serial numbers, and calls for the inspection of the lever every 100 hours and replacement if cracks are found.

Figure 5 shows a diagram of the collective lever and the potential location of the cracks.

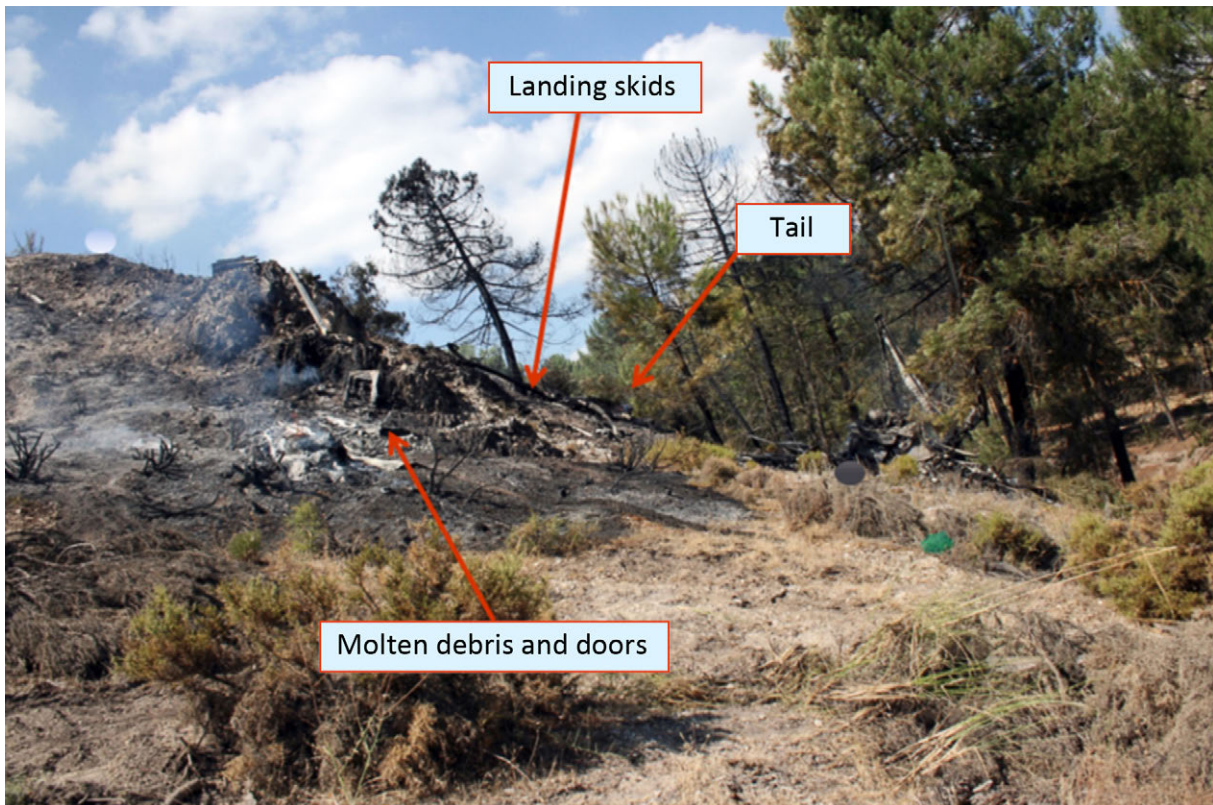
Figure 15. Debris field on the hillside

Downhill from the rock, spread out over a 15-m distance, were the left side fuselage doors, molten aluminum material and finally the engines, main rotor and crew compartment, heavily damaged by the fire. The two flight recorders were located inside.

The four main rotor blades were in one piece and remained attached to the rotor head. They were bent at the middle and had no apparent damage at their leading edges. The

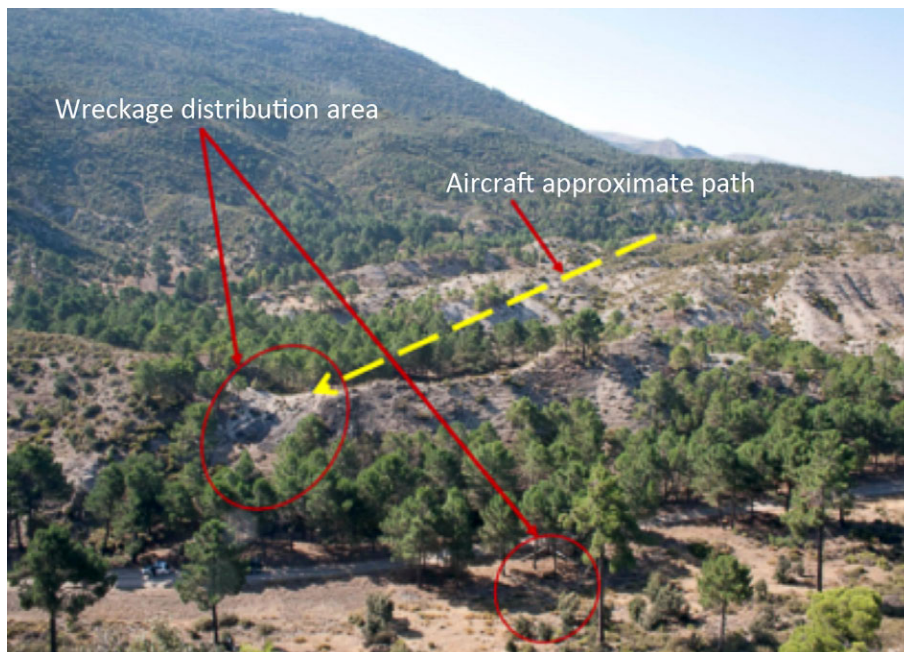
Figure 19. Area overflown by the aircraft and location of the wreckage

elevation was considerably higher than the preceding elevation. A panoramic view of the ground they would have had to fly over is shown in Figure 19.

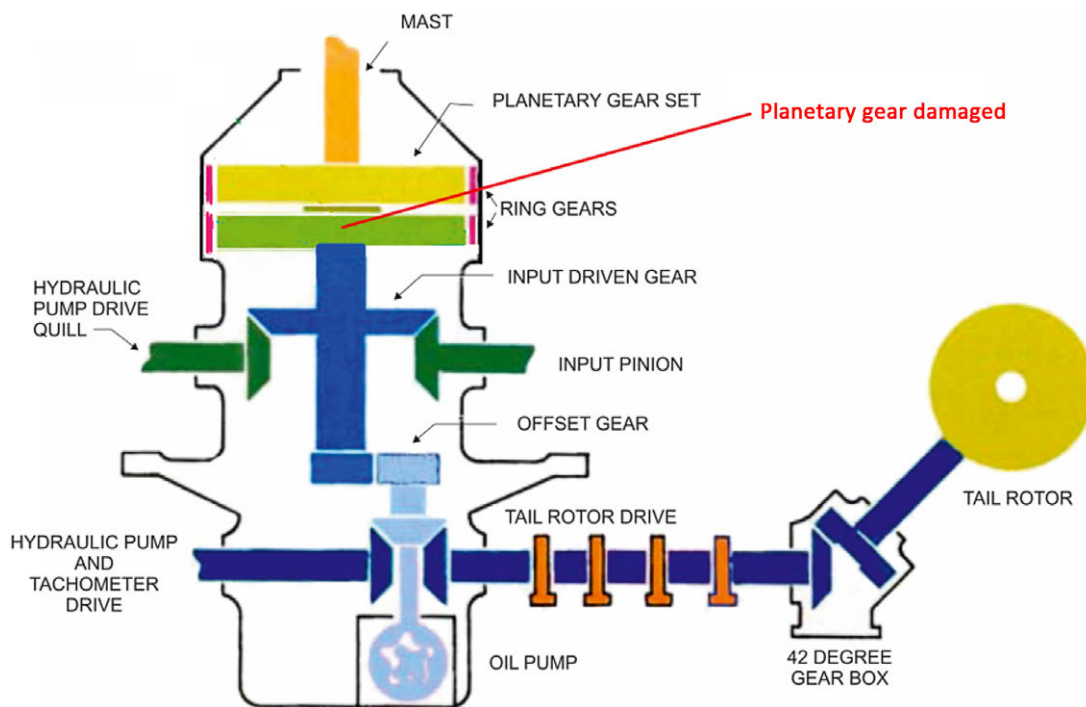
Figure 25. Area where the chain of transmission was interrupted

The fault affecting the lower planetary gear in the main gearbox caused the main rotor mast to be removed from the chain of transmission, see Figure 25. The remaining elements downstream, however, continued operating due to the rotation that the input pinion was receiving from the engines. This means that in this case, the tail rotor continued operating at the rate that was being driven by the engines.

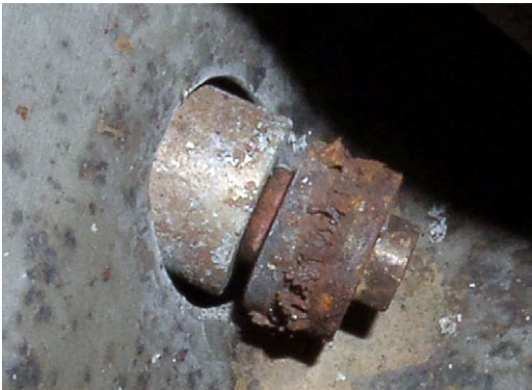
Figure 5.4. Chip detector

Inside, debris was confirmed to have adhered to the planetary chip detector, which caused the chip detector to be activated.
