Report A-008/2013

Accident involving a BOEING B-757-300,
registration D-ABOC, operated by
Condor, at the Gran Canaria Airport
on 22 March 2013

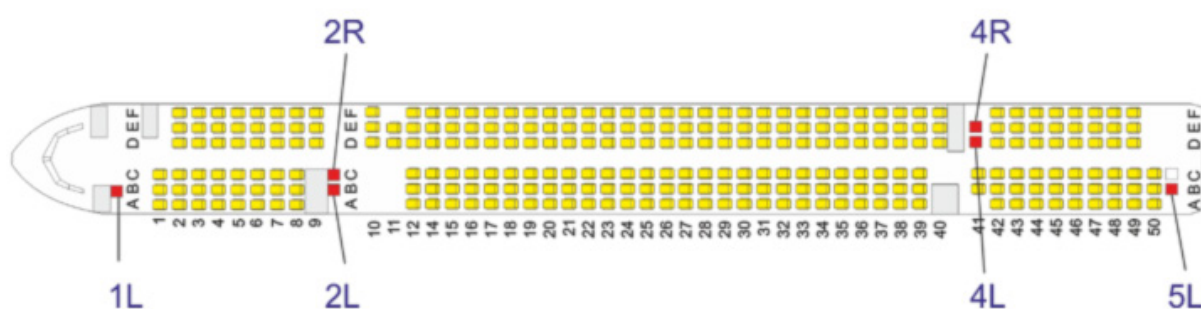
The crew coordinated with the control tower, which cleared them to do the test at position R1, which is next to the 03L threshold. A tractor towed the aircraft to that position, during which the aircraft only had the APU running. Onboard were all the crew, a maintenance technician and an operator from the airline's Gran Canaria base. Each crewmember was in position so they could immediately report any anomaly. Once at R1, the APU bleed and the left air conditioning pack were connected. As soon as this was done, a strong smell became noticeable and seconds later, the cabin crew reported that the two crewmembers in the 2L/R positions were having physical problems.

Figure 1. Seating map of the aircraft showing the positions of the cabin crew

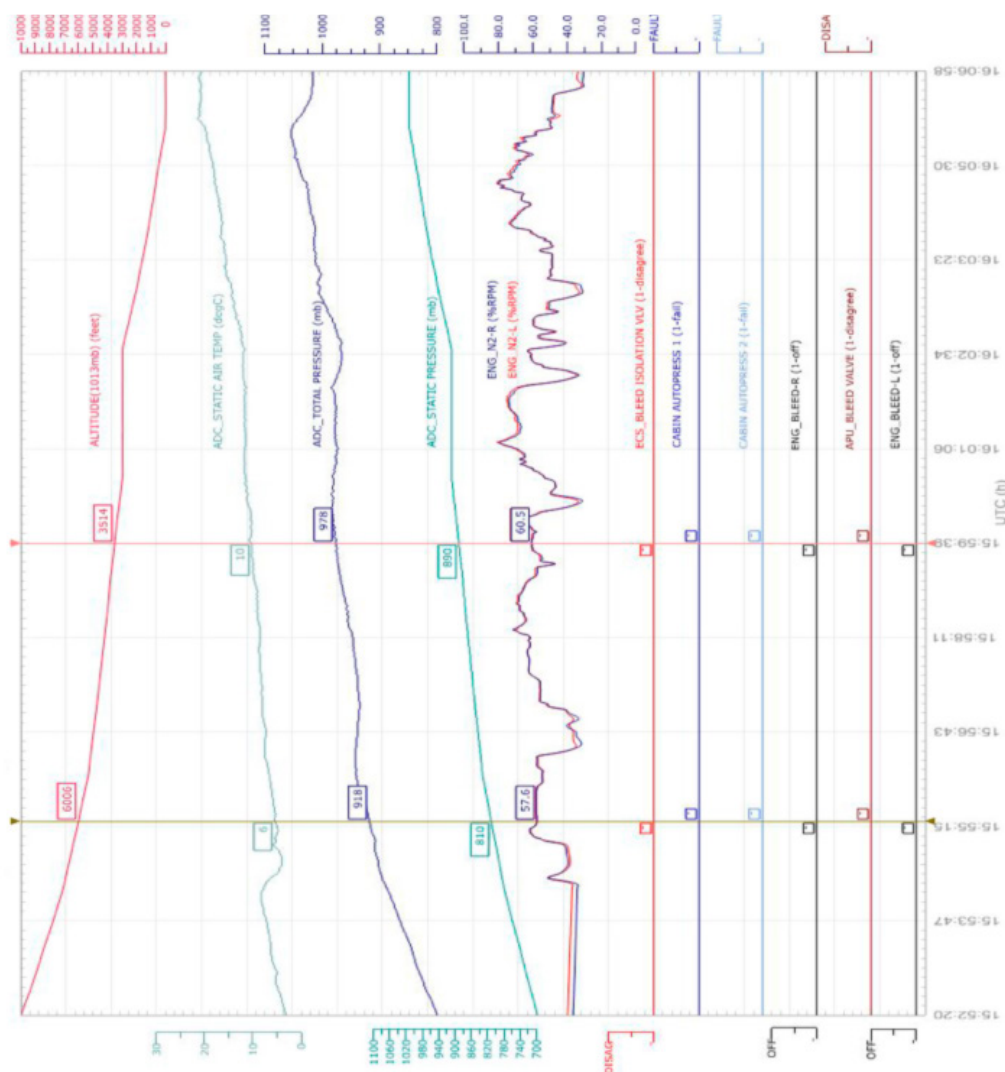
The information contained in the recorder did not indicate the presence of any abnormalities.

Figure 6 shows a graph of the values for several outside air parameters (pressure altitude, outside temperature, total pressure, static pressure), as well as for aircraft systems (N2 for both engines, position of the engine bleed valves, automatic cabin pressure fault indications, and agreement between the positions of the APU bleed valves and bleed isolation valves). The graph spans from the time the aircraft was on approach at an altitude of 10,000 ft until seconds after landing.

Figure 6. Graph showing several parameters during the approach
