Report IN-009/2016

Incident involving an Airbus
A-320-232 aircraft, registration
EC-MGE, at the Bilbao airport
(Bizkaia, Spain) on 28 March 2016

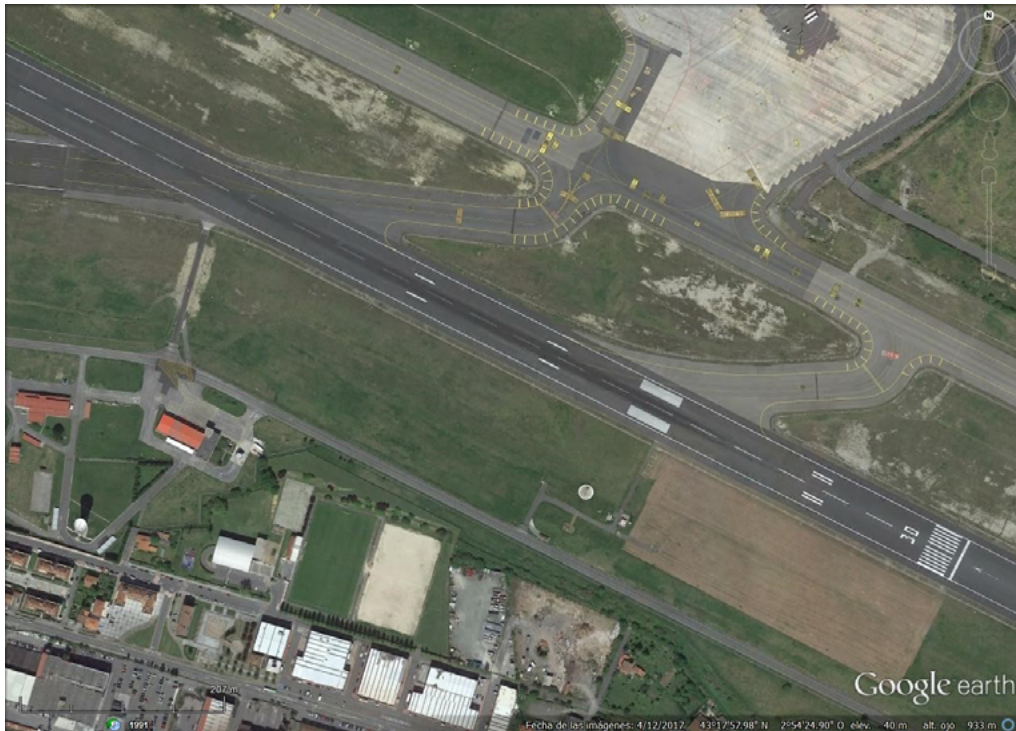
According to these specifications, on the date of the incident, runway 30 (LDA⁵ of 2140 m) should have had its TDZ indicated with four distance-coded markings consisting of four pairs of markings extending 600 m away from the threshold, separated by 150 m between them (only three are present, since the second coincides with the aiming point marking), concluding with two pairs of markings with a single line each to provide intuitive information on the length of the TDZ, the LDA and the distance between thresholds.

Figure 5. Photograph 2 Current TDZ markings on runway 30

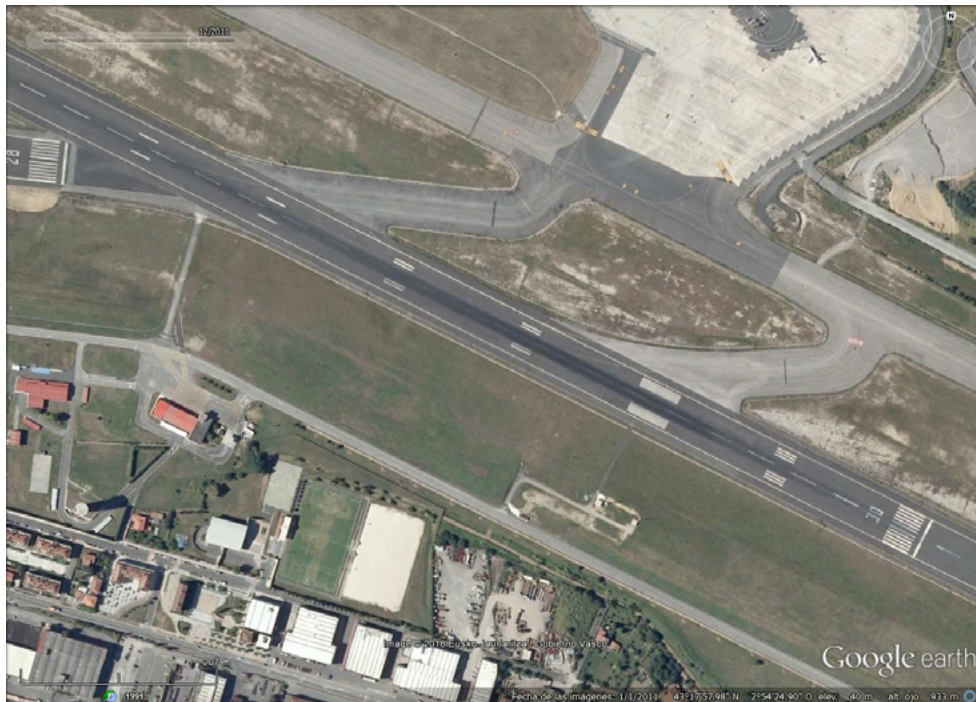
Initially, runway 30 had one indication for the touchdown zone consisting of six pairs of markings separated by 150 m between them and extending along 900 m from the threshold (only five were visible, since the second coincided with the aiming point marking).

Figure 6. Photograph 3 TDZ markings, runway 30, before the date of the incident

According to information provided by AENA, in August 2012, work was done to adapt the horizontal markings by using pressurized water to change from 3-2-2-1-1 to a 3-2-2 configuration. The transition from a 3-2-2 to a 2-2-1 configuration took place in November 2016, and relied on pressurized water to clean the six outside lateral stripes on the first pair and then repainting them, and the four erased in 2012, with a gray patina to remove any doubt with respect to the contrast between the clean aggregate and the asphalt.
