Report A-032/2017

Accident involving a Bell 412SP aircraft, registration EC-MMC, operated by Babcock International Group PLC, and a CASA 1131 aircraft, registration N1950M, at the aerodrome of Mutxamel (Alicante, Spain) on 30 December 2017

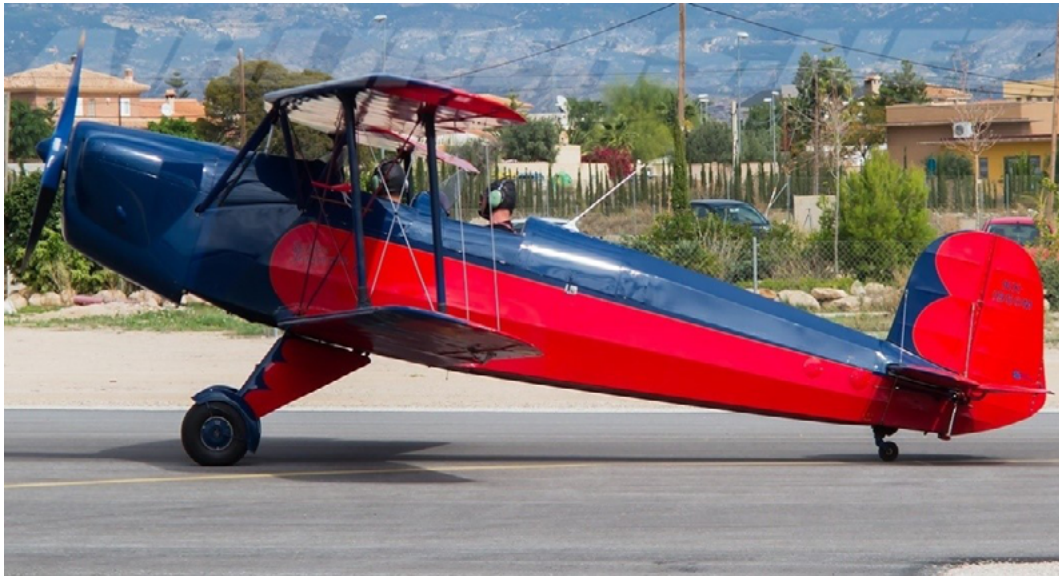
Figure 1. Aircraft N1950M

Both right wings and the propeller on aircraft N1950M broke, and there was damage to the fuselage.

Investigators were unable to locate the aircraft logbook either at the pilot's home or among his belongings at the hangar where the aircraft was parked. The airworthiness information provided by the FAA indicated that when the aircraft was purchased on 2 August 2013, work was done to remove the coating on the wings, ailerons and central section, inspect the ribs, spars and fastening components, and repair ribs and supports. Since then, the accident pilot had flown about 500 hours on the aircraft.

Figure 1 shows an image of the Bücker 131 aircraft.

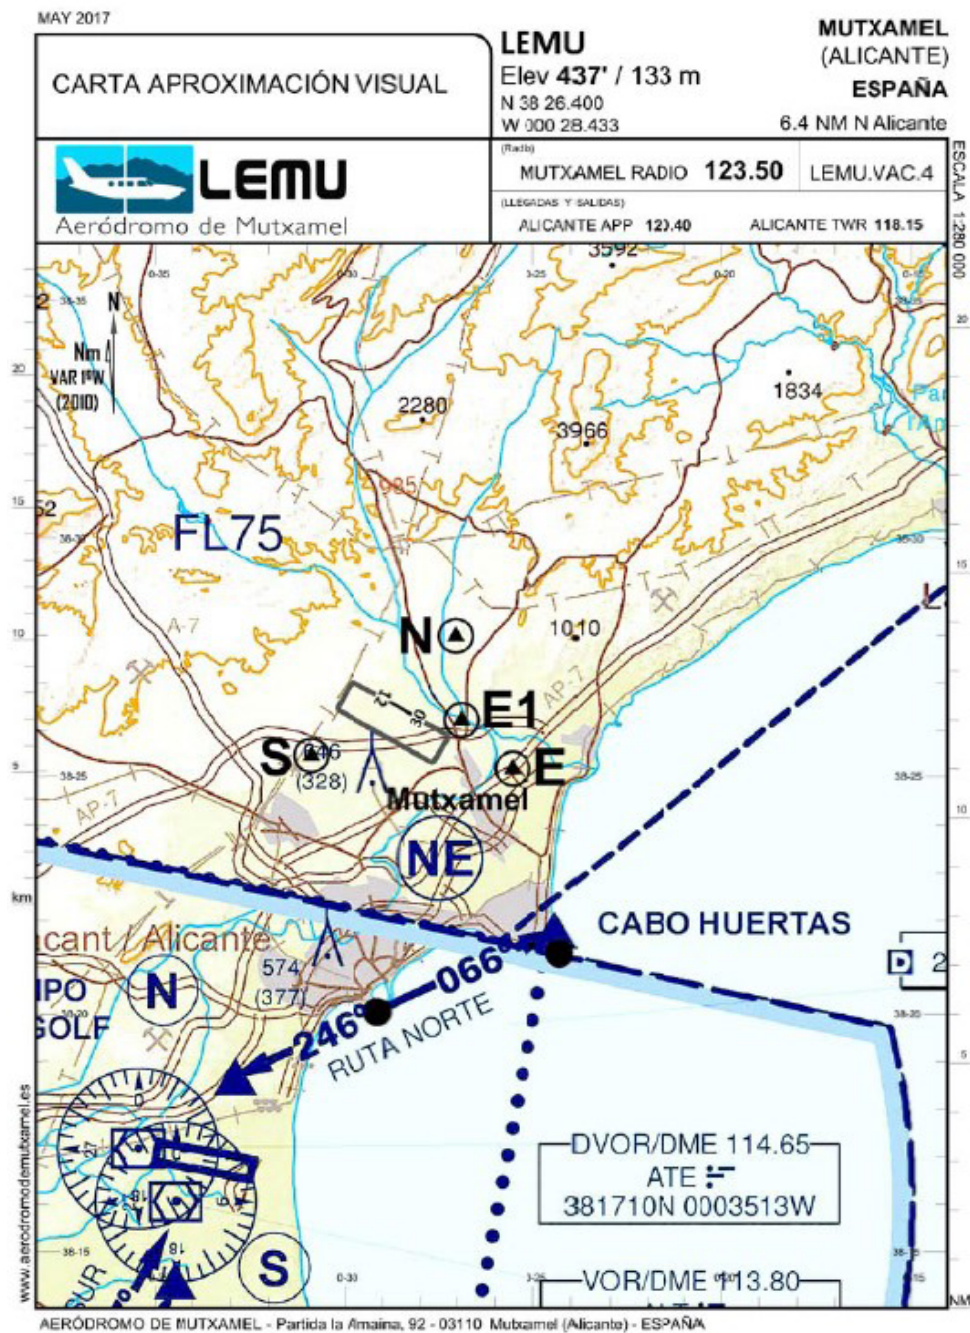
Figure 6. LEMU visual approach chart

Figure 6 shows the visual approach chart for the Mutxamel aerodrome.

Indicated on the chart are the N, E, E1 and S reporting points.

Aircraft joining the pattern must report their position in the pattern. Arrivals via point E join the pattern on the right downwind leg for RWY 12 or on final for RWY 30.

The track followed by aircraft EC-MMC shows that it directly joined the final segment of the pattern to land on runway 30, as instructed in the visual approach chart for the aerodrome.
