**COMISIÓN DE
INVESTIGACIÓN
DE ACCIDENTES
E INCIDENTES DE
AVIACIÓN CIVIL**

Report A-002/2019

Accident involving a PIPER
PA-28R-201 (Arrow III) aircraft,
registration G-OARI, on Mount
Ernio in Errezil (Gipuzkoa)
on 9 January 2019

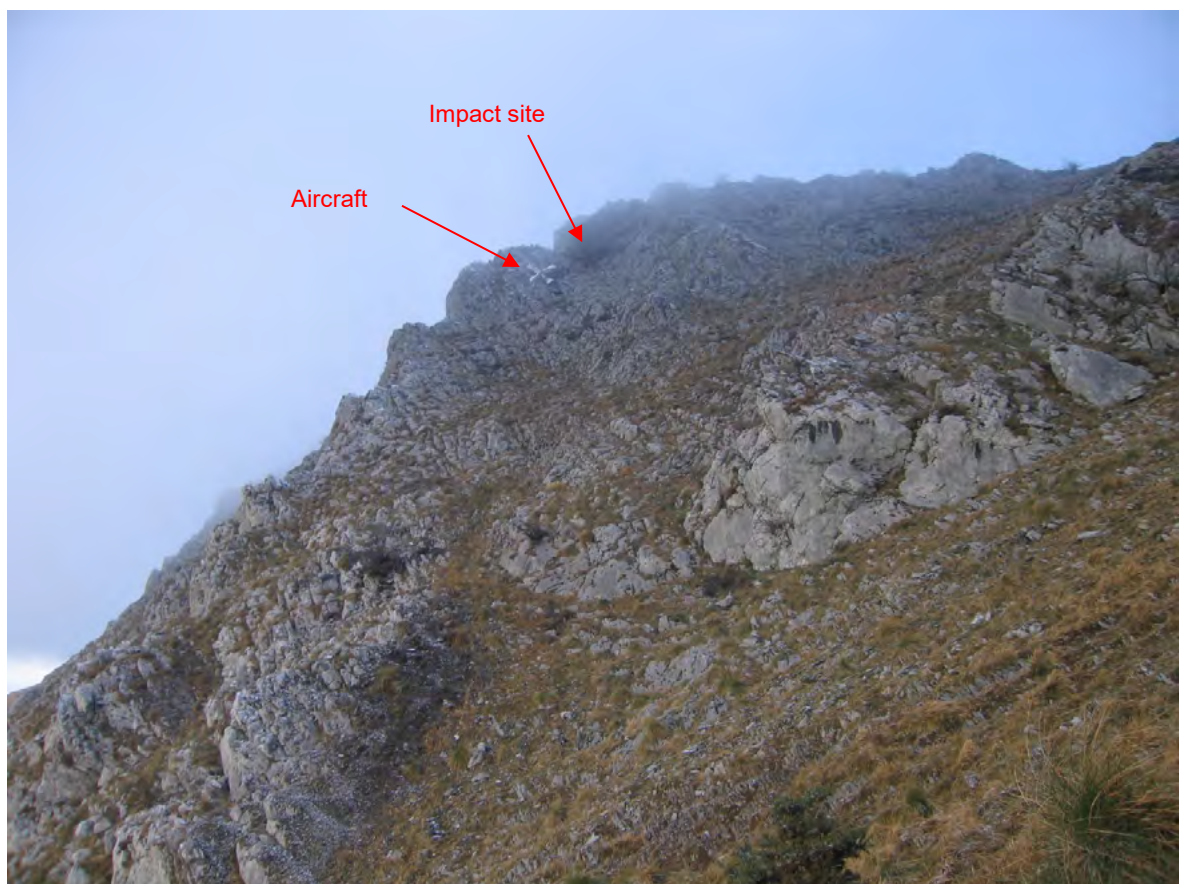
Figure 1. Photograph of Mount Ernio

Shortly afterwards, the aircraft impacted against the south face of Mount Ernio, located in the town of Errezil, in the province of Gipuzkoa.

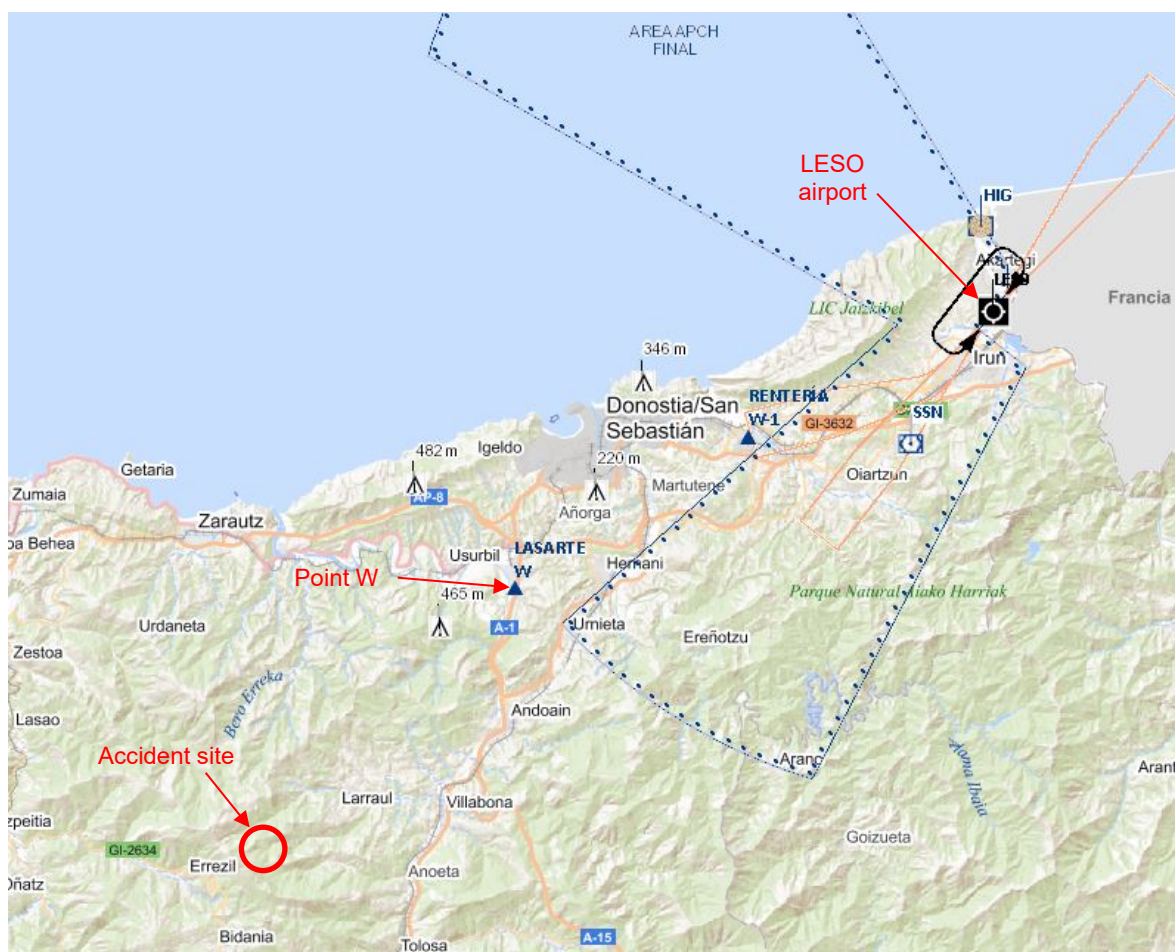
Figure 5. Map showing the accident area and the San Sebastian Airport

Figure 5 contains a section of a map that covers the area from the accident site, circled in red, to the airport of San Sebastian, which is at the top right of the map. The aerodrome circuit is shown with a black line ending in arrows. Reporting point W (Lasarte), where the aircraft was headed, is in approximately the middle of the map.
