Report A-002/2020

Accident involving a DIAMOND
DA20-A1 aircraft, registration
EC-JLN, in front of El Altillo beach
on the island of Gran Canaria
(Las Palmas de Gran Canaria),
on 19 January 2020

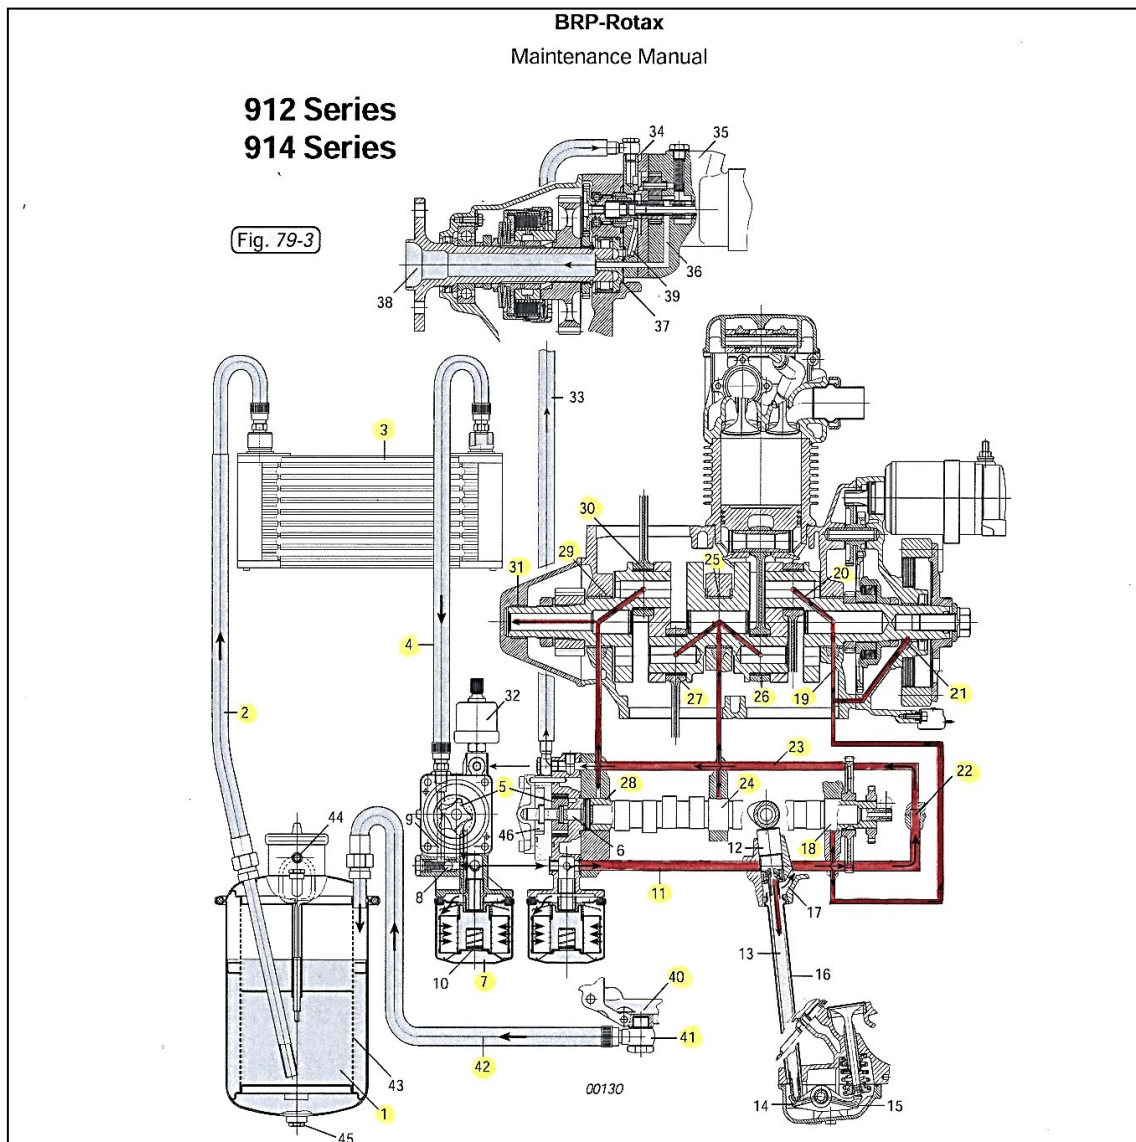
Figure 2. Diagram of the Rotax 912 and 914 series engine lubrication circuit

Figure 2 contains a diagram of the lubrication system extracted from the maintenance manual (heavy maintenance) of the 912 and 914 series engines. The part located after the filter that lubricates the camshaft, crankshaft and connecting rod bearings has been highlighted to facilitate their visualisation.

The camshaft bearing (18) and the main crankshaft bearing (19) are lubricated by the next branch of the duct (11). From the latter, the oil flows through a duct inside the crankshaft to lubricate the connecting rod bearing (20) of cylinder 4 and the bronze bushing (21) of the IH01 support bearing in the ignition housing.

The oil flows from the duct (11) through the sealing surface of the semi-crankcases (22) and into the right semi-crankcase, then continues flowing through another duct (23). This duct is divided into three branches: one of them channels the oil to the camshaft bearing (24) and another channels it to the main crankshaft centre bearing (25). From there, the oil travels through two internal conduits in the crankshaft to the connecting rod bearings (26) and (27) of cylinders 2 and 3; the third branch continues towards the front of the engine.
