Technical report A-003/2022

Accident on 10 January 2022, involving a PS-28 Cruiser aircraft operated by Flyschool Air Academy, registration EC-NKP, at Casarrubios del Monte Aerodrome (Toledo, Spain)

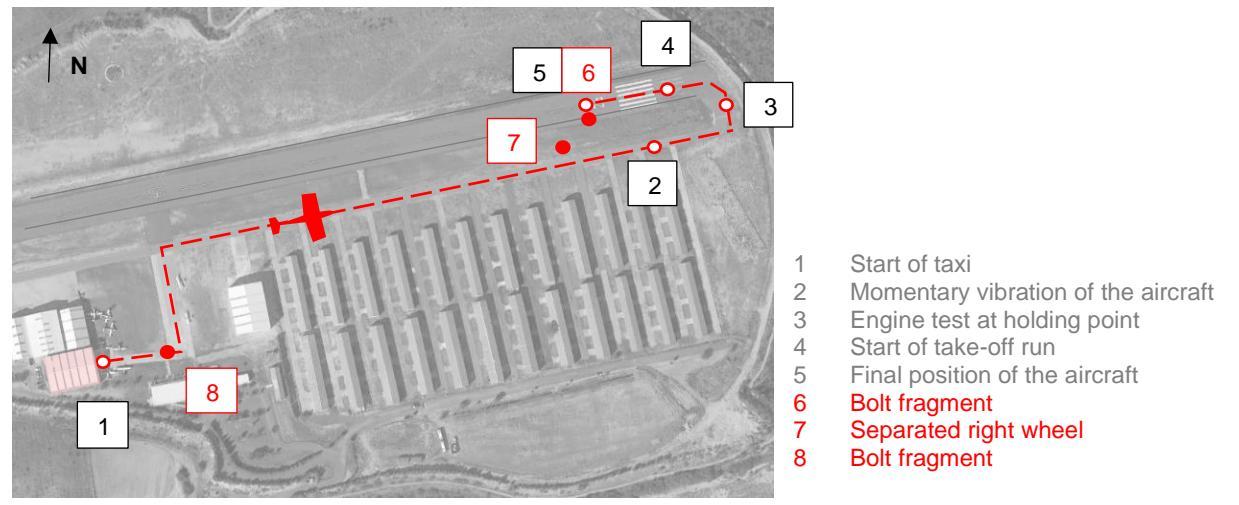
Figure 1. Take-off run (described by the crew)

The detached wheel, belonging to the right main gear, was recovered about 30 m from the aircraft. Two bolt fragments from the right wheel, with their washers and nuts in place, were also found. The location of these parts and the ground trajectory followed by the aircraft are shown in figure 1. Based on the sketch made by the instructor, it's estimated the aircraft travelled 70 m on the runway.
