**COMISIÓN DE
INVESTIGACIÓN
DE ACCIDENTES
E INCIDENTES DE
AVIACIÓN CIVIL**

Report A-004/2017

Accident involving a Socata
TB-20 Trinidad aircraft,
registration D-ECJP, in
Sierra de Tejeda,
Canillas del Aceituno (Málaga)
on 29 April 2017

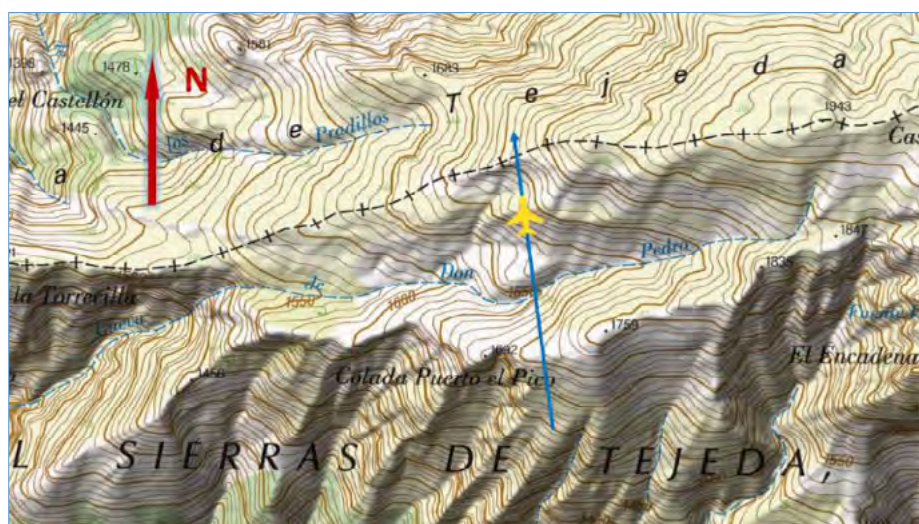
The aircraft wreckage was found scattered on a slope with a 28° gradient at an elevation of 1718 m (5636 ft), rising in the direction of flight. The first impact point contained debris from the propeller and, fanning out, other aircraft parts, with the engine, at 23 m, being the furthest away. Spreading out from this first point was an area affected by the fire caused by the fuel contained in the tanks. Figure 7.

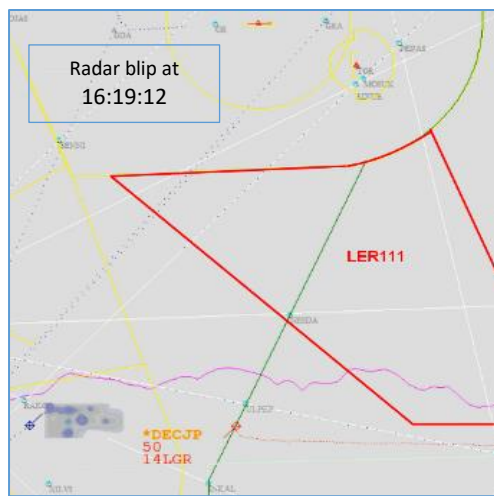
16:18:55	DECJP	<i>DECJP squaking 6303 we are VFR flight from LEMU to LEGR presently 5000' inbound PTM⁹, request to cross airspace and 5000' via PTM, LEAX, S from LEGR inbound for LEGR</i>
At 16:18:55 , the crew of the aircraft contacted LEMG APP and after identifying itself as a VFR flight on route to point PTM at 5000 ft, they requested to cross the airspace at 5000 ft via PTM, LEAX, point S for LEGR and LEGR.		
Remarks:		
<ul style="list-style-type: none"> The phraseology used and the data provided by the crew of the aircraft in their report conform to the communication standards for VFR¹⁰. The crew are aware that VFR rules apply. The crew know the points they are flying, indicating they have available to them a navigation chart (identified in the wreckage). The crew anticipate entering class-D airspace and contact ATC to request crossing the airspace. The aircraft started a right turn during the transmission, as shown by the radar track, in order to stay at an altitude of 5000 ft.

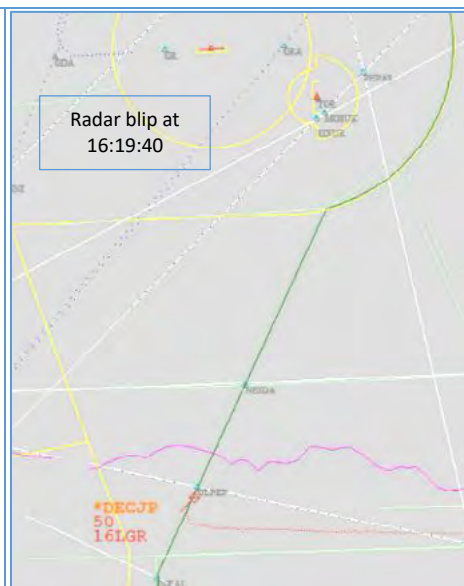
16:19:40	DECJP	<i>I don't understand. May we continue in 5000' direct PTM now?</i>
At 16:19:40 , the crew of the aircraft requests clarification since they "don't understand", and asks about the possibility of continuing at 5000 ft direct to point PTM.		
Remarks:

- Since the controller makes no reference to the altitude, the crew seek clarification by trying to determine if they can continue to point PTM, the first point listed on the route, at 5000 ft.
- The crew of the aircraft are uncertain about their current altitude and the altitude they should be at in order to cross the airspace.
- The aircraft continues turning right while holding at 5000 ft during the conversation.

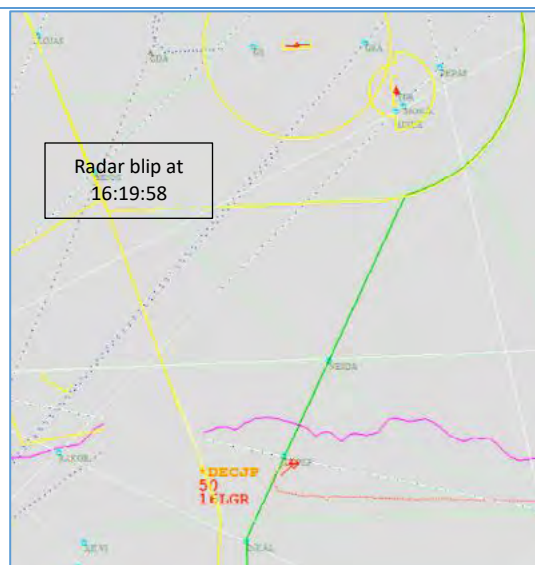
16:19:58	DECJP	<i>Ok, so, confirm we are climbing to 5500' direct PTM, then after LEAX then S point from LEGR</i>
At 16:19:58 , the crew confirm they are climbing to 5500 ft direct to PTM, then LEAX and then point S of LEGR.		
Remarks:

- The use of the term “confirm” in its communication means that the crew are confirming the climb to 5500 ft and the route to LEGR point S.
- The confirmation is used to verify that the correct altitude is 5500 ft, since the altitude is the only change made during the messages exchanged.

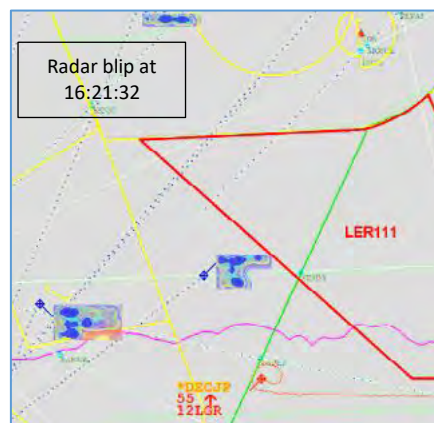
16:20:15	LEMG APP	<i>Affirmative, affirmative</i>
At 16:20:15 , the controller replied “Affirmative, affirmative”, possibly due to the immediate communication it was maintaining with an IFR flight.		
Remarks:		
<ul style="list-style-type: none"> • It is not an acknowledgment by the controller, but rather a confirmation of the pilot’s message. • The “Affirmative, affirmative” reply received from the controller could have reinforced the crew’s mistaken belief that it was safe to cross all the waypoints at 5500 ft. • Under no circumstances would the controller’s reply release the crew from their responsibility to maintain separation from the terrain.

At **16:21:32**, the crew reached 5500 ft while still turning.
