Report A-012/2020

Accident involving a Piper
PA-60-602P aircraft, registration
EC-HRJ, on final approach to
Pamplona Airport (Navarra) on 20
February 2020

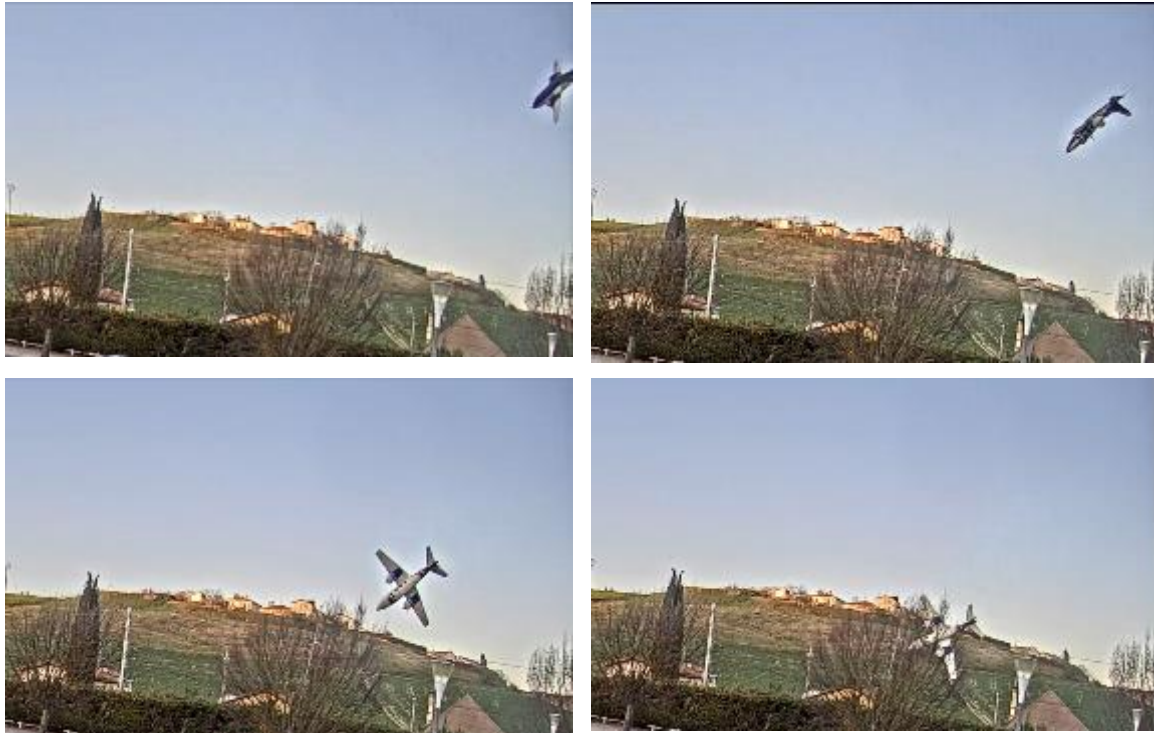
The accident aircraft did not have any flight recorders because they are not a requirement for that type of aircraft. However, the last moments of the aircraft's flight were captured by security cameras installed in a group of warehouses near the accident site. From the images, it is concluded that the aircraft rolled to the right before hitting the ground.

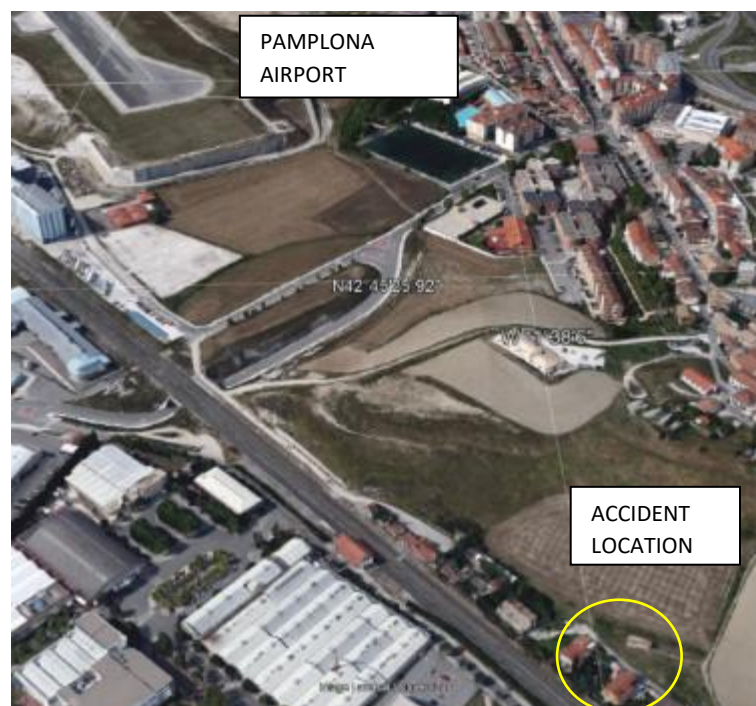
The image on the right shows the location of the accident and the runway at Pamplona Airport.

As it fell, the aircraft hit and severed a power line. The wreckage inspection revealed that it probably hit the power line with its tail cone because marks compatible with the cable impact were found on the vertical stabiliser.

Afterwards, the aircraft split part of a house fence. Again, the wreckage inspection revealed that it probably hit the fence with its left wingtip, which was found on the ground near the fence. At the same time, the left propeller left marks on the cement road, and the right propeller left tracks on the soft ground.

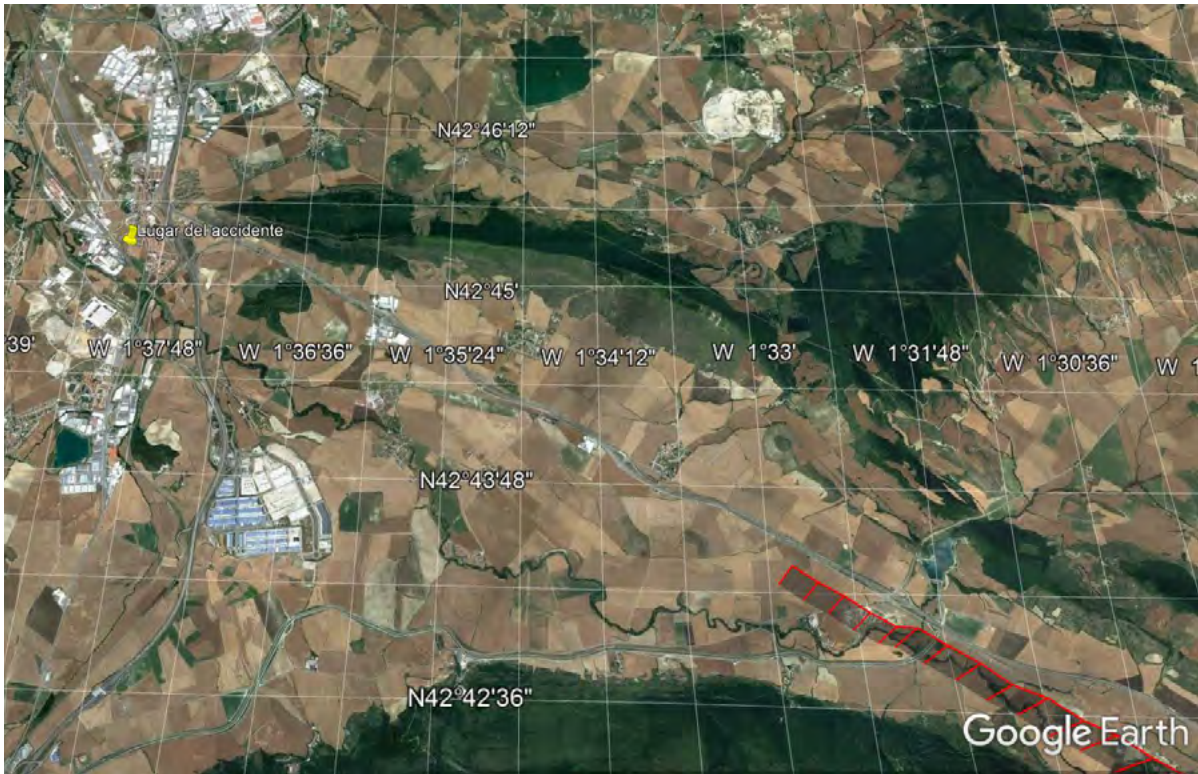
The following Google Earth image shows the course the aircraft was following moments before losing the radar trace and the location of the wreckage of the crashed aircraft (in yellow). The runway at Pamplona Airport can be seen.

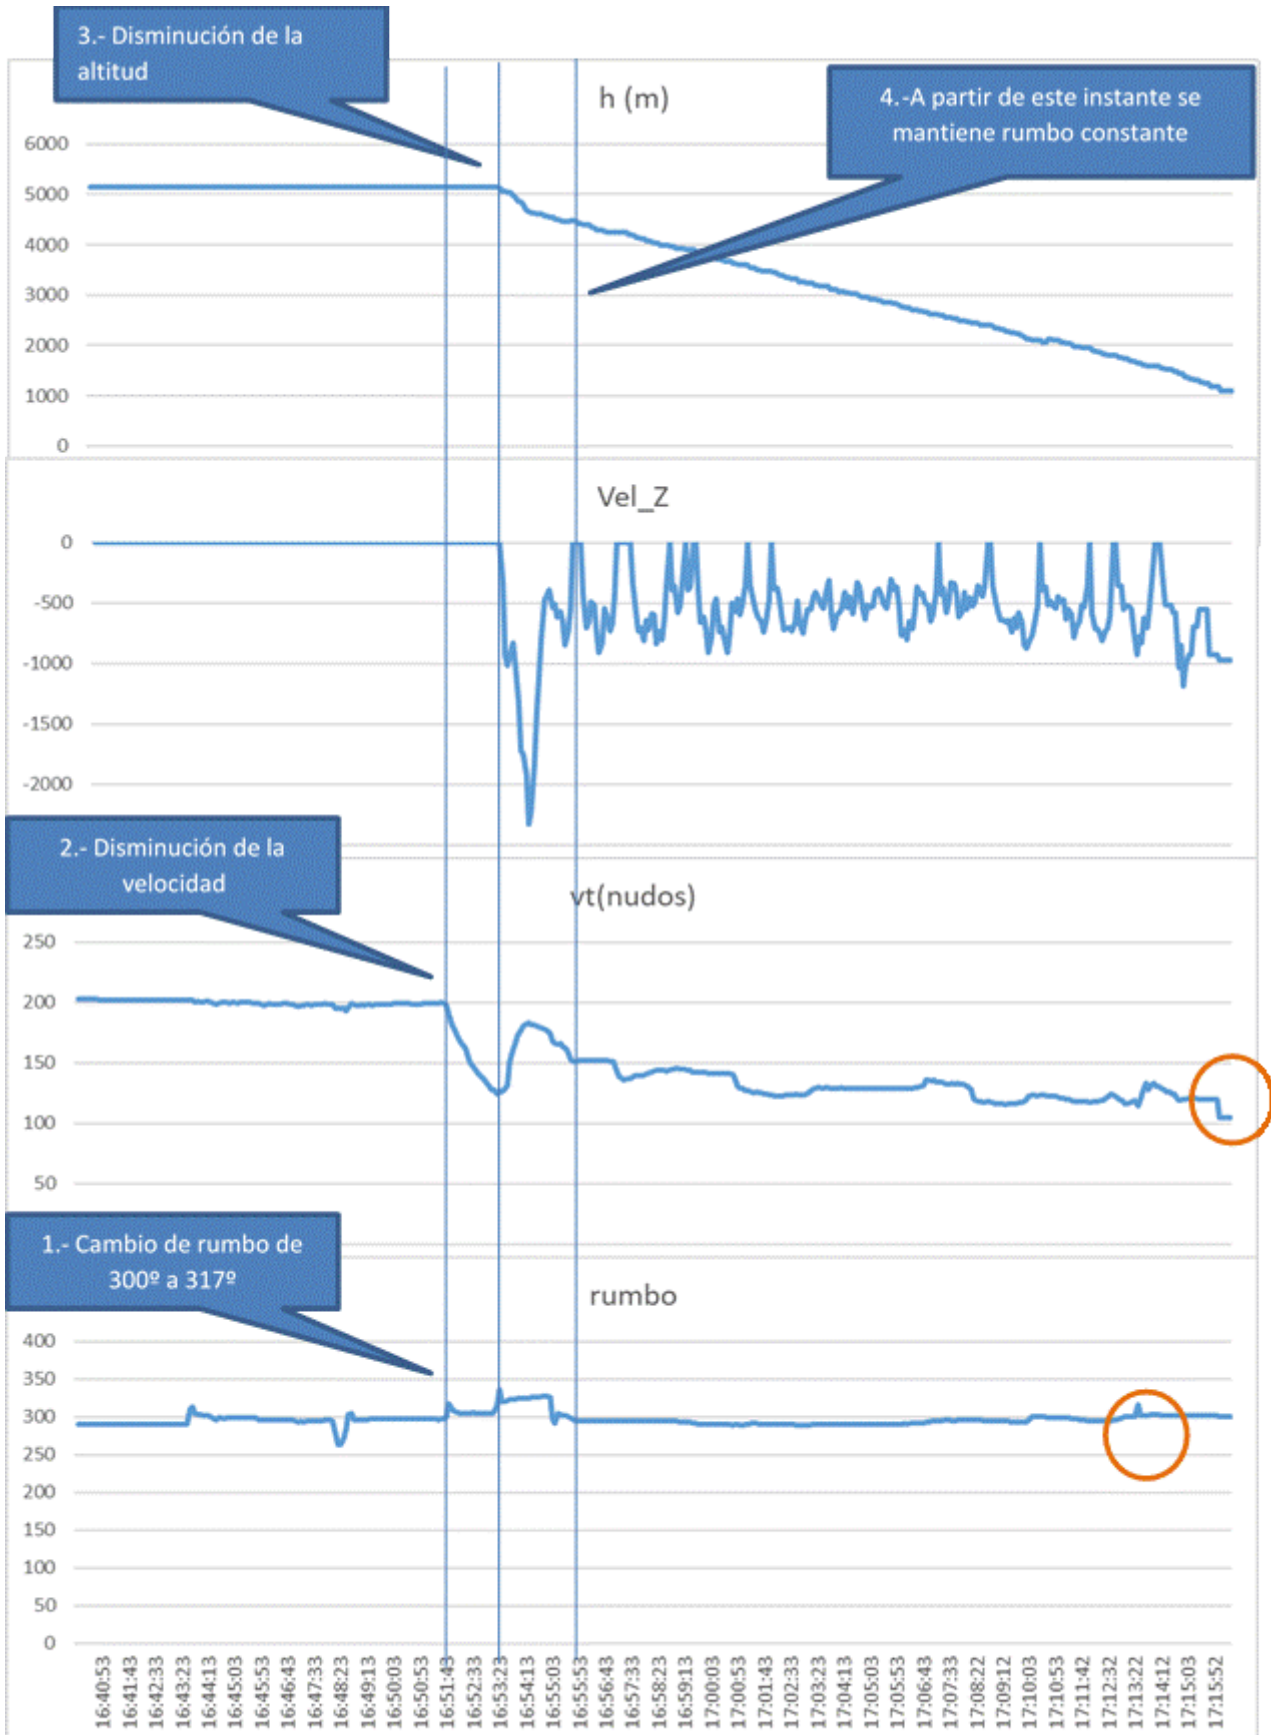
Illustration 9: altitude (in meters), descent speed (in ft/min), ground speed (in knots) and heading (in degrees) as a function of time

- The aircraft's ground speed remained between 140 and 120 knots.
- It continued to descend until it reached the vicinity of Pamplona Airport, where its radar trace was lost. On average, the aircraft descended 500 feet/minute, and from 17:11 UTC, its speed increased to 600 feet/minute. Prior to the increase in descent speed, the aircraft's speed had dropped below 117 knots.
- The heading remained constant, except for the yaw (to the right), which must have been unintentional because it was rectified moments later. (An orange circle on the graph illustrates the yaw). It did not affect the aircraft's altitude.

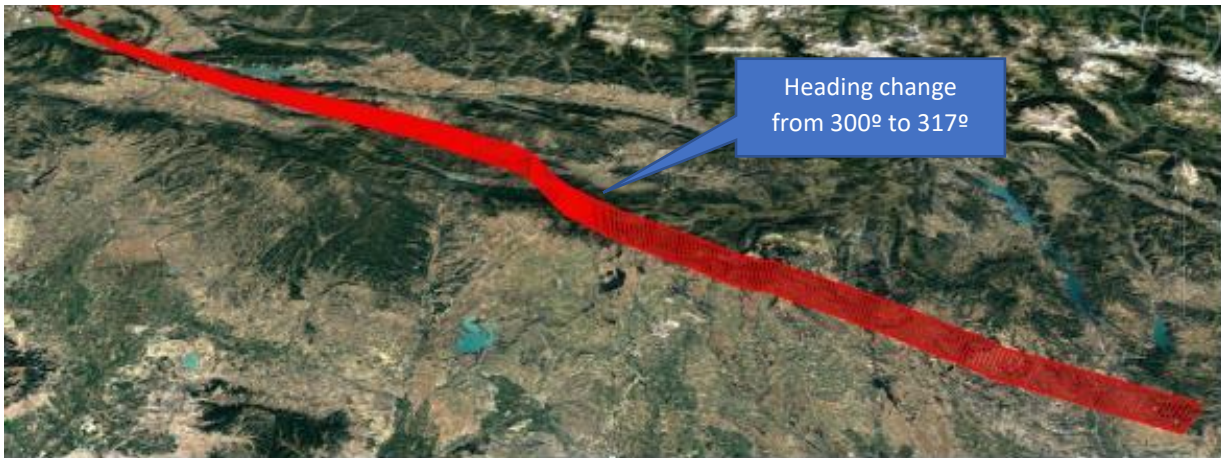
Illustration 10: the aircraft's trajectory from 16:40:08 utc to 17:16:22 utc

The following image shows the aircraft's trajectory over the terrain from 16:40:08 UTC to 17:16:22 UTC. It shows the aircraft's change of heading.

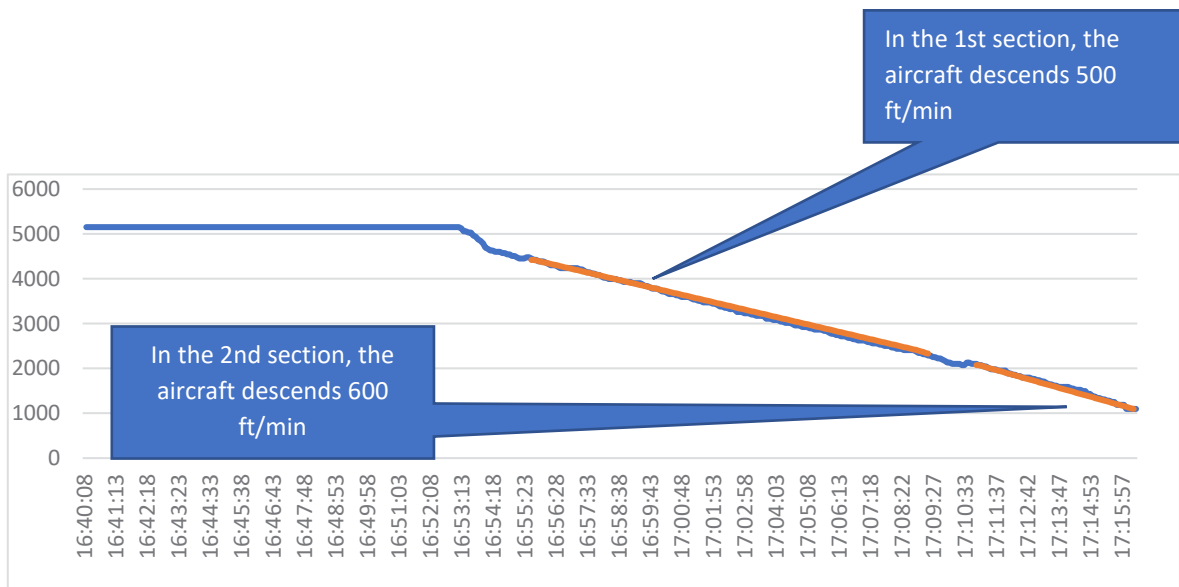
illustration 12: rate of descent as a function of time

As of 17:11 UTC, the descent speed increases from 500 ft/min to 600 ft/min.
