**COMISIÓN DE  
INVESTIGACIÓN  
DE ACCIDENTES  
E INCIDENTES DE  
AVIACIÓN CIVIL**

## **Report A-016/2018**

Accident involving a Mooney  
M20K aircraft, registration  
D-ETFT, in the municipality of Flix  
(Tarragona), 12 May 2018

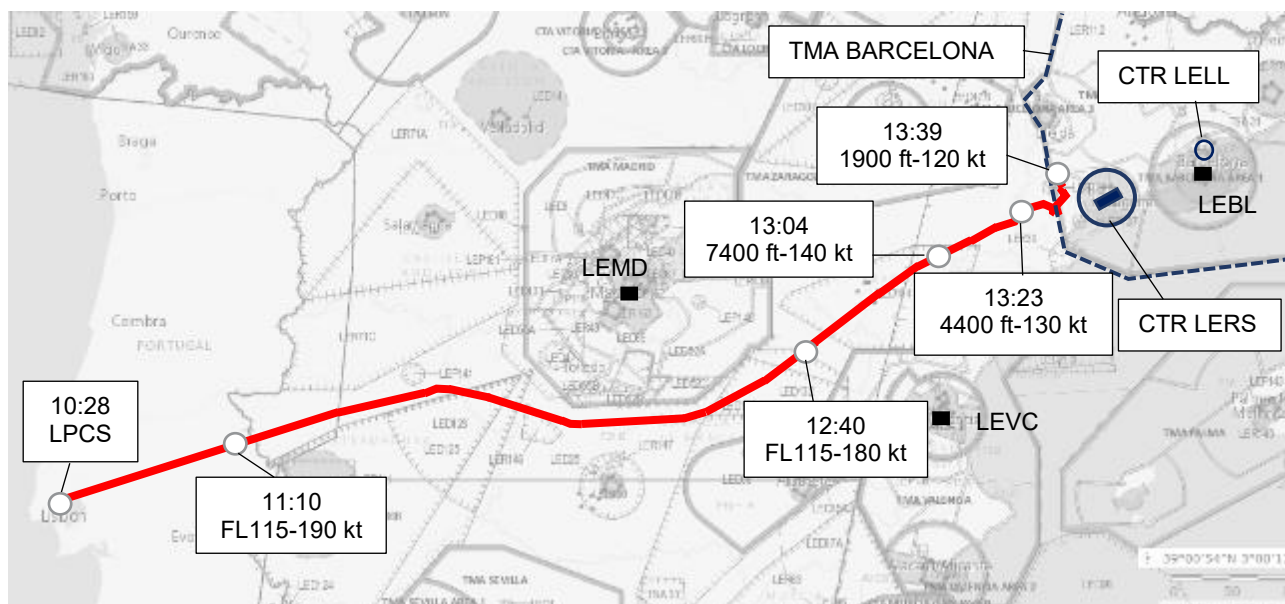
Figure 1. Complete flight path

After arriving in Cascais on Thursday the 10<sup>th</sup>, the aircraft was refueled with 151 l of fuel<sup>2</sup>. No further activities were logged until Saturday. On Saturday, 12 May, a flight plan was filed at the Cascais Airport to fly from Cascais to Reus under visual flight rules (VFR). The flight had an estimated duration of 4 h at a speed of 150 kt and a cruise level of FL115. The range was 5 h 30 min and the alternate airport selected was Sabadell (LELL).

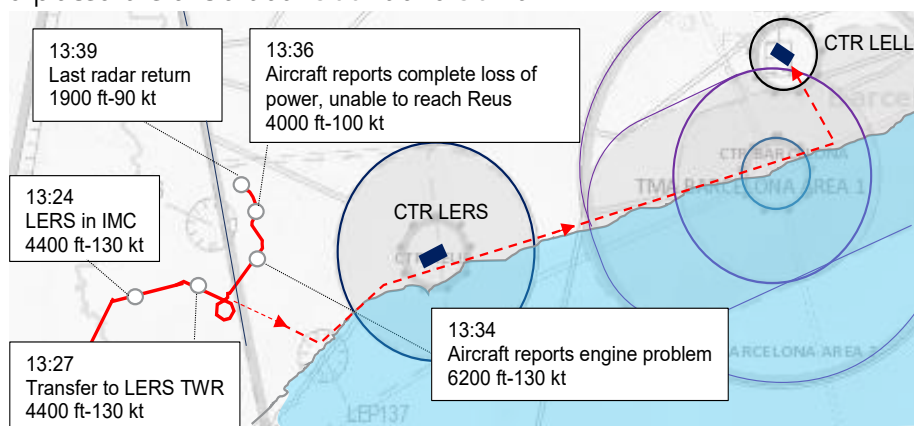
Figure 2. Flight path from 13:23

At 13:24, with the aircraft at 4400 ft and 130 kt, the pilot was informed that Reus, the destination airport, was in IMC. The pilot reported he would go to the alternate, Sabadell, following the coastline (shown with a dashed red line in figure 2). Even though ATC informed him that he could not fly that route because it crossed the airspace associated with the Barcelona Airport, the pilot repeated his initial intentions on up to three occasions. Finally, while in contact with Reus TWR, the pilot changed his mind and requested vector guidance.

At 13:34, the pilot reported that he needed to descend due to an engine problem ("we have trouble with the engine"). In addition to this initial report, the pilot made three more, each more serious than the last, before reporting "loss of engine power".

The pilot again requested radar vectors to the nearest airfield. The controller informed him that Reus, 22 NM away, was the nearest one. The pilot replied they could not reach Reus and again requested an airfield on which to land. The final message from the pilot was intermittent and took place at 13:38, with the following content: "I...road...below". The last radar return was received at 13:39 and placed the aircraft at 1900 ft and 90 kt.

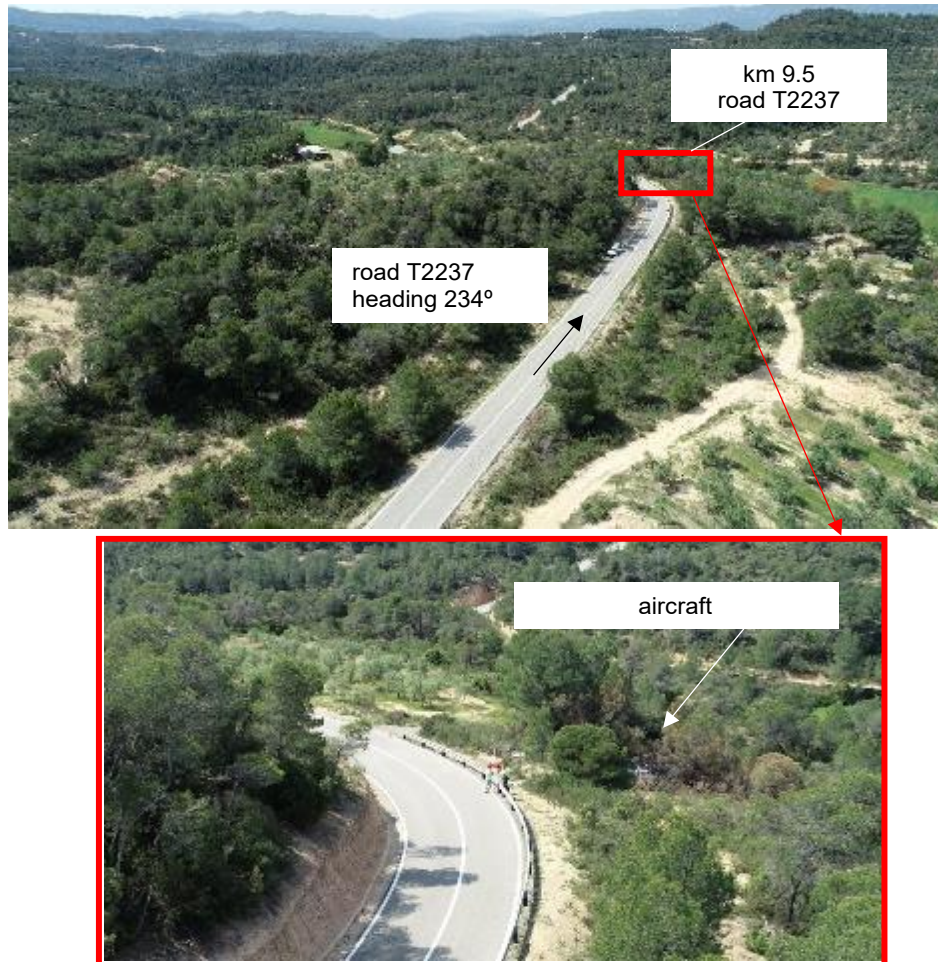
Figure 3. Position of the aircraft relative to road T2237

The aircraft impacted the ground in a mountainous area in the municipality of Flix (Tarragona), at kilometer marker 9.5 of road T2237. This point was 2.9 km south of the last radar return. After impacting the ground, a fire broke out that was seen by a couple that was traveling on road T2237 and that called emergency services. All three occupants of the aircraft were killed in the accident.

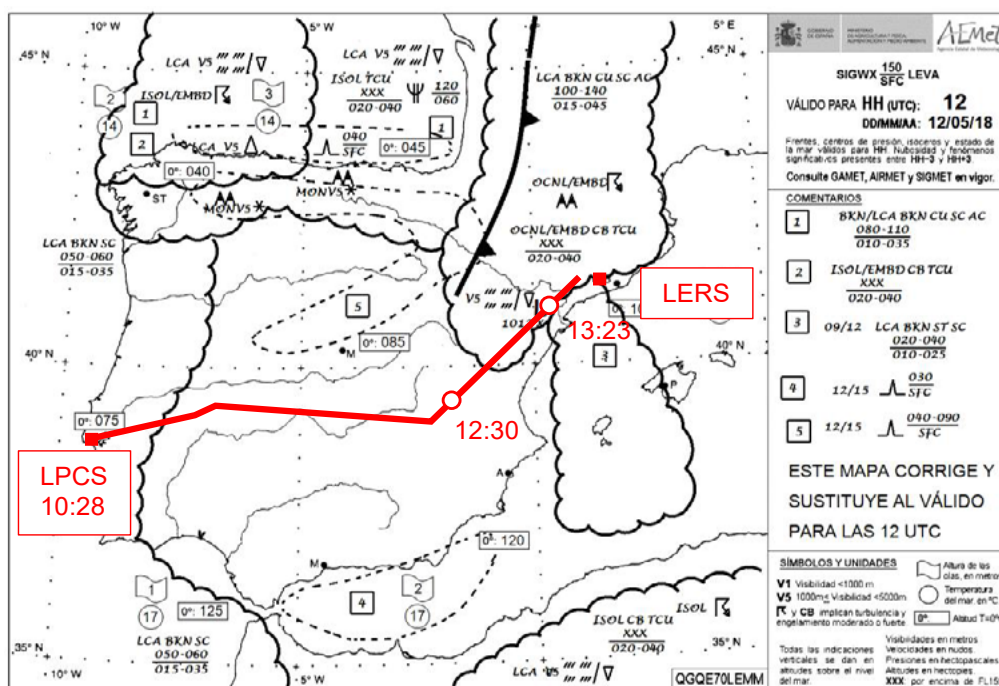
Figure 5. 12:00 UTC SIGMET, issued at 05:00 UTC, and applicable to the flight

The service provider at the Cascais Airport weather office confirmed that the pilot had not made any requests involving the expected weather along the flight path or at the destination and alternate airports, although there are other ways (internet) to find that information.

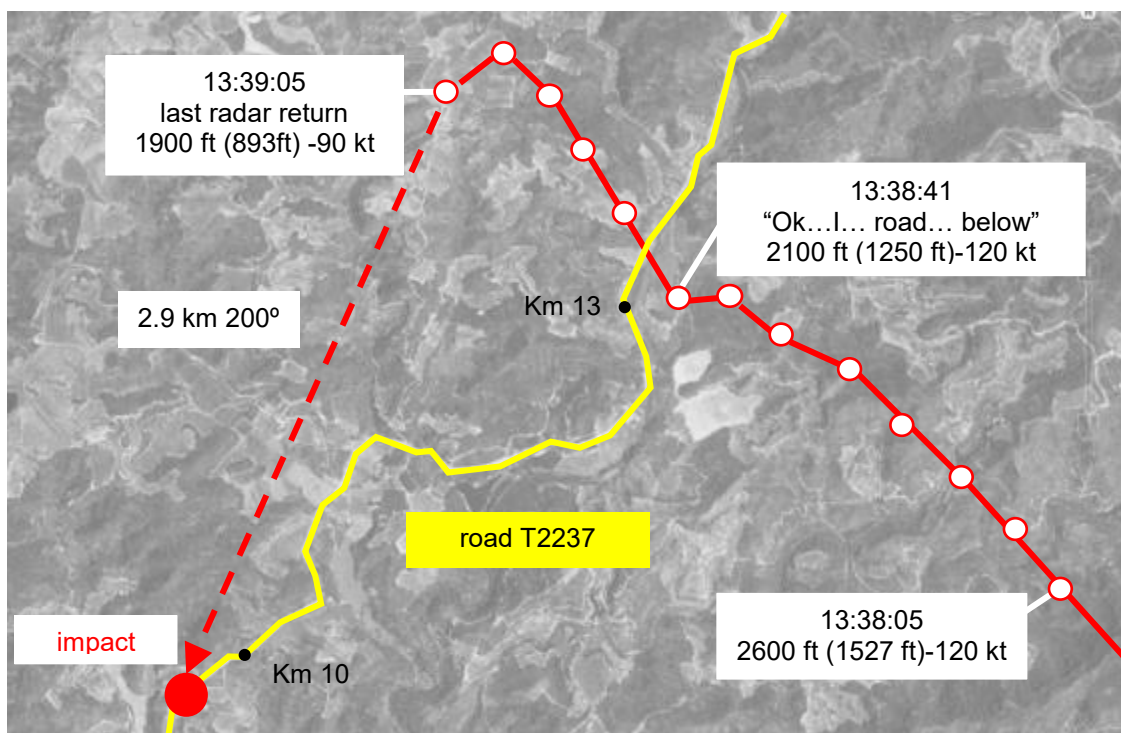
Figure 6. Flight after 13:38:05 (altitude AGL shown in parentheses)

The last valid radar return was recorded at 13:39:05, and showed the aircraft was 893 ft AGL. Assuming the aircraft maintained its final recorded speed of 90 kt<sup>9</sup> until the time of impact, it is estimated that the aircraft may have made contact with the ground 62 s<sup>10</sup> later, at 13:40:07.

During this final minute before impact, the aircraft descended 100 ft, since the road was at an elevation of 238 m (793 ft), meaning that this final descent was carried out at a rate of 100 fpm. Figure 6 shows the flight path over the ground during the last two minutes of the flight. The altitude, AGL (in parentheses) and ground speed (GS) are shown at certain significant points.

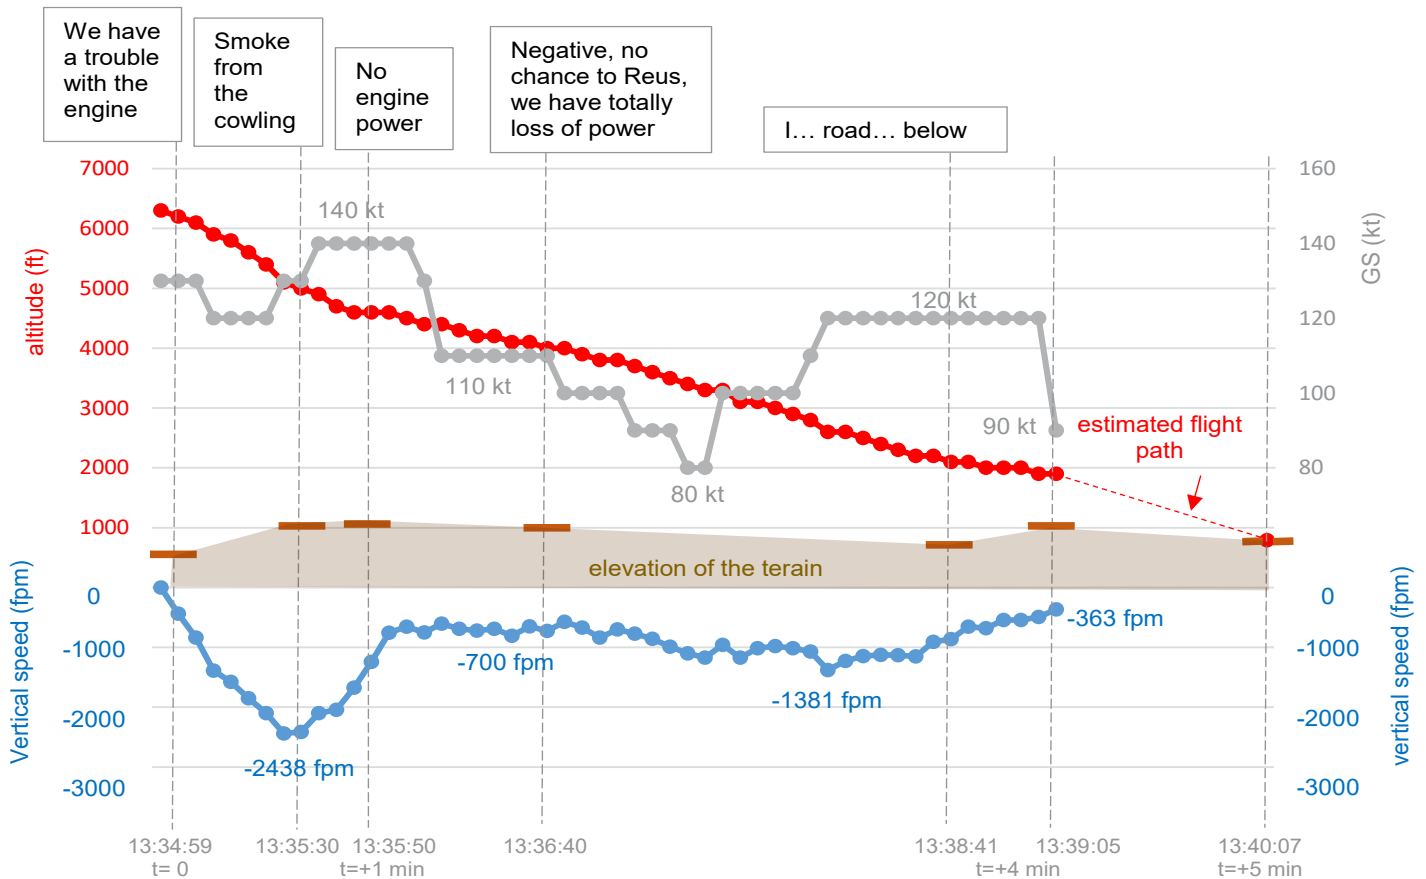
Figure 7. Flight profile after engine failure report

Figure 7 shows the aircraft's flight profile from the time the pilot reported the engine problem until it made contact with the road. The total distance traveled was 9.5 NM. The ground speed (GS) is shown in gray, the altitude in red and the descent rate in blue. In addition to these three parameters, the graph includes:

- Horizontal marks and brown shading representing the elevation of the terrain at the most significant moments.
- The most relevant messages sent by the pilot.
- An estimate of the descent between the last valid radar return until contact with the ground.

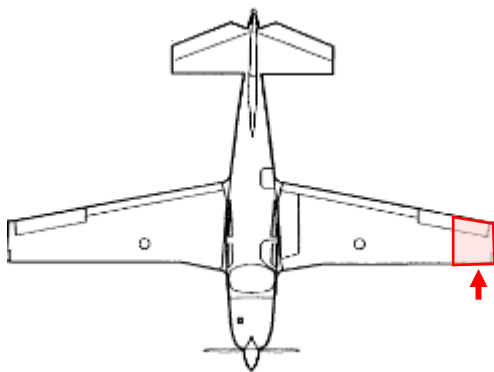
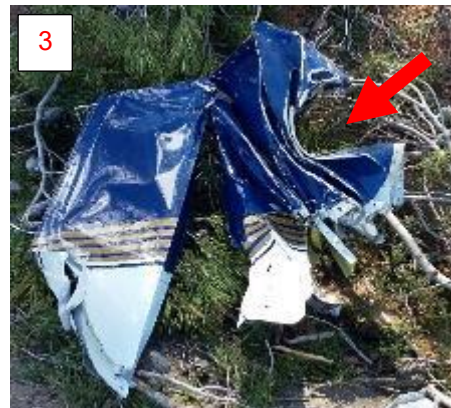
- 1 Tree #1 (pine), which was missing the branches found next to road T2237. This point, at an elevation of 238 m, was at the end of a straight 300-m section on a southwesterly heading (234°). The tree trunk and its upper branches were intact. The severed branches were at a height of 8.5 m above the road.

- 2 Tree #2 (pine), 3 m away from the first, which was also missing branches on the side facing the road at a height of 8.5 m.
- 3 Branches ripped from trees 1 and 2 found on the left side of the road and after the last tree. The branches found were very leafy. Also found with these branches were two pieces that made up the final 90 cm of the left wingtip. There was a round deformation and compression marks on the leading edge, 45 cm away from the tip. The other fracture zone exhibited deformation toward the upper surface of the wing. The debris found in this area was not affected by the fire and still had the original paint.

- 4 67 m away from point 1 there were friction marks on the asphalt, with small flecks of blue paint, that were oriented practically perpendicular to the length of the road. Continuing in the direction of this mark, there was similar abrasion on the guardrail. This point is at an elevation of 236 m, and the marks are believed to have been made by the right wingtip, and that the marks and deformations found in 6 were created here.

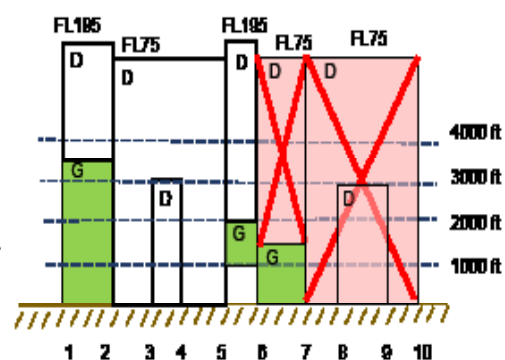
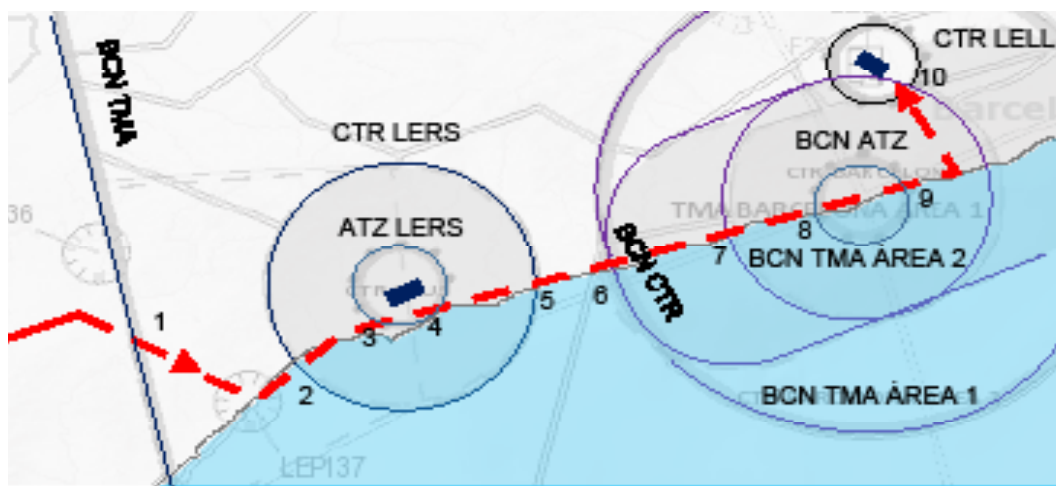
Figure 14. Viability of route to Sabadell along the coast

The aircraft was about to enter the Barcelona TMA when the pilot was notified that Reus was in IMC. The Barcelona TMA has several airspaces, each with different restrictions regarding VFR flights. This information is contained in the AIP, in the VFR traffic chart of the Barcelona TMA (AIP ENR 6.5). Figure 14 shows a vertical cross section (not to scale) of the different airspaces the aircraft would have to cross to travel along the coastline. It contains three types of airspaces (described in section 1.18.1):

- G in green, no restrictions for VFR traffic.
- D in white, subject to ATC clearance.
- D in red, no VFR traffic allowed.

- Barcelona TMA (1-2) (5-6)
- Reus CTR (2-3) (4-5)
- Reus ATZ (3-4)
- Barcelona CTR (6-7)
- Barcelona TMA Area 2 (7-8) (9-10)
- Barcelona-El Prat ATZ (8-9)
