## Report A-016/2020

Accident involving a Piper  
PA-28R-200 aircraft, registration  
EC-HLV, at Casarrubios del  
Monte Aerodrome (Toledo)  
on 9 June 2020

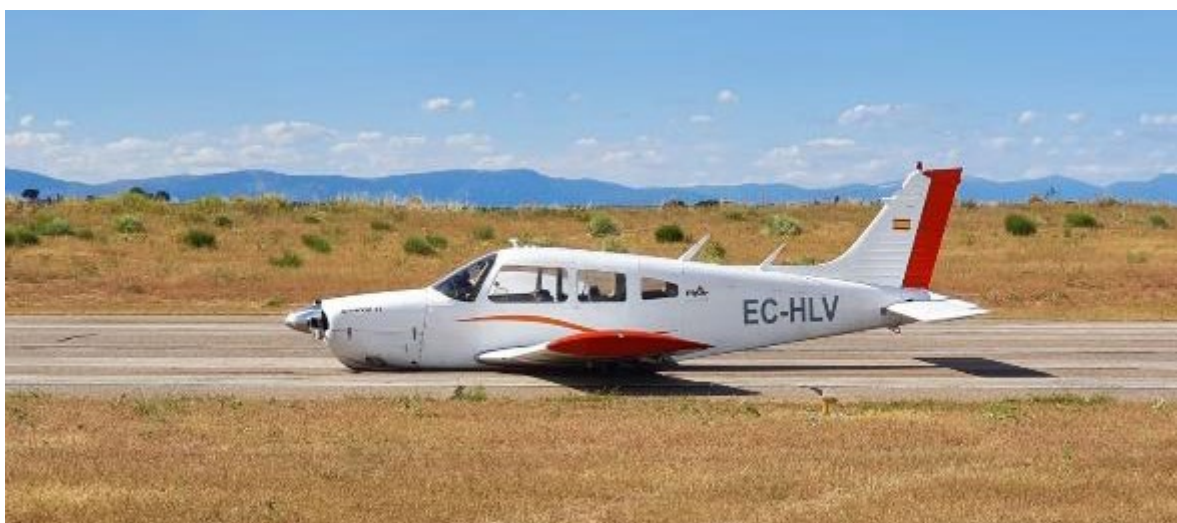
Photograph 1. Damaged aircraft at the accident site

During the accident, the aircraft incurred significant damage to its propeller, the underside of its fuselage and its flaps.

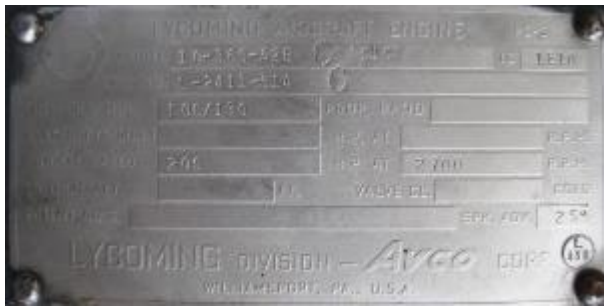
Photograph 4. Engine ID plate

According to the most engine logbook issued on 23/07/2007 (second book), the engine installed was a Lycoming with p/n: IO-360-A2B s/n: L-2411-51AC, which matches the inscription on the engine plate (photo 4). However, the current AESA license plate registration has the aircraft logged with p/n: O-360-C1C, which is not an injection engine like the one in the accident aircraft.

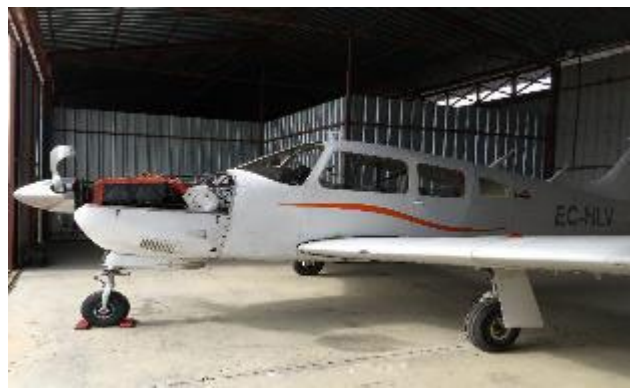
The aircraft suffered significant damage as a result of making an emergency landing without extending the gear. A backhoe was used to lift the aircraft while the landing gear was extended and unfolded without issue. The main and nose landing gear legs were then locked into position to support the weight of the aircraft.

Photograph 7. Incident aircraft supported on its landing gear

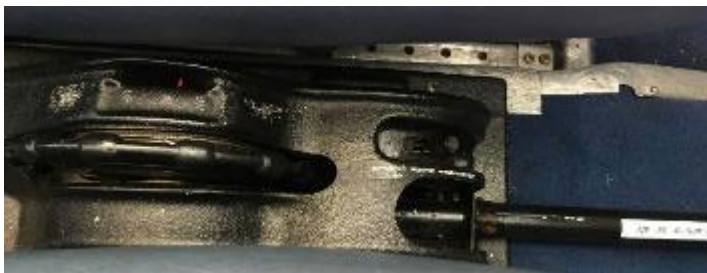
Photograph 15. Automatic landing gear extension system, flap and compensator

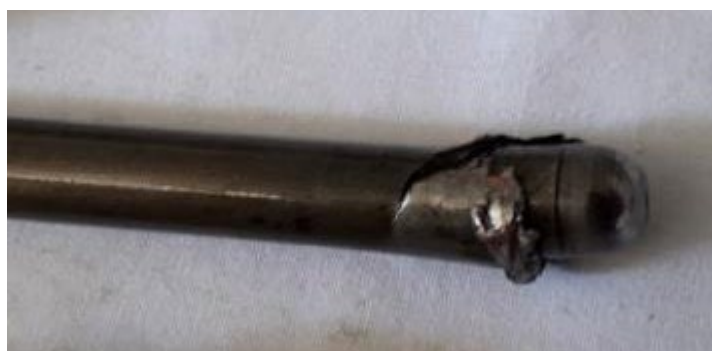
Photograph 22. End of the pushrod

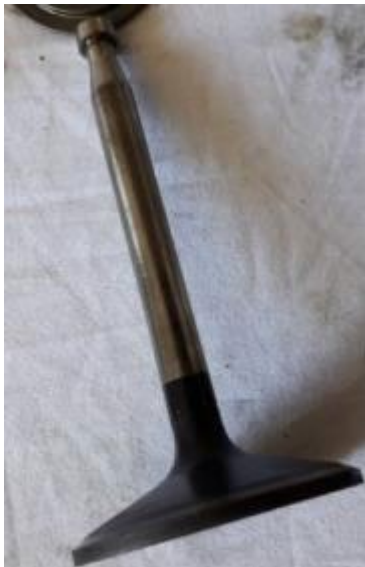
There was no corrosion on the rod or the guide.

The exhaust valve had adequate movement and came out of its guide without difficulty, although there was evidence of surface corrosion and deposits on the rod and guide.

Photograph 23. Cylinder no. 4 intake valve
