Technical report

A-017/2021

Accident on 18 May 2021 involving a SPEED
2002 aircraft, registration EC-XIE, in
Torremocha de Jiloca (Teruel, Spain)

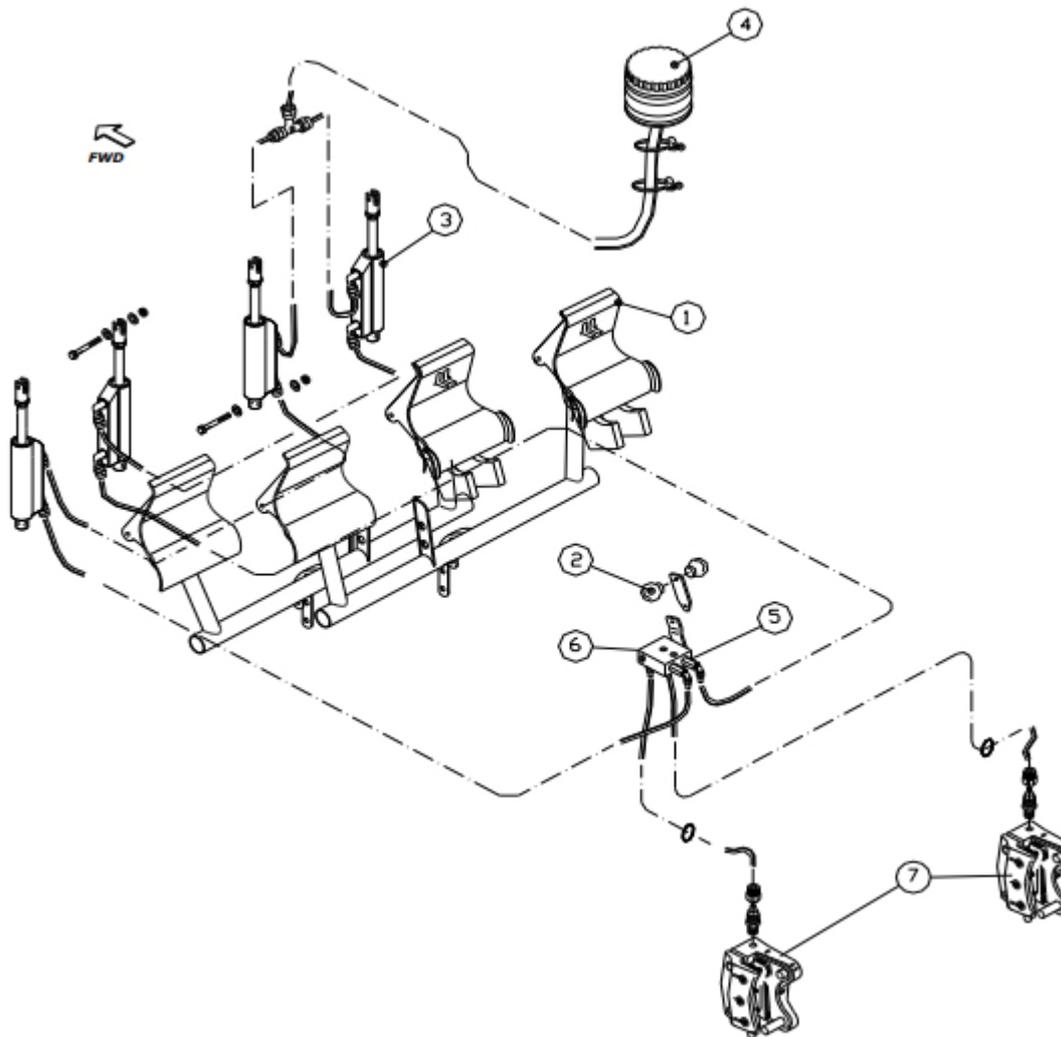
FIG. 1 IMAGE EXTRACTED FROM THE FLIGHT MANUAL OF THE TECNAM P2002 SIERRA DELUXE AIRCRAFT

The reservoir (4) is directly connected to the brake master cylinders (3), as shown in the figure. Two flexible hoses connect the master cylinders on the co-pilot's brake pedals to the master cylinders on the pilot's brake pedals. The parking brake valve (6) is mounted on the floor of the fuselage, below the seats and is activated by lever (2).

The EC-XIE aircraft only had brake pedals in the pilot's seat.

Since the aeroclub acquired the aircraft, the brake system has always been the same, has not been modified and has undergone the necessary maintenance for wear and tear.

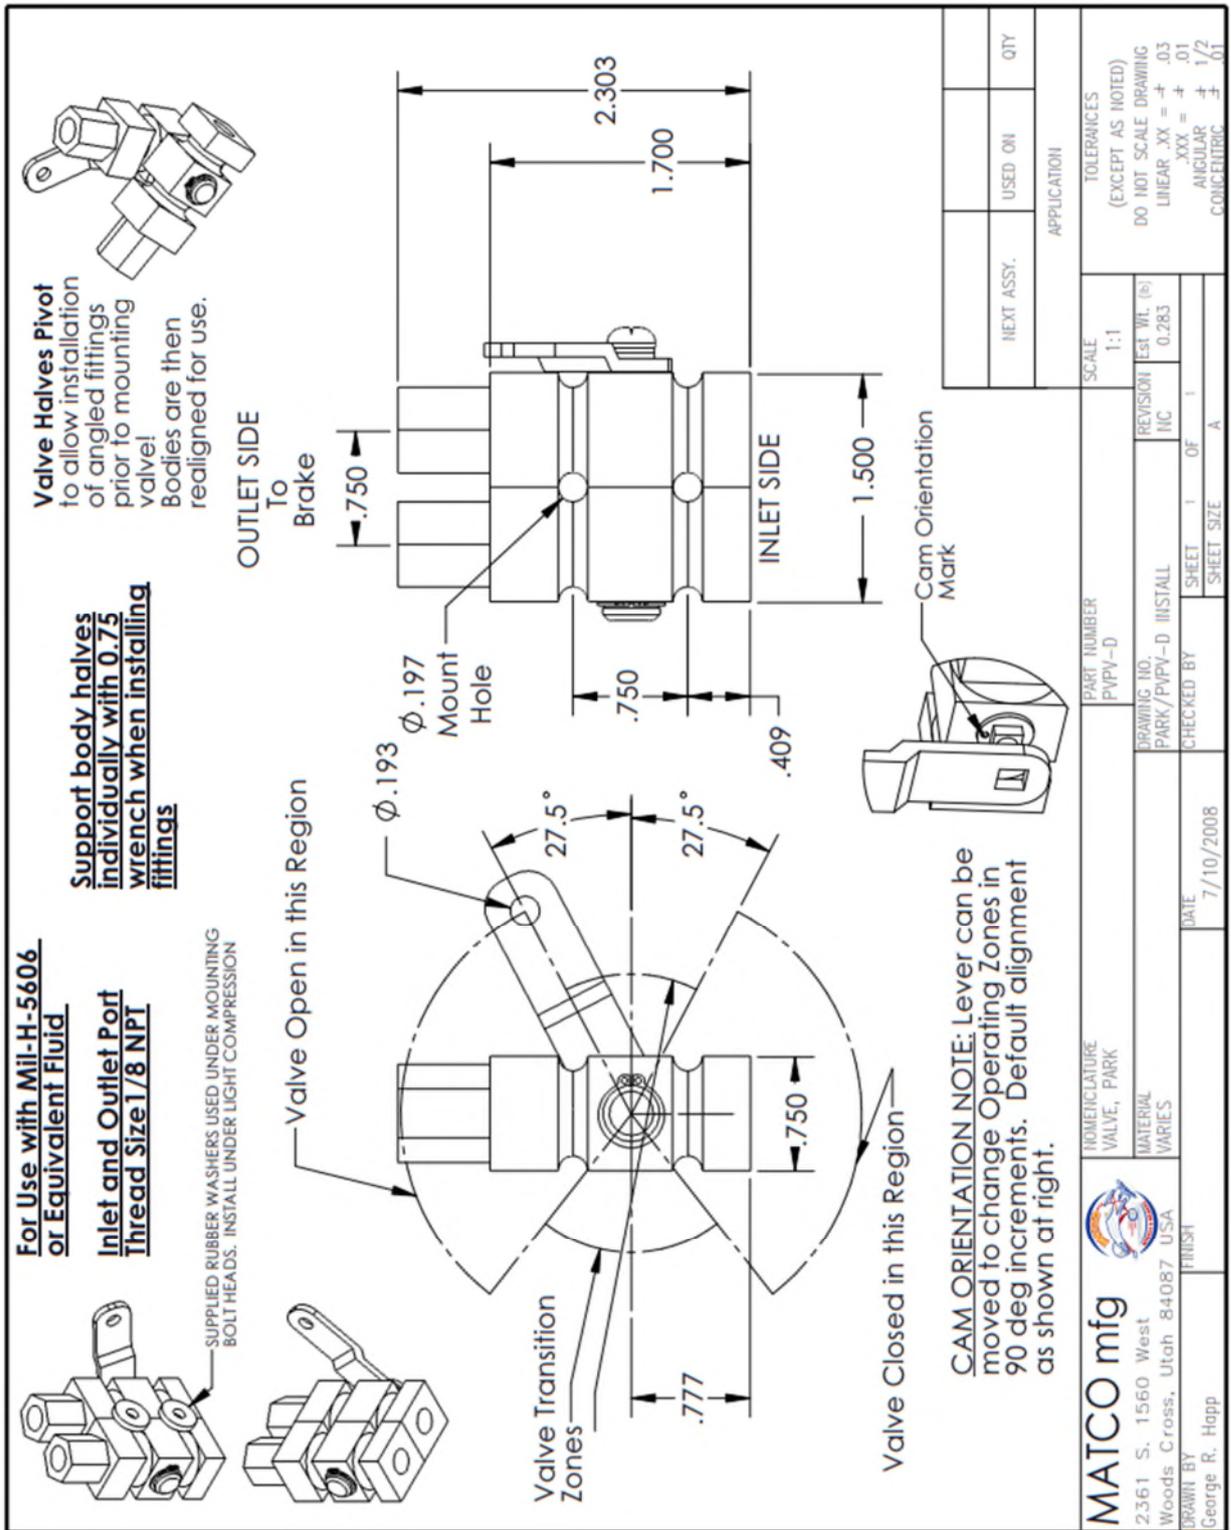
FIG. 12 INSTALLATION OF THE VALVE MATCO PVPV-D(2)

In the manufacturer's exploded view of the parking brake valve, which can be found in the appendix, the hexagonal adapters with item number 6 in the manufacturer's exploded view (fitting, adapter) are connected to the wide part of the valve body; however, in the installation diagram provided by the manufacturer (figure 11), they are connected to the narrow part. This is shown in the diagrams below:

Having reviewed the manufacturer's information on installing the parking brake valve (sections 1.6.6 and 5.1) and the information gathered from the inspection of the brake system on the EC-XIE aircraft (section 1.16.1), the investigation has found that the valve was installed in the opposite direction to that indicated by the manufacturer in figure 11.
