**COMISIÓN DE
INVESTIGACIÓN
DE ACCIDENTES
E INCIDENTES DE
AVIACIÓN CIVIL**

Report A-022/2018

Accident involving an Air Tractor
AT-802 aircraft, registration
EC-GVN, operated by Martínez
Ridao Aviación S.L, in the
Mediterranean Sea near the
municipality of Pollença
(Mallorca-Spain) on 12 June 2018

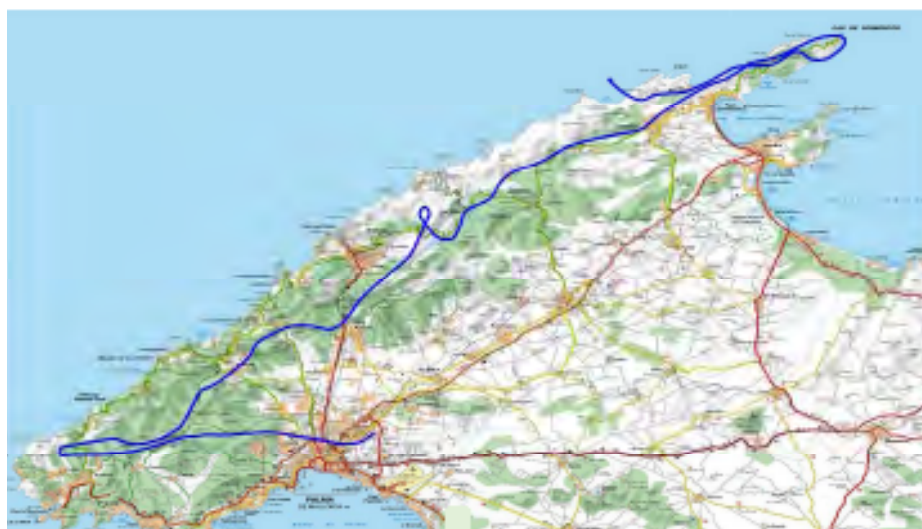
Figure 1: Aircraft's complete flight path

The flight lasted 40 minutes and covered 150 km. Figure 1 shows the aircraft's flight path.

As shown in Figure 1, the aircraft made a 180° turn over Cape Formentor and doubled back over the same north side of the Tramuntana Mountains. Upon reaching the municipality of Pollença, it turned right, going out to sea and eventually crashing into the water.

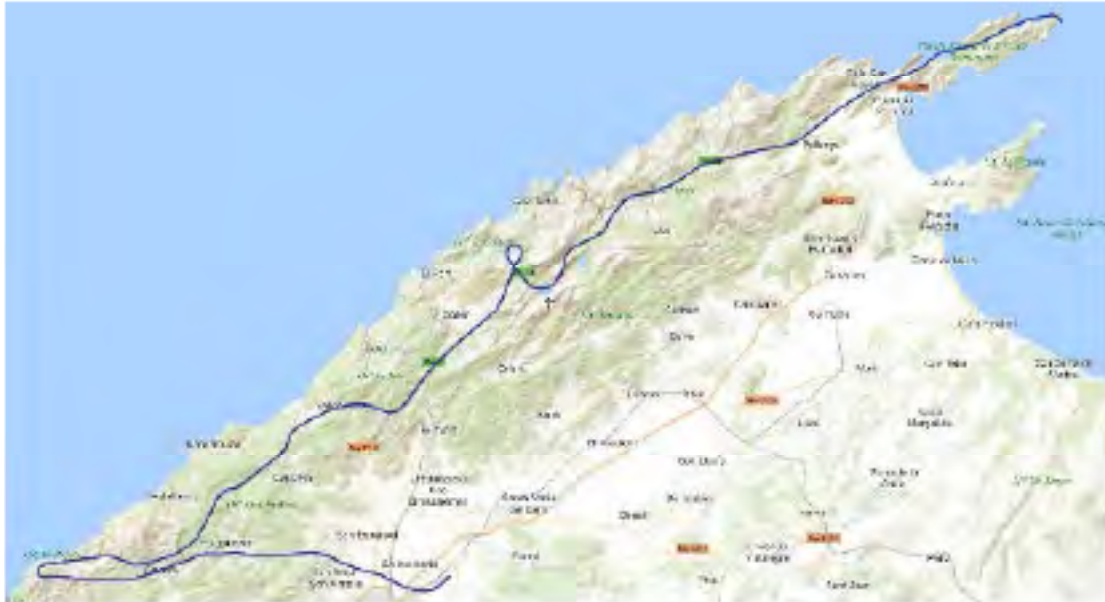
Figure 7 : Aircraft flight path to Cape Formentor

Figure 7 shows the initial section of the flight path, from the aerodrome of Son Bonet to Cape Formentor, a total distance of 136.5 km.

In this section, the data indicate that the aircraft first flew to the western tip of the island, where the town of Andratx is located, before proceeding along the north side of the Tramuntana Mountains.

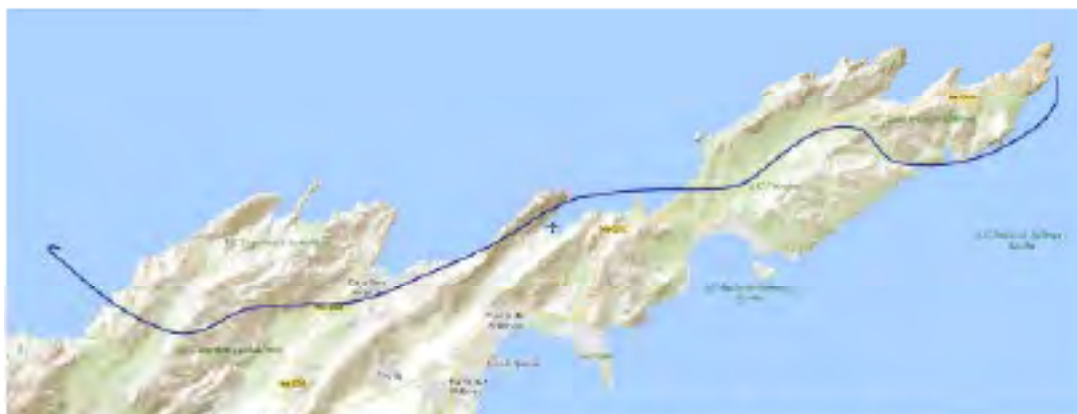
Figure 8 : Aircraft's flight path from Cape Formentor

Figure 8 shows how, after making the turn, the aircraft doubled back over the same route it had taken as far as Pollença.

After that point, during the final 3 minutes of the flight, the orography became more abrupt, and the data show a constantly increasing altitude in an effort to clear the hills that were in its way.

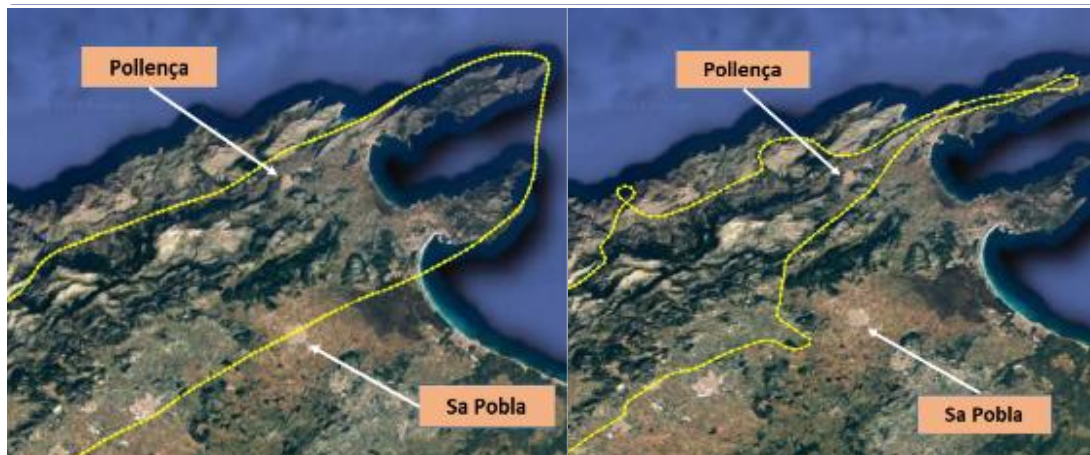
Figure 11: Typical paths flown on Route 3

Figure 11 shows the typical routes taken, with the one to the left being the most common one. These routes do not contain any segments over open water. Once Cape Formentor is reached, the return route is initiated by making a wide turn over the bays of Pollença and Alcudia and then heading southwest and flying over the town of Sa Pobla. The figure on the right shows an alternative route where the return involves making a tight turn and doubling back in the opposite direction as far as Pollença, leaving this town to the right (to the north) and then flying the route shown in the left figure, which travels close to the town of Sa Pobla.

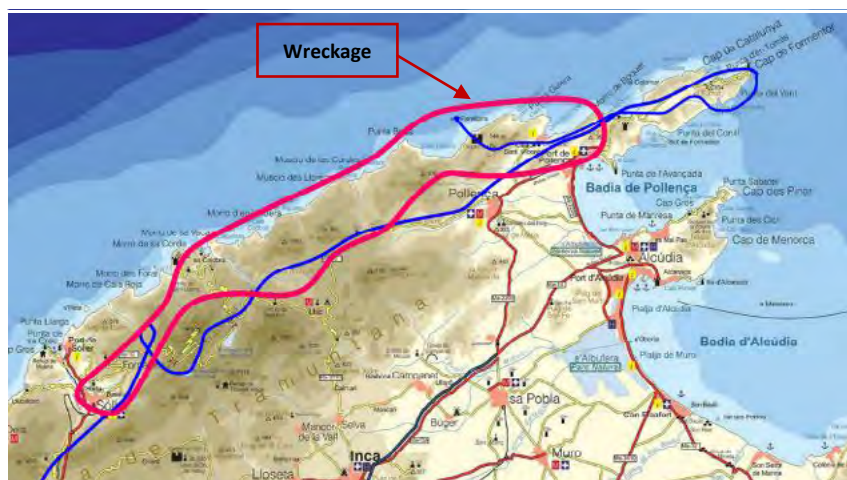
Figure 12: Range of the black vulture population in the north of Mallorca

The IBANAT Bird Control Service informed investigators that in the month of June on the north of the island, sightings of black vultures in the area overflown by the aircraft indicate a population of 20 to 30 specimens out of the total of around 200 specimens on the entire island. The weight of an adult bird is around 7-8 kg, and they fly at an altitude of some 100 m above the ground. They do not fly over the water. The nesting chicks had not yet started to fly. Figure 12 shows their distribution in the Tramuntana Mountains.

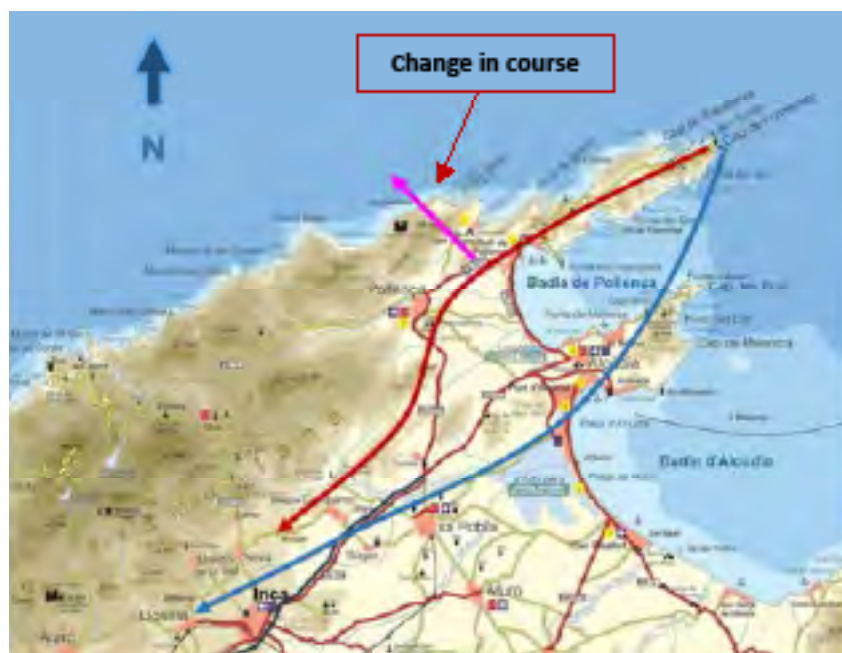
Figure 13: Description of the return routes

Figure 13 shows the two alternatives used to start the route along the south face of the Tramuntana Mountains, one in red and the other in blue. The bottom route, in blue, travels over the bays of Pollença and Alcudia en route to the south foothills of the Tramuntana range.

The alternative at the top, in red, employs a southwesterly course from Cape Formentor to the vicinity of Pollença. From there, it intercepts the blue route to the southwest. In the accident flight, the data show that the pilot, after reaching this locality, diverted from the usual route and proceeded to the northwest to fly over the foothills that are located to the north of Pollença, in the direction of the coast.

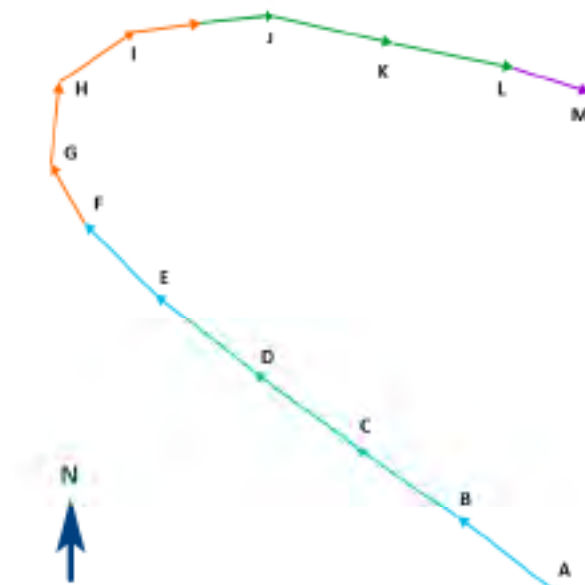
Figure 14: Flight path

Figure 14 shows an overhead representation of the values in the above table.

The data in the above table were used to evaluate the pilot's actions during the maneuver. To do so, as Figure 14 shows, the segments that comprise each row were grouped to create "Sections" based on the geometric and proportionality characteristics that relate the measured parameters to one another. This yields the following five groupings: Section A-F, Section F-I, Section I-J, Section J-L and Section L-M.
