Technical report

A-027/2019

Accident on 12 June 2019, involving AgustaWestland AW139
aircraft operated by Babcock Spain, registration EC-NEH, at the
municipality of Albarracín (Teruel, Spain)

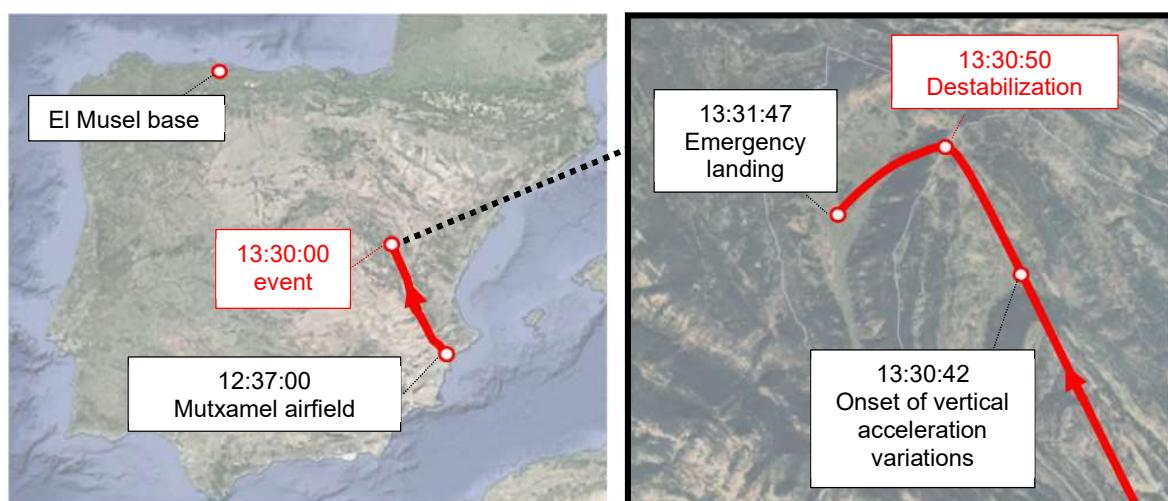
Figure 1. Full flight path and last 2 minutes in detail

The recorders confirmed that at 13:30:50, the helicopter was flying straight and level at a heading of 331°, at an altitude of 6,537 ft (1142 ft off the ground), 135 kt IAS and 152 kt GS, when the destabilization began, which reached its maximum development at 13:30:53:

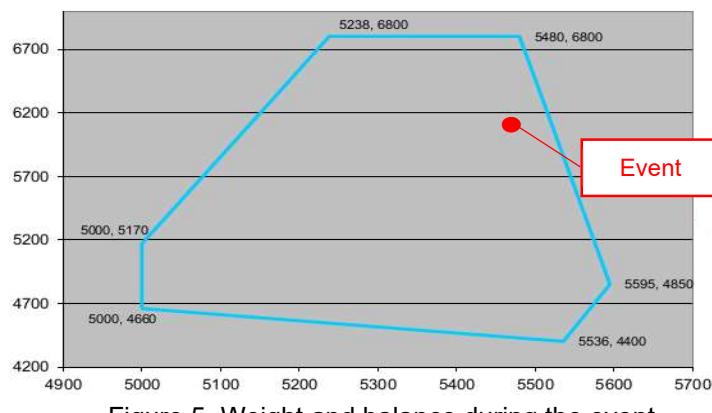
Figure 5. Weight and balance during the event

Weight and balance calculations at the time of the event, considered a pilot weight of 85 kg and 1,152 kg of remaining fuel, with an aircraft weight of 6,112 kg, below the maximum certification (6,800 kg). The centre of gravity was within limits.

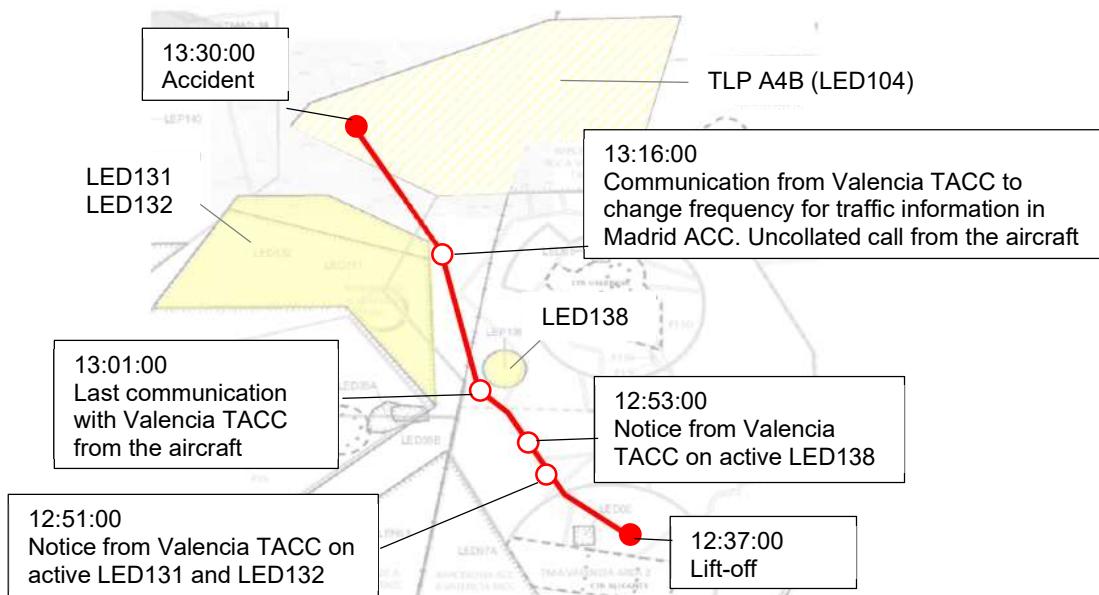
Figure 7. Reserved airspaces and communications with ATC in the flight path

As far as civilian traffic is concerned, no echoes were identified nearby which could have caused a turbulent wake that would affect the EC-NEH.

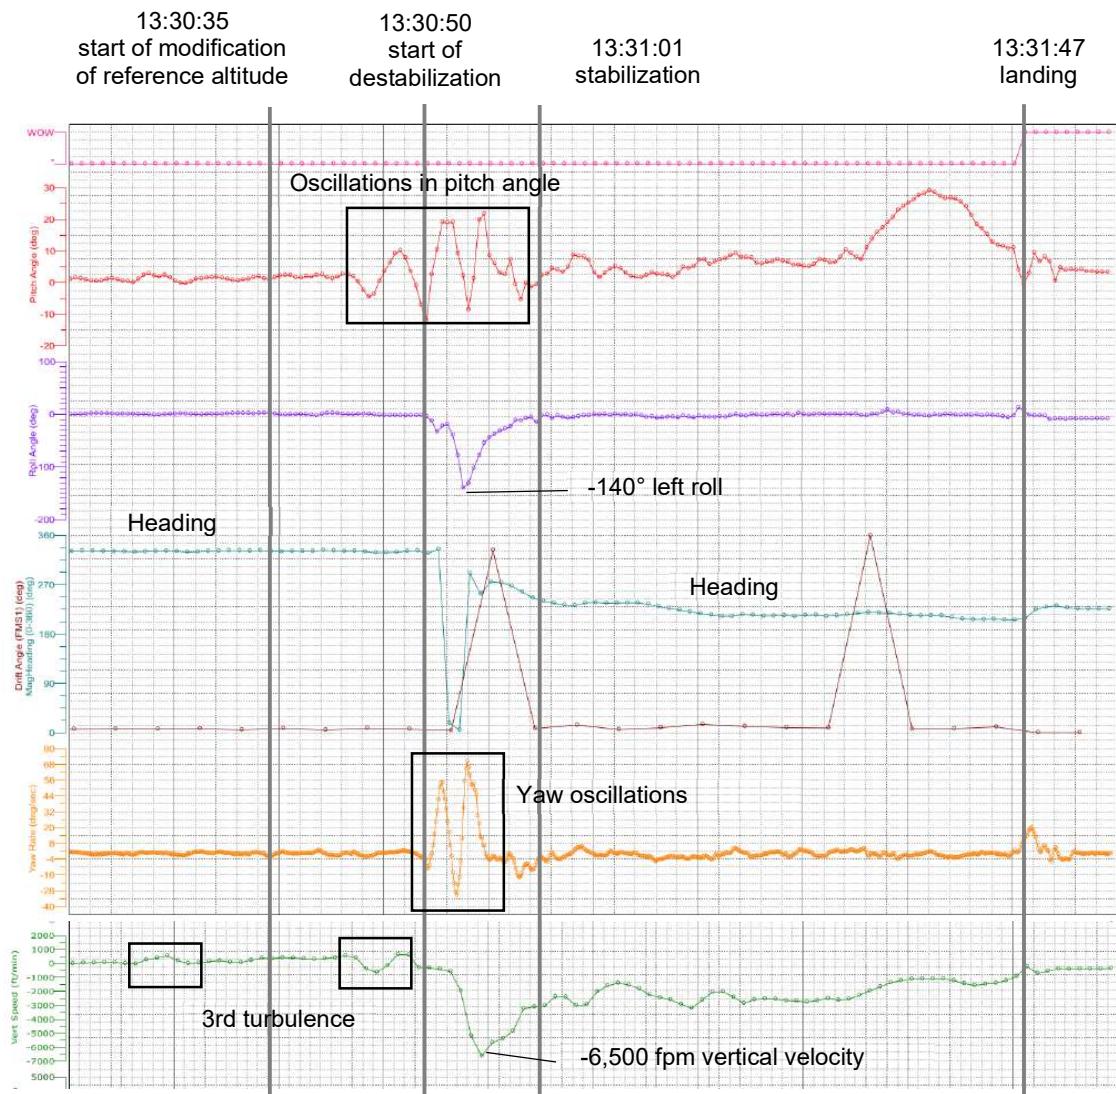
Figure 9. Altitude parameters from the event until landing

Up to that point, 13:30:49, the automatic flight system compensated for the external effects on the helicopter and the flight was developed with the lateral, vertical and collective FD modes coupled and activated. At 13:30:49, the helicopter was at 130 kt IAS, 144 kt GS, 6,598 ft, a heading of 332°, with a stable roll angle of -2°. The pitch angle was increasing from -2° to -7°, with maximum vertical accelerations of ±0.8 g, maximum lateral accelerations of ±0.3 g and maximum longitudinal accelerations of -0.2 g.

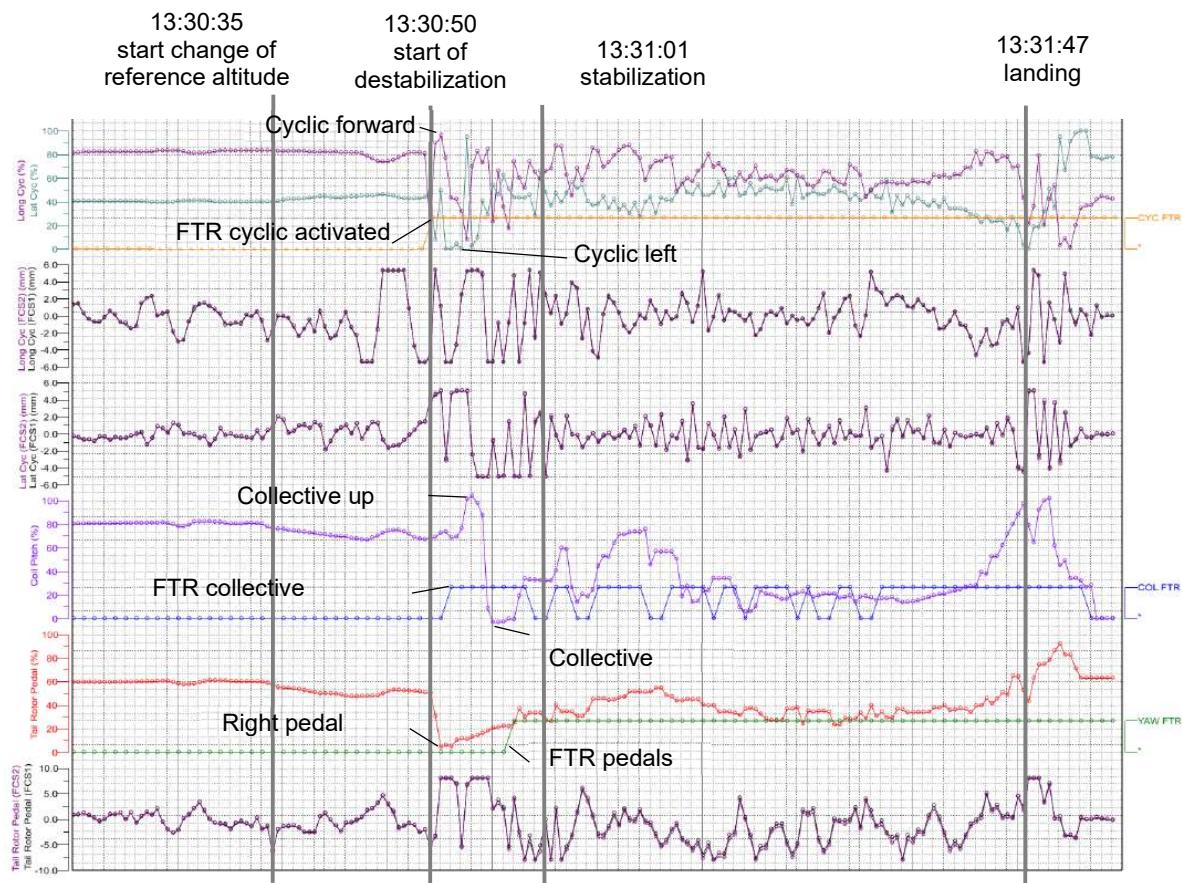
Figure 10. Flight control parameters from the incident until landing

- 13:30:51: The cyclic remained forward, moving toward the centre and then completely to the left. The right pedal was completely pressed down, and the collective control began its upward movement (from 69% to 74%). The helicopter's speed was 128 kt IAS. The roll to the left had increased to -33° and the nose-up position increased to -19°. The yaw rate continued to increase to +54°/s to the right.

- 13:30:52: The cyclic remained completely to the left and then moved backwards to the middle of the longitudinal path of the lever, with the right pedal fully applied. As a result, the helicopter continued to increase the roll angle to the left to -40°, maintained the nose-up position at +19° and the yaw rate changed direction from +54°/s to the right to -31°/s to the left, for one second before increasing again to the right. The speed decreased to 113 kt IAS. At this moment, the CVR recorded the appearance in the cabin of a very strong aerodynamic noise, probably produced by the detachment of one of the windows.
