Report A-028/2020

Accident on 23 July 2019,
involving a PC-28 CRUISER
operated by FLYBAI, S.L.,
registration EC-NAO, at
Valladolid Airport
(Villanubla-Valladolid, Spain)

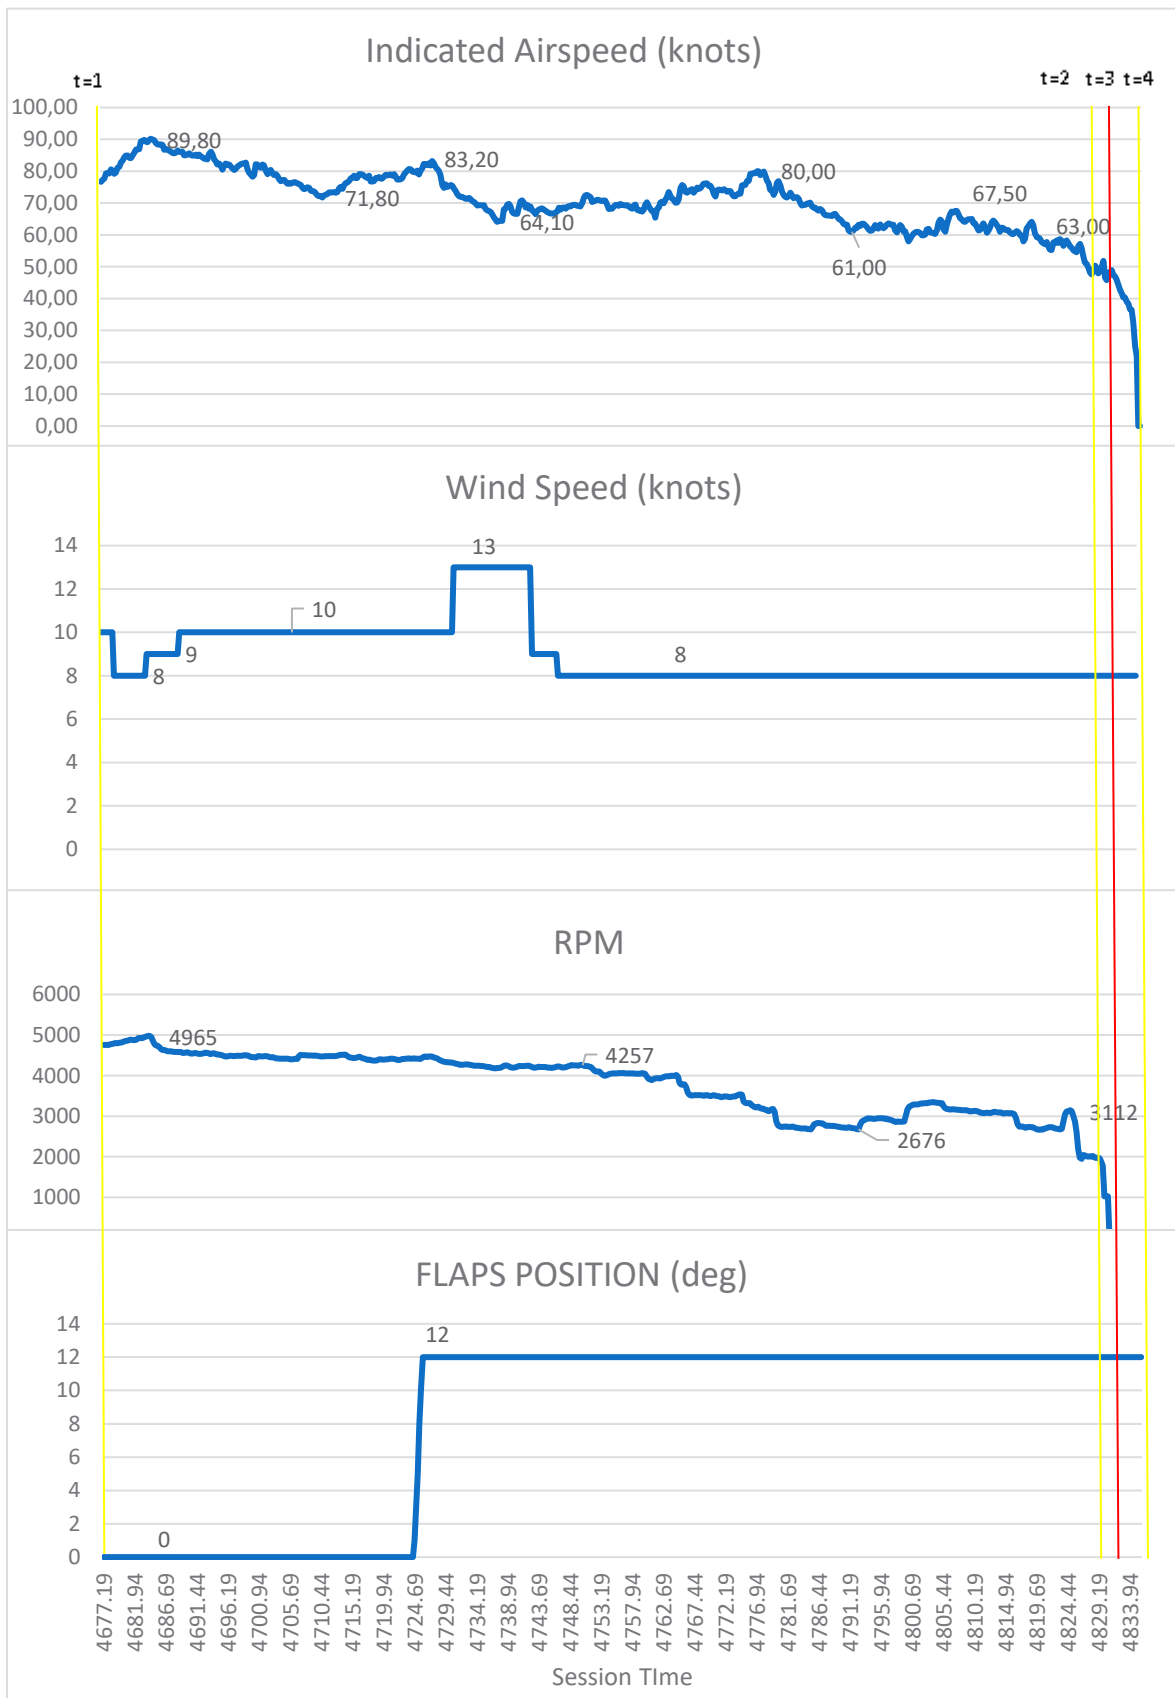
Graph 3. Flight data during touchdown (continued)

- The vertical acceleration had its maximum and minimum values of 3.1 g and 0.2 g at 13:31:28 and 13:31:31 UTC. For reference, the maximum positive load factor limit with flaps extended for this type of aircraft is 2 g, and the maximum negative limit is 0 g. From 13:31:28 UTC (4825.44) to 13:31:32 UTC (4829.38), the "GEES" alert was registered, which is displayed when the "g" meter is in the yellow range of the indicator (i.e. it's between the values of -0.5 and 3 g).

- The indicated speed had its maximum and minimum values of 90.20 kt and 0 kt at 13:29:07 and 13:31:38 UTC, respectively. Consequently, the aircraft came to a stop at 13:31:38. This aircraft has a maximum flaps-extended speed of 75 KIAS and a maximum flaps-extended approach speed of 60 KIAS. Up to 13:30:42 UTC (4779.38), the FLAPS OVERSPEED alert was registered, with minimum speeds of 75.5 KIAS.
