# Technical report

## A-035/2022

Accident on 20 July 2022, involving a  
Eurocopter AS-350-B3 aircraft,  
registration EC-LBU, operated by Pegasus  
Aviación, in the municipality of Tortuero,  
Guadalajara (Spain)

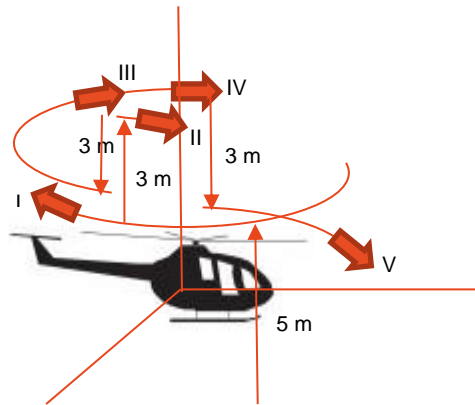
Figure 3: Changes in heading and altitude in the final part of the flight

From the moment the helicopter landed (altitude 1012 m) to disembark the firefighters, prepare the helibucket for use and proceed to take off again to continue the firefighting mission, 4'15" elapsed (from 10:33:15 h to 10:37:30 h). At that point it climbed 5 m with a heading of  $112^{\circ}$  and a speed of 1 km/h (phase I of figure 3).

At 15" (10:38:00 h), it climbed 3 m further, rotating anticlockwise to  $106^{\circ}$  (phase II of figure 3), and then descended over the next 15" (10:38:15 h), rotating clockwise to  $233^{\circ}$  (phase III of figure 3).

At 10:38:30 h, maintaining an altitude of 1017 m, it continued rotating to a heading of  $272^{\circ}$  and 0 km/h (phase IV of figure 3), returning to its initial heading of  $0^{\circ}$  (phase V of figure 3) at 10:38:45 h descending 3 m (altitude 1014 m).

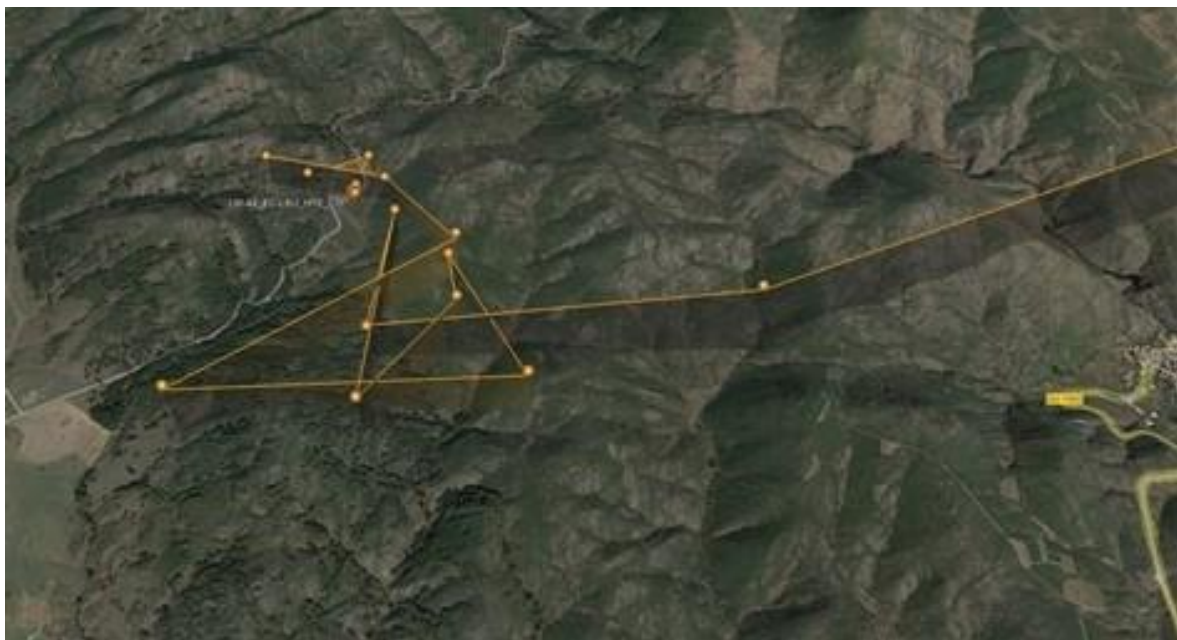
Figure 4: Final phase of the trajectory of the incident flight

This flight, lasting a total of 2' 33" and comprising phases I to V as described above, is the flight in which the impact with the electrified fence took place, the trajectory of which can be seen in figures 4 and 5.
