Technical report

A-038/2022

Accident on 25 July 2022 involving a Eurocopter AS-350-B3 aircraft operated by Pegasus Aviación, registration EC-NTE, in the municipality of Cerezo de Mohernando, Guadalajara (Spain)

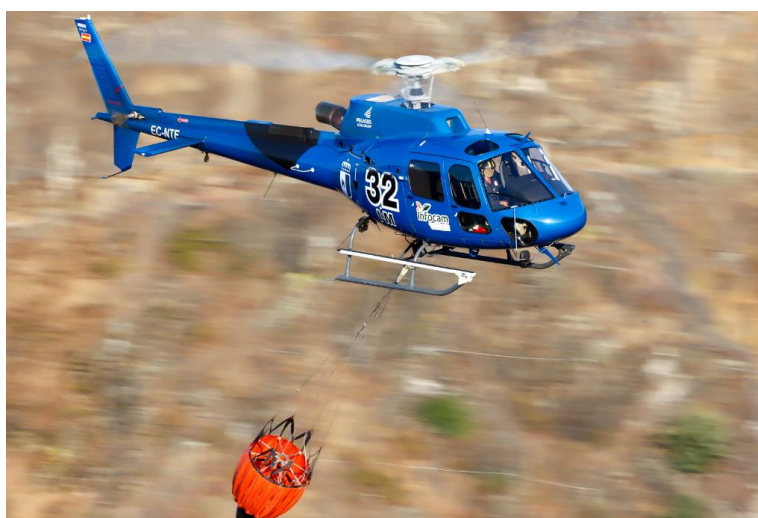
Photograph 2. Helicopter EC-NTE involved in the accident

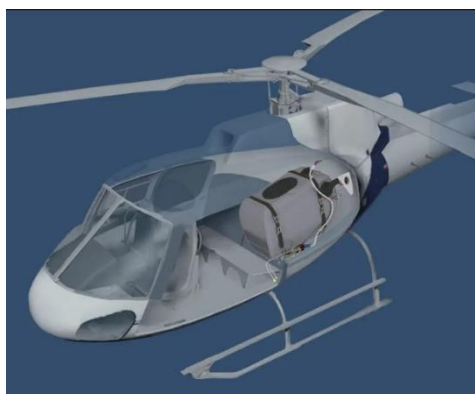
The AS 350 B3 helicopter has two different crash-resistant fuel system options in compliance with the EASA recommendation under Safety Information Bulletin SIB No.: 2017-18R1 dated 15/05/2019. The system manufactured by Airbus Helicopters is called CRFS (Crash Resistant Fuel System). The other system, called CRFT (Crash Resistant Fuel Tank), is manufactured by Standard Aero. Only the CRFT system is certified for installation in the lower fuselage.

Figure 2. Position of anti-impact fuel tank

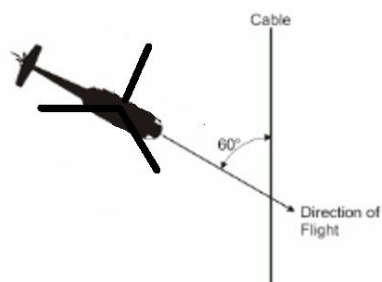
Figure 3. Maximum angle of impact with the cable

As such, for the cutting blades to be effective, the helicopter must be flying above 30 kt (in the event in question, the helicopter was flying at 40 kt). The blade manufacturer states that the system may be ineffective if the helicopter strikes the wire at an angle of less than 60° to the wire. In addition, to be effective, the maximum angle of inclination at which the blade must strike the cable is $\pm 5^\circ$. In this event, as the collision happened during a left turn, the angle changed during the manoeuvre.

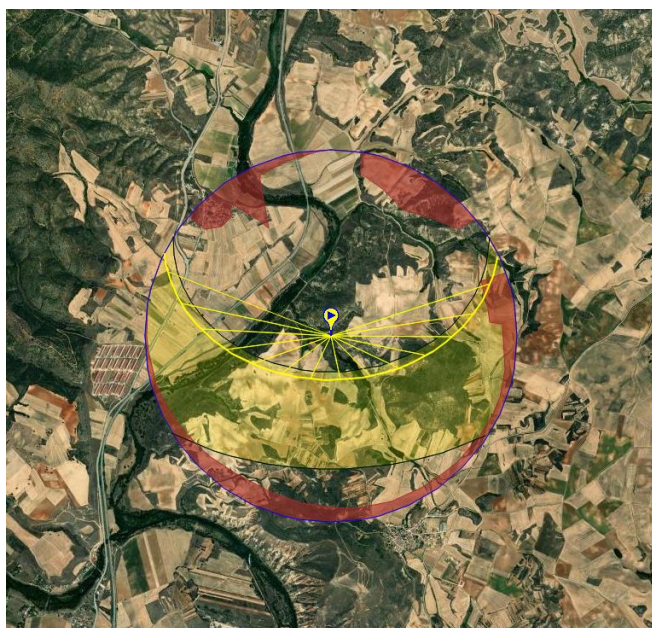
Figure 4. Graph illustrating sunlight at the time of the accident

The natural light conditions at the time of the event were close to sunset at 20:45 local time: according to the IGN National

Astronomical Observatory in Cerezo de Mohernando (Guadalajara), sunset occurred at 21:35 local time. Figure 4 contains a graph illustrating the sunlight conditions at the time of the accident.

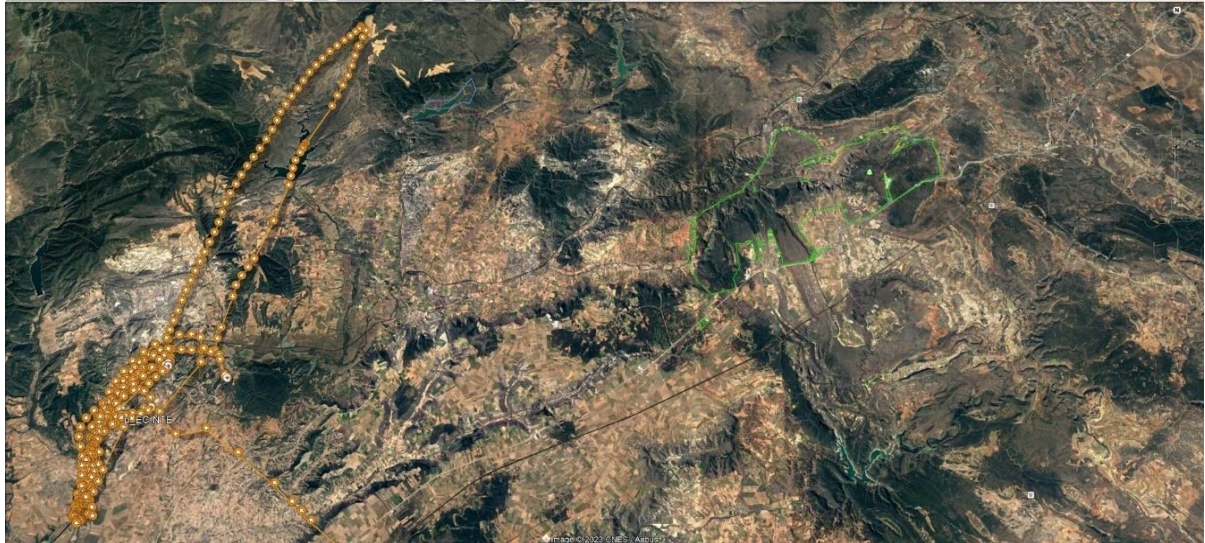
The data was recorded at 15" intervals between 10:01:26 h (time of startup) and 10:40:03 h (time of shutdown) as per the trajectory shown in figure 7.

Figure 7. Trajectory of the incident flight

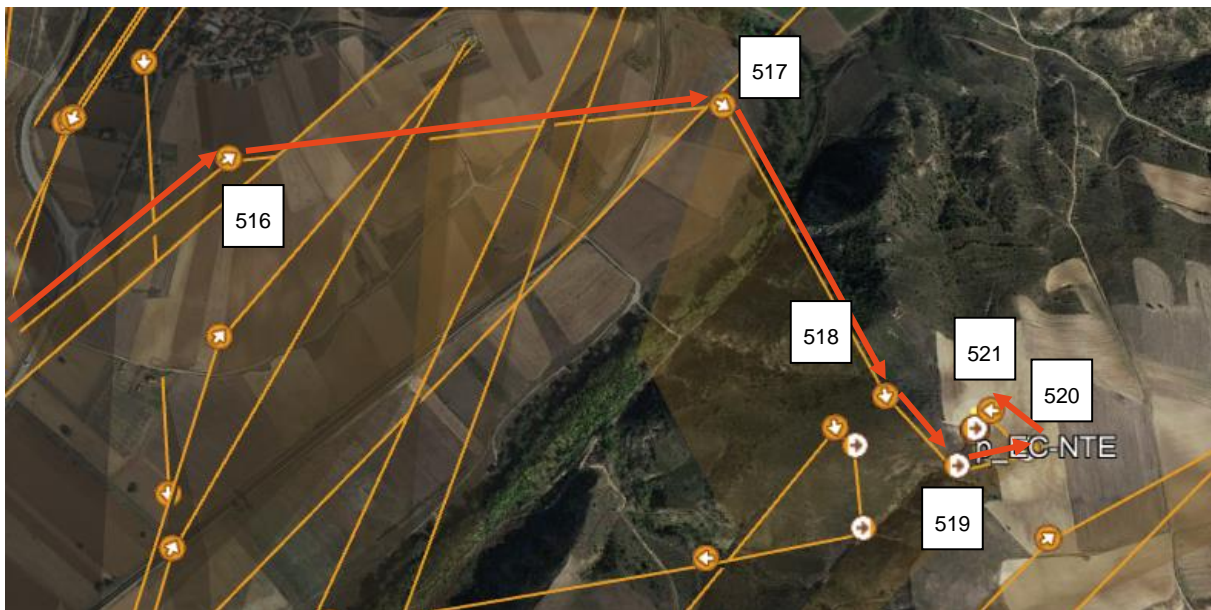
Figure 8. Flight path during the final leg of the incident flight section I

Sequence 516: 20:55:15 LT position: 40.8674°, -003.11386°; altitude: 823 m; track: 054°; speed: 166 km/h.
 Sequence 517: 20:55:30 LT position: 40.8682°, -003.11654°; altitude: 814 m; track: 122°; speed: 133 km/h.
 Sequence 518: 20:55:45 LT position: 40.8647°, -003.11463°; altitude: 797 m; track: 169°; speed: 83 km/h.
 Sequence 519: 20:55:50 LT position: 40.8638°, -003.11380°; altitude: 793 m; track: 122°; speed: 94 km/h.
 Sequence 520: 20:55:55 LT position: 40.8640°, -003.11278°; altitude: 787 m; track: 007°; speed: 68 km/h.
 Sequence 521: 20:56:00 LT position: 40.8645°, -003.11313°; altitude: 770 m; track: 273°; speed: 35 km/h.

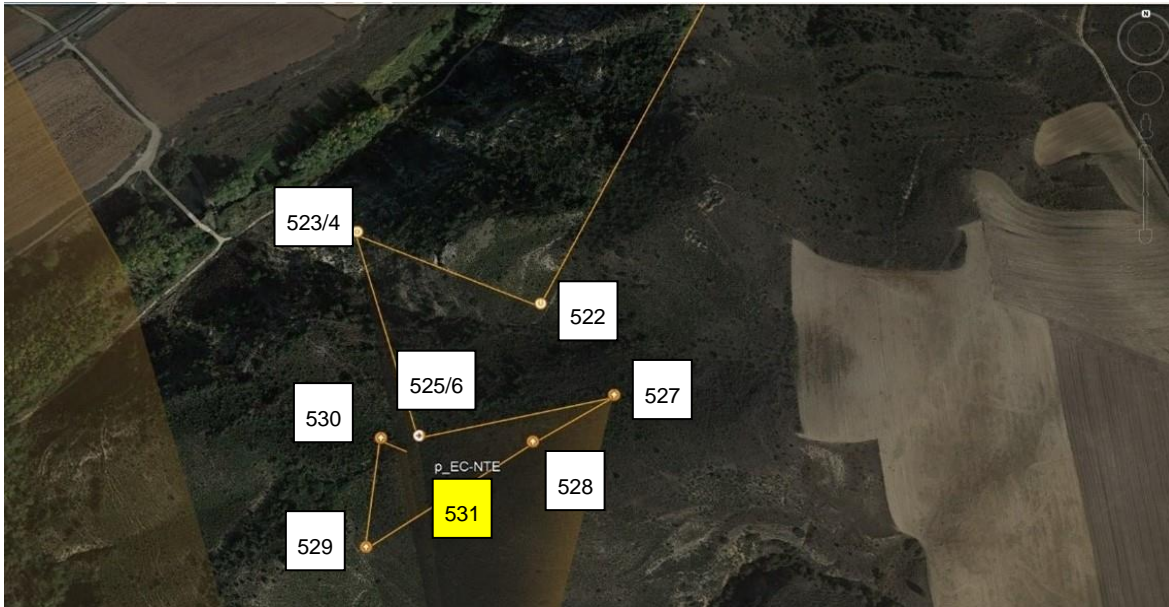
Figure 9. Flight path during the final leg of the incident flight section II

Sequence 522: 20:56:08 LT position: 40.8644°, -003.11326°; altitude: 743 m; track: 264°; speed: 16 km/h.
 Sequence 523/4: 20:56:09 LT position: 40.8644°, -003.11329°; altitude: 745 m; track: 265°; speed: 7 km/h.
 Sequence 525/6: 20:56:15 LT position: 40.8644°, -003.11328°; altitude: 743 m; track: 0°; speed: 0 km/h.
 Sequence 527: 20:56:30 LT position: 40.8644°, -003.11324°; altitude: 737 m; track: 0°; speed: 0 km/h.
 Sequence 528: 20:56:45 LT position: 40.8644°, -003.11326°; altitude: 740 m; track: 0°; speed: 0 km/h.
 Sequence 529: 20:57:00 LT position: 40.8644°, -003.11329°; altitude: 741 m; track: 0°; speed: 0 km/h.
 Sequence 530: 20:57:15 LT position: 40.8644°, -003.11329°; altitude: 740 m; track: 0°; speed: 0 km/h.
 Sequence 531: 20:57:18 LT position: 40.8644°, -003.11328°; altitude: 739 m; track: 0°; speed: 0 km/h.
