CIAIM-03/2020 REPORT

Collision of the passenger and wheeled vehicle ferry EXCELLENT against the South Dock (dock 24B) and the BABCOCK&WILCOX PANAMAX gantry crane number 904 on the 31st of October 2018

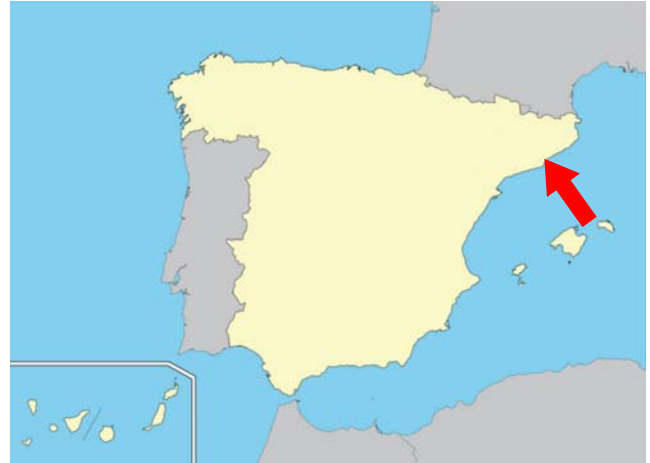
Figura 2. Accident site

As a result of the collision, the crane fell over and caused a fire in the APM container terminal on the South Quay, while damage was also caused to the vessel's bulbous bow, the starboard forecastle and the weather deck. The Port Self-protection Plan was activated at level 2.

On land, the crane fell, as already mentioned, and there was damage to various containers and their contents, which the CIAIM has not evaluated. Damage to the quay was also observed, in the area where the bulbous bow collided with it. No personal injuries were caused.

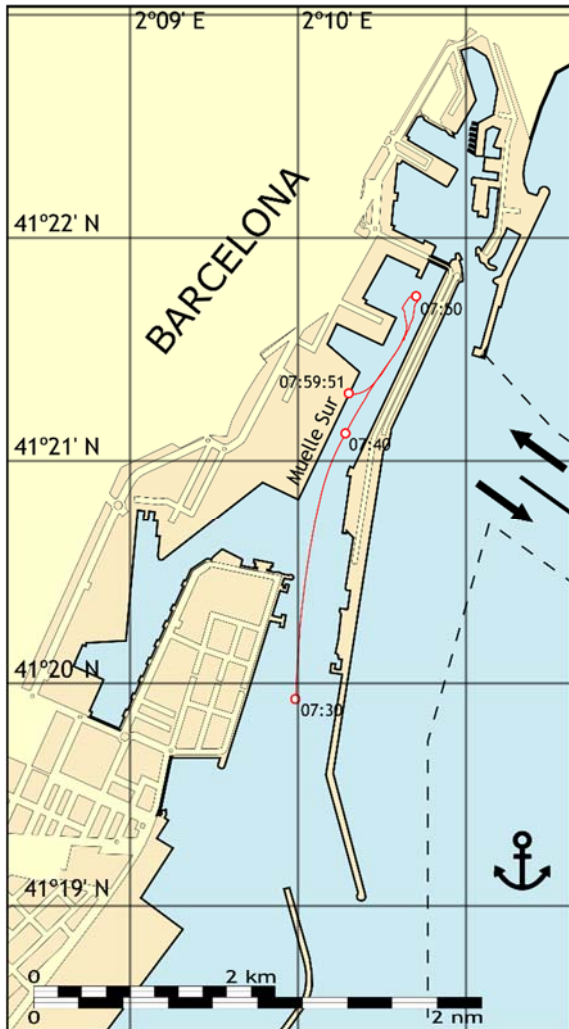
Figura 3. Accident site

At 07:46, the RO-PAX EXCELLENT started to turn around in the Morrot Dock, to head for the assigned mooring. The available docking space was very limited, since the GNV CRISTAL was moored in this dock, with the bunker ship SPABUNKER VEINTIUNO refuelling it. (See figures 3 and 4).

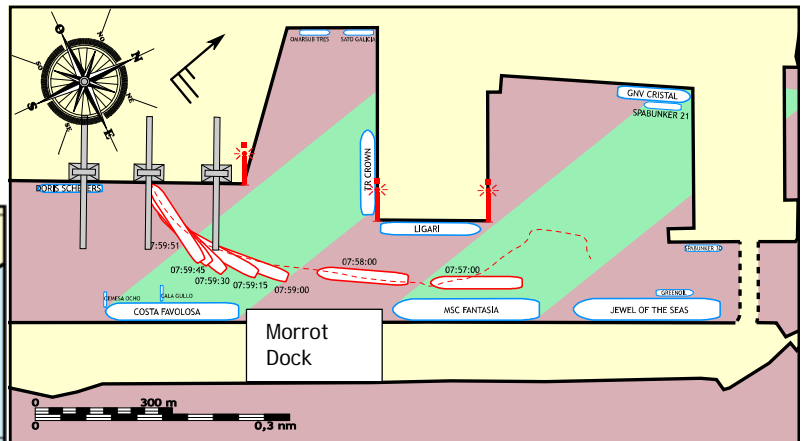
Figura 4. Detail of the positions prior to the collision

Costa Quay 21 A,
intended mooring
