## CIAIM-19/2021 REPORT

Operational accident on board the CIUDAD DE PALMA in Santa Cruz de Tenerife during loading operations on the 20th of June 2020, resulting in one fatality and two very serious casualties.

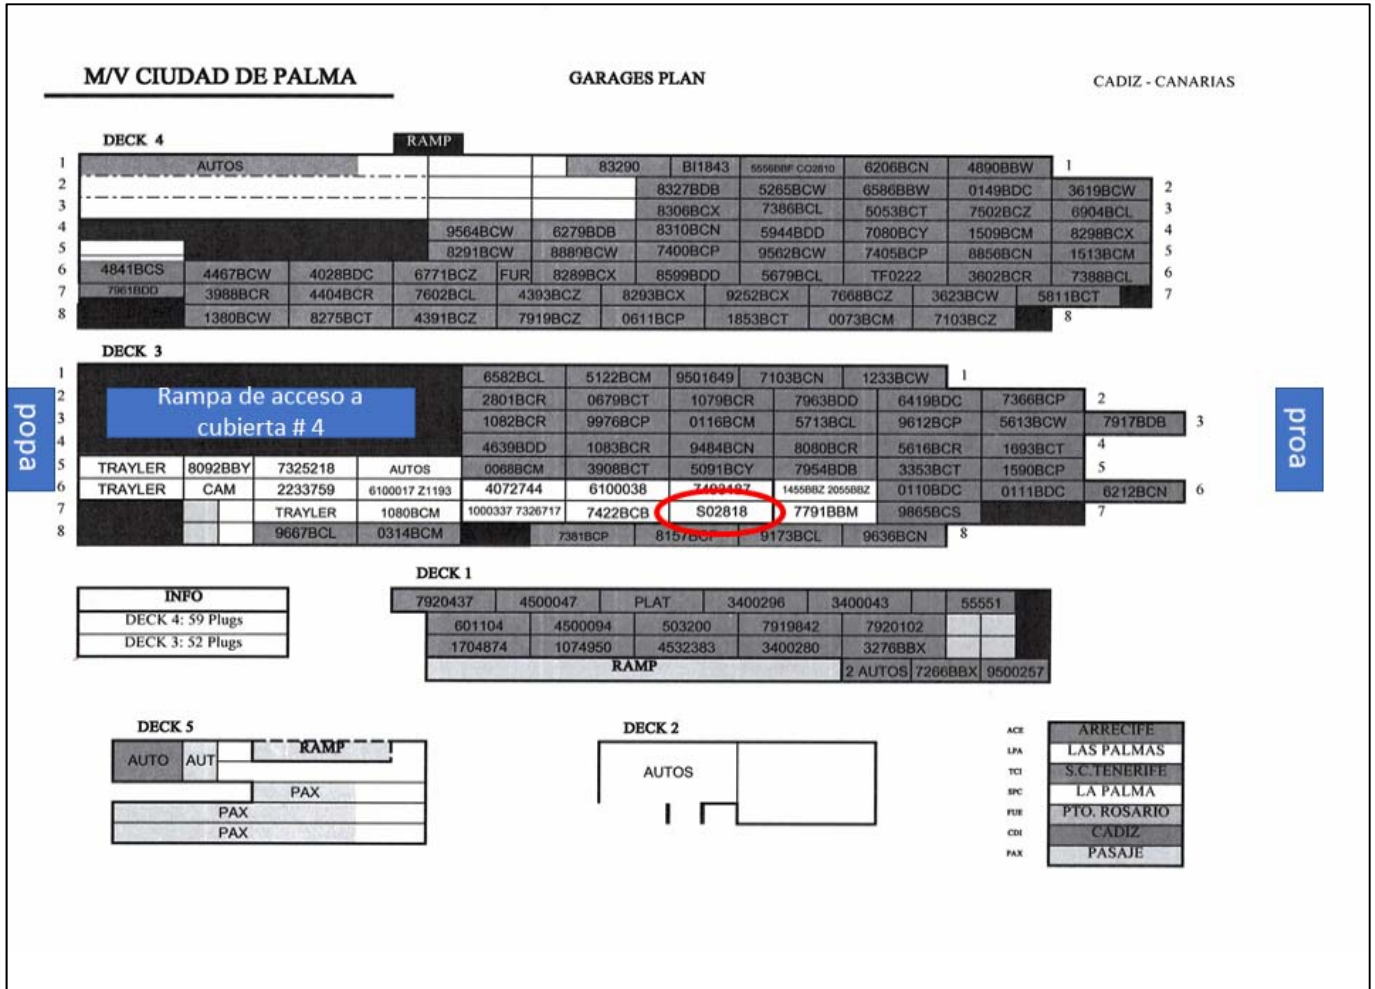
Figure 6. Loading Plan

The deck was not yet fully loaded; approximately half of the trailers still needed to be brought on board. During loading, trailer no. S-02818-R (circled in red on the Loading Plan shown in Figure 6, and destined for row 7 on Deck 3) was brought to the vehicle stowage area by the tractor unit. On the starboard side, the space adjacent to the one assigned to the trailer was occupied, while on the port side, the space adjacent was free.

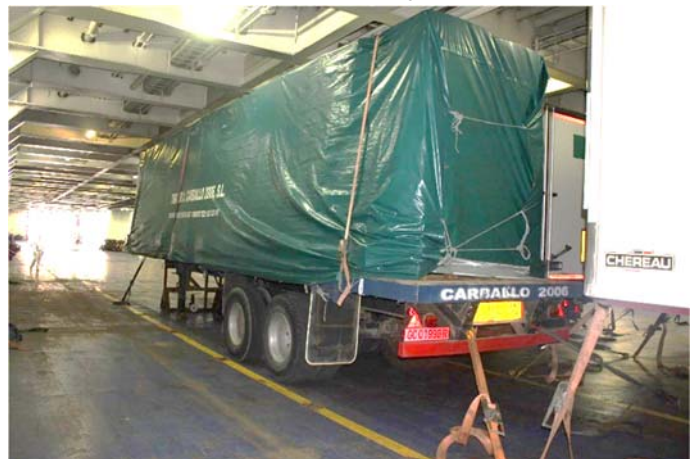
The driver withdrew the tractor unit around five metres from the trailer he had deposited, and then stopped<sup>6</sup>. Meanwhile, the crew made their way to the trailer in order to tie it down, to which end they positioned themselves between the trailer and the tractor unit. While the seamen were working at the front of the trailer, with their backs to the tractor unit, they were alarmed to hear the sound of an unexpected acceleration<sup>7</sup>. The cadet was positioned a short distance away from the tying-down area, in order to avoid getting in the way, and he saw the tractor unit drive at full speed - owing to the acceleration provided by the engine - into the trailer. He gave a warning shout, but there was not enough time for the seamen to react to it and they were unable to avoid the impact. The tractor unit's fifth wheel impacted violently<sup>8</sup> against the trailer's king pin, lifting the trailer up and moving the trestle.

Figure 7. Trailer similar to the one involved in the accident, shown from the rear.

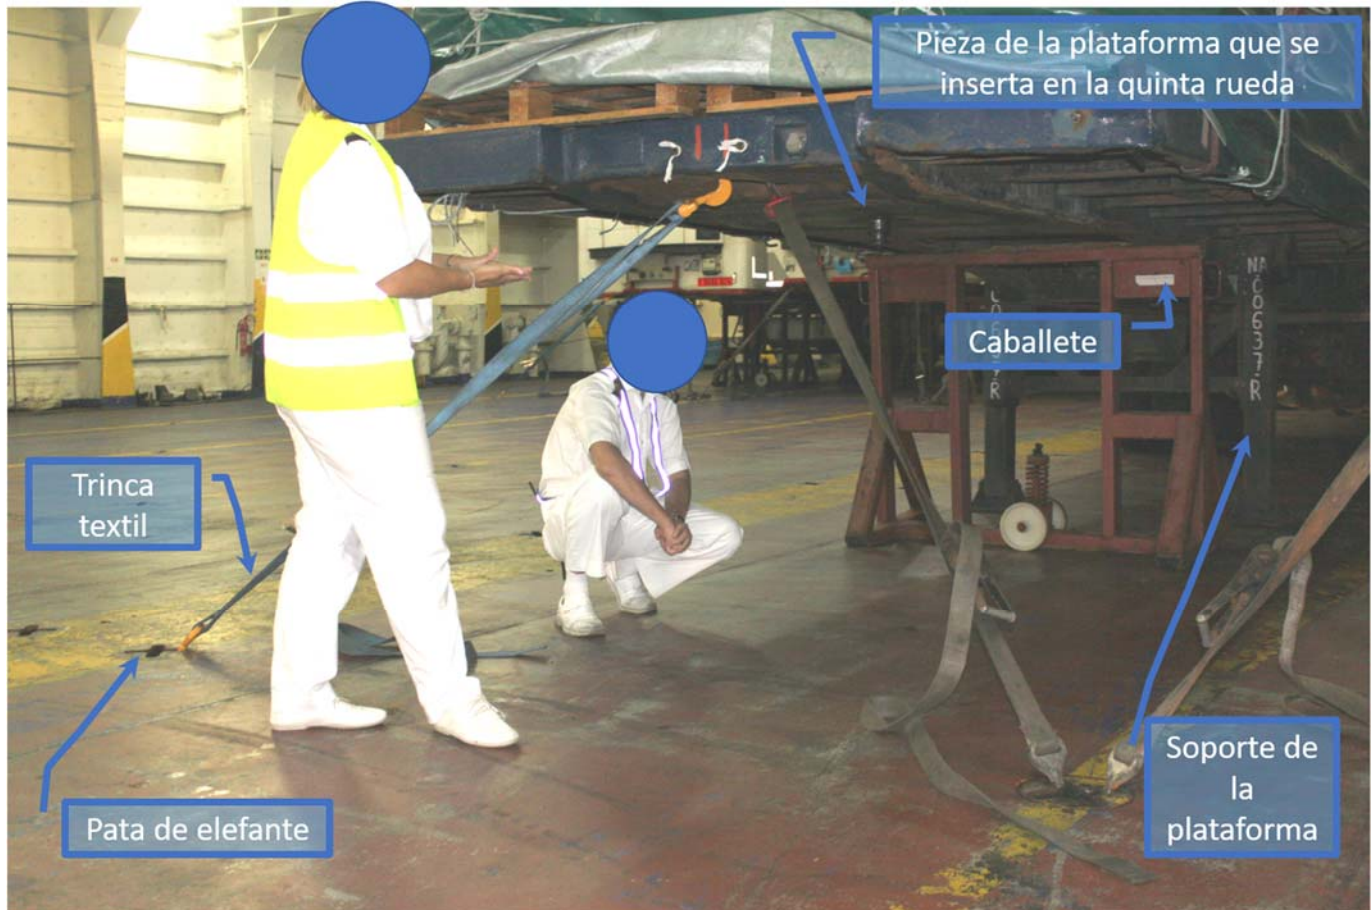
Figure 8. Officers of the CIUDAD DE PALMA demonstrating a working environment similar to the one in which the accident occurred<sup>10</sup>.

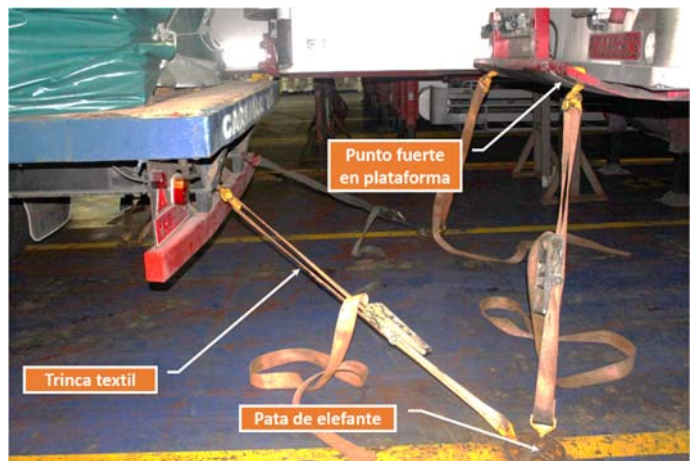
Figure 9. Tying down the ends of the trailers.

Meanwhile, the crew, after making sure the trailer's number matches the one specified in the Loading Plan, use fabric straps to tie down the ends of the trailer to the lashing points provided for this purpose on the deck, in order to prevent the trailer from moving around while at sea.

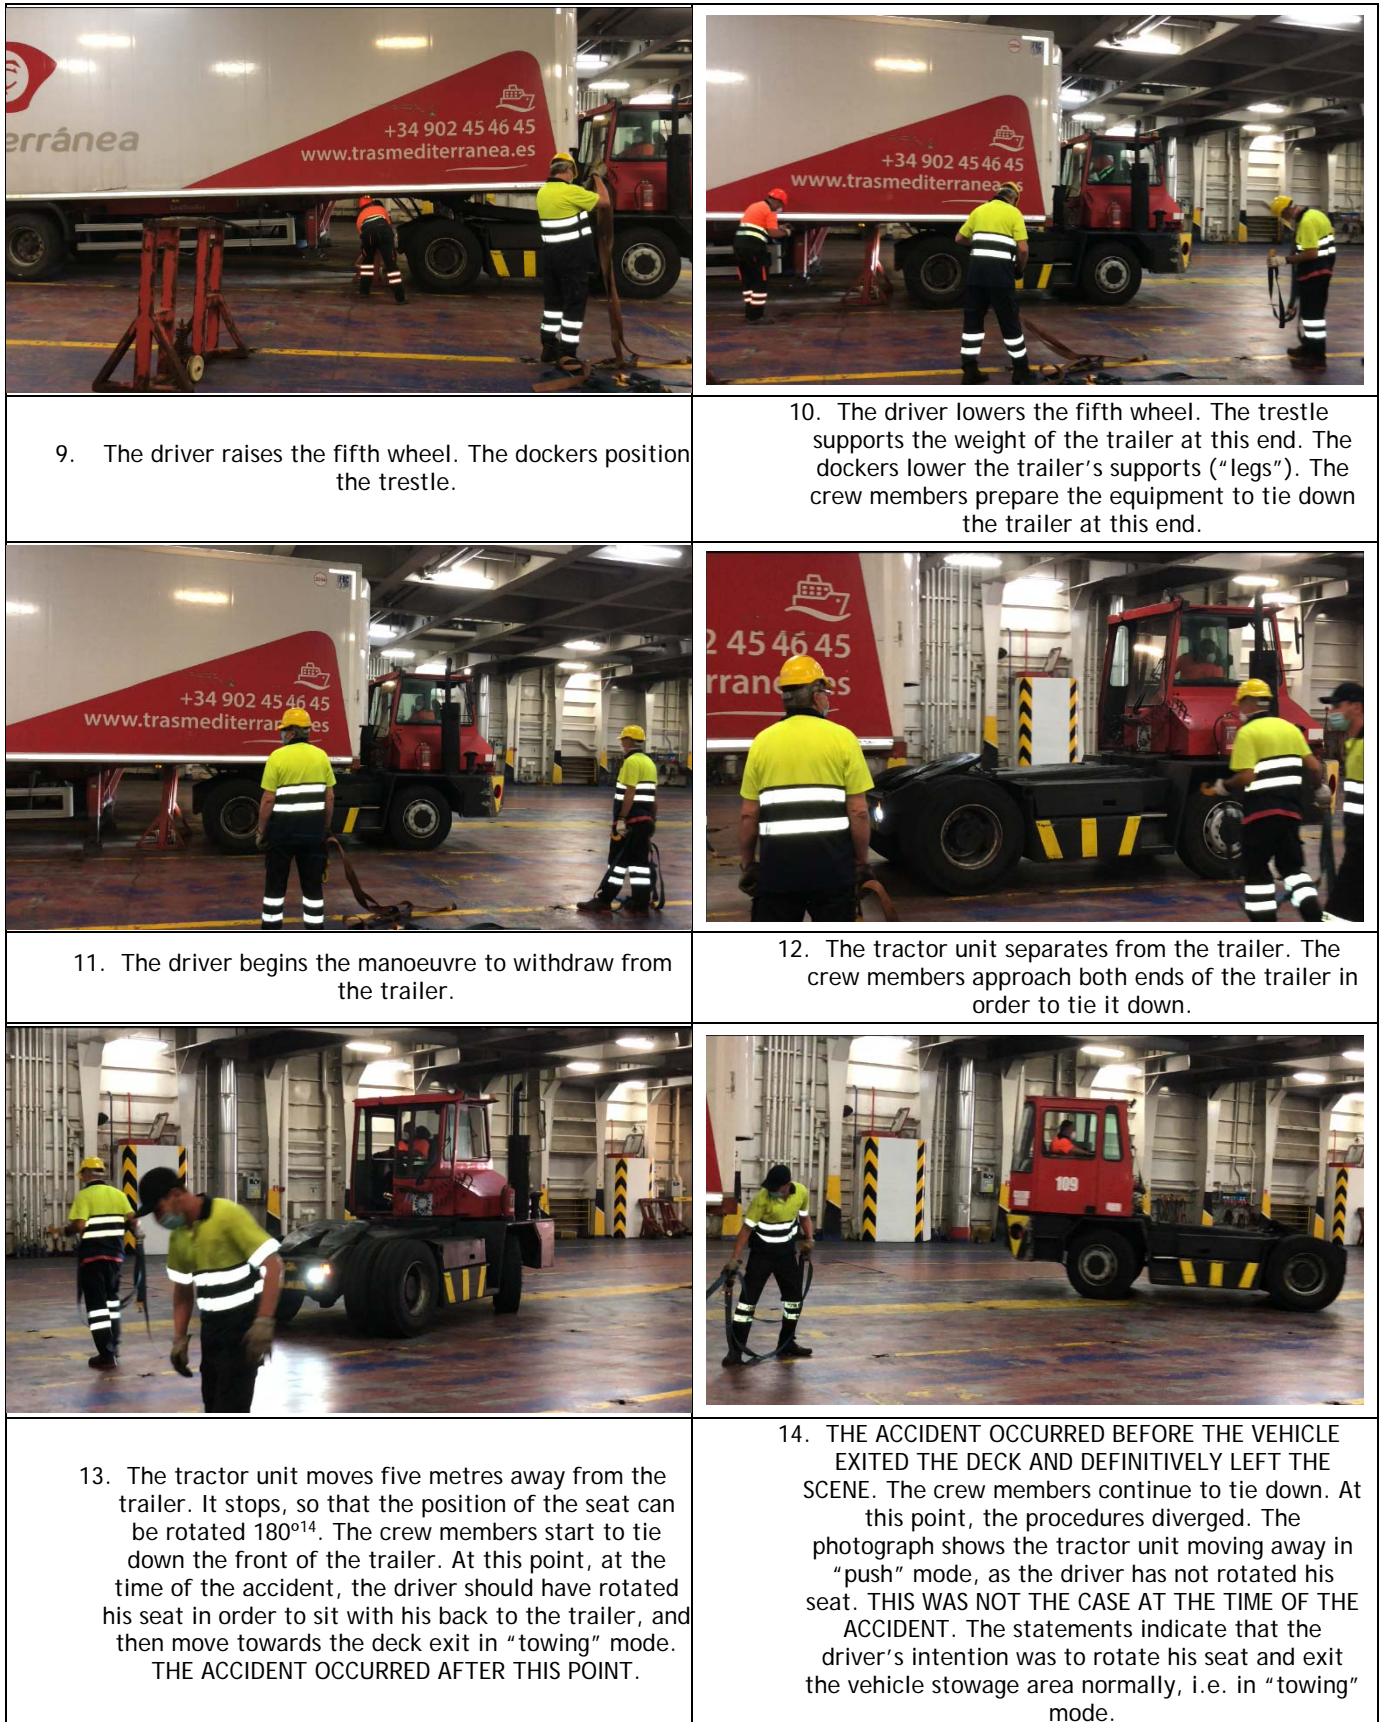
Figure 10. Sequence of movements

<sup>14</sup> To clarify the discrepancy observed in the images, the two photographs illustrating stages 13 and 14 of the example shown in Figure 10 do not show the action described: rather, the driver chose not to stop and instead continued to operate in the "push" position, first reversing back in order to withdraw several metres, then stopping, then selecting a forward gear and driving away in "push" mode, without rotating his seat.

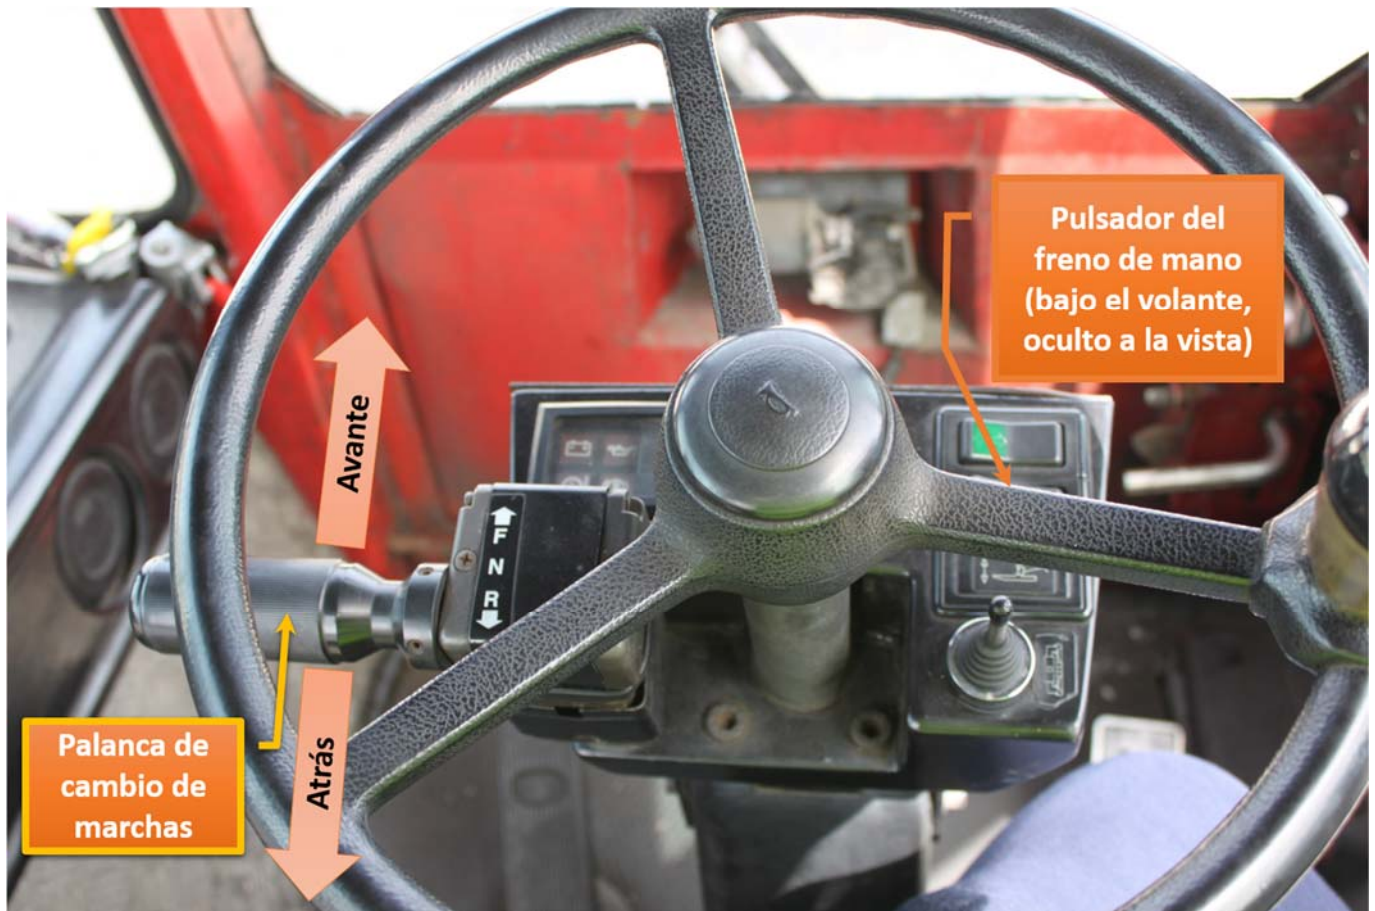
Figure 13. Main operating controls for the tractor unit.

The “Forward” and “Back” directions indicated in Figure 13 are not absolute; rather, they are relative to the position that the vehicle’s seat has been placed in. In other words, “Forward” always refers to movement in the direction that the driver is facing. If the driver is sitting in the “push” position and moves the lever forward (as shown in the figure), to an outside observer it will appear as though the tractor unit is reversing, and vice versa.
