Report IN-008/2020

Incident involving a Tecnam
P2006T aircraft, registration
LY-MEP, at the Castellón Airport
(Spain) on 10 February 2020

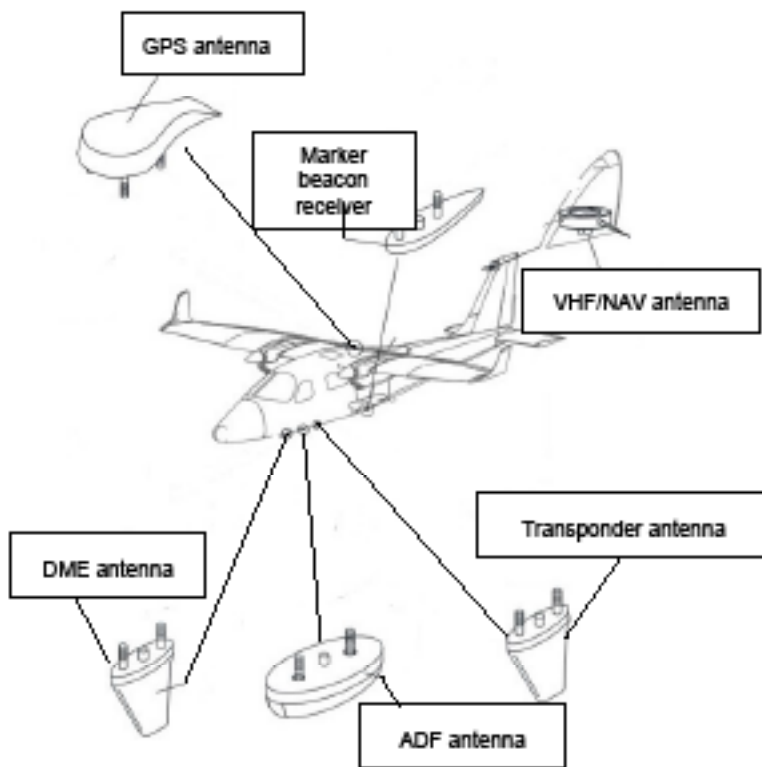
Figure 1: Locations of antennas

The locations of the various antennas installed on the incident aircraft are shown in Figure 1, and include:

The wear on the underside of the fuselage, as well as the loss of the antennas located there (DME, ADF and transponder, as well as the marker beacon receiver), were due to landing on the runway with the underside of the fuselage with the gear not deployed.

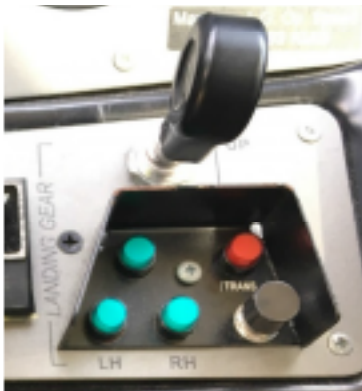
Photograph 20. Landing gear control panel

The pump is controlled by a lever switch located in the instrument panel in the cockpit (the gear control panel, see Photograph 20), such that when the handle is in the UP or DOWN position, the pump directs fluid through the corresponding pressure lines to each hydraulic actuator. To prevent an undesired retraction, the lever switch must be actuated by pulling out on the handle before it can be pushed into the UP position.

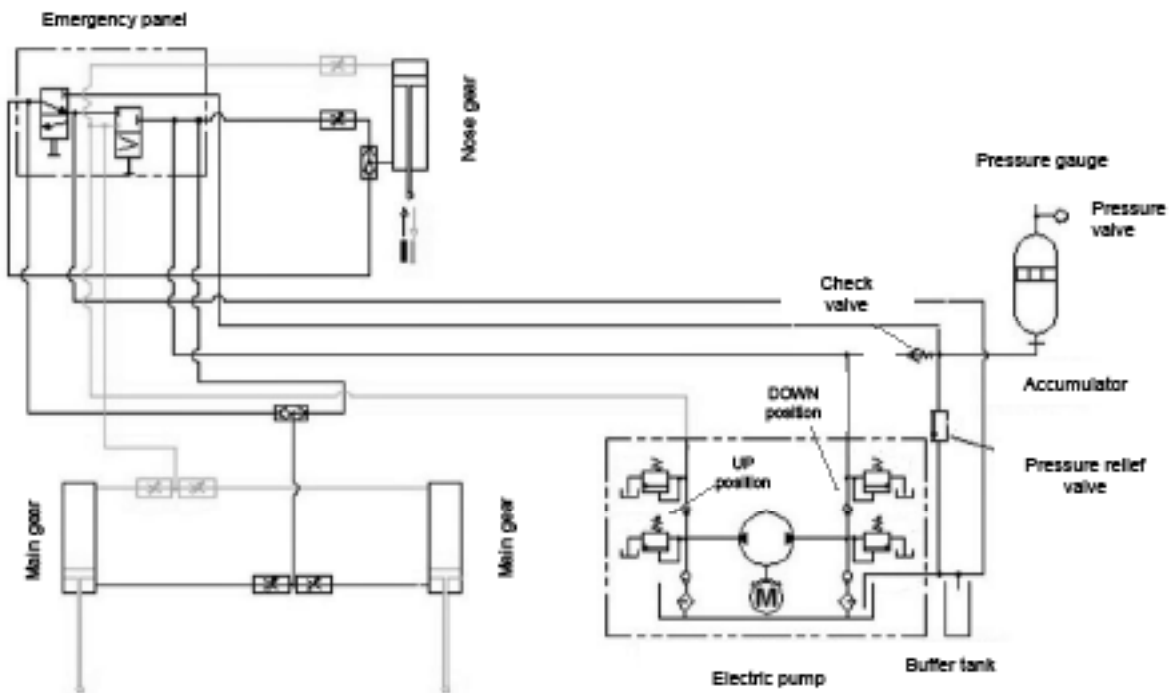
Figure 4. Diagram of the hydraulic system for the landing gear

The normal and emergency extension lines converge, however, in accordance with the selector valves (two valves, one for the nose gear and another for the emergency operation of the main gear).

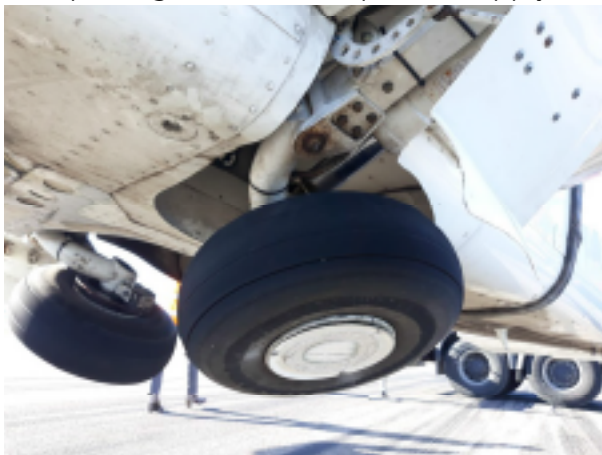
Photograph 21. Retracted main landing gear on the incident aircraft

The legs are not locked in the UP position. They are held there by the hydraulic pressure. If the pressure drops, the UP position microswitches would actuate the pump motor and restore the hydraulic fluid pressure before the gear falls from the well under the effect of gravity, or under the effect of the positive load factors that are present during flight.

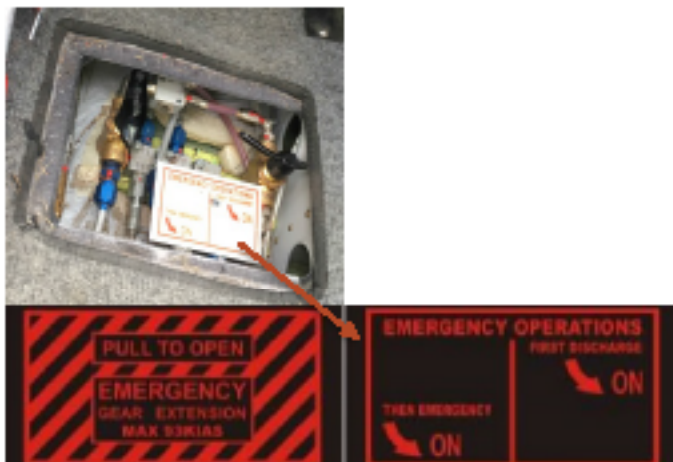
Photograph 24. Emergency gear extension panel

If this tank is full, any excess fluid is collected in a buffer tank (normally empty). Another hydraulic fluid line that comes from the hydraulic accumulator supplies the hydraulic actuators through the first handle (to the left in the "emergency panel" shown in the photograph) and two selector valves.

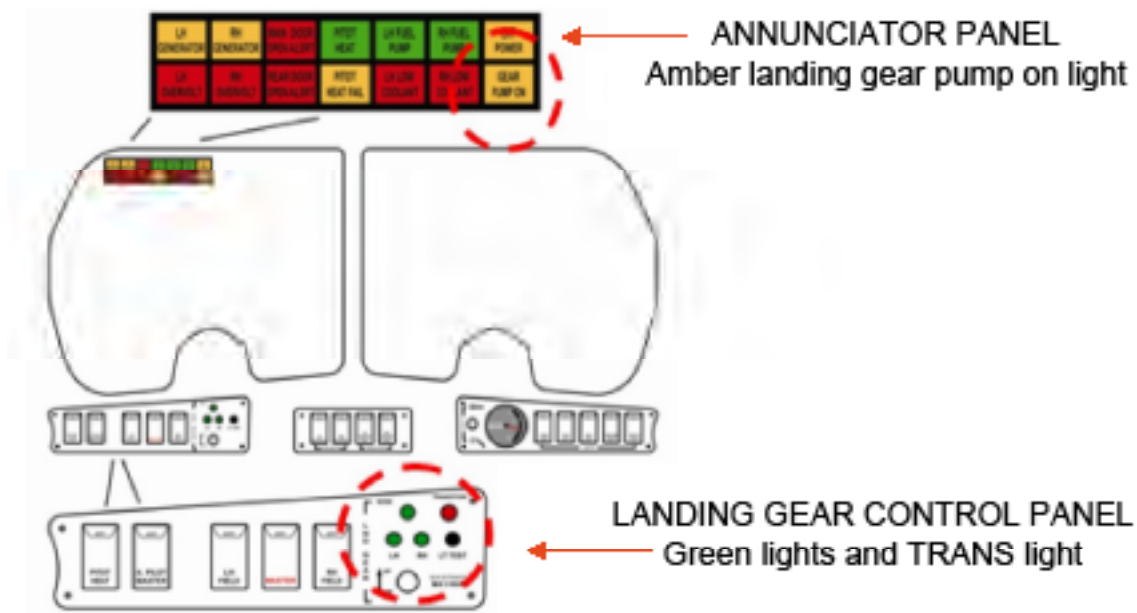
Figure 5. Indicators on the landing gear annunciator panel and control panel.

- 3 green gear indicating lights. If on, they indicate that the gear is down and locked.
- red transit light. If on, it indicates that the gear is moving.
- amber pump light on the annunciator panel. On when the pump is powered.
- UP/DOWN microswitches (6 contacts, two per leg).
- push-to-test button: to test that the red light and 3 green lights are working correctly.

The three green lights are only on when the associated leg is down and locked. The red light indicates that the gear is moving up or down, and the amber light on the annunciator panel indicates that the pump is being powered.

The red transit light only turns off when the gear legs are “down and locked” or “up”, while the amber “pump on” light only turns off when the power supply to the electric pump is shut off.

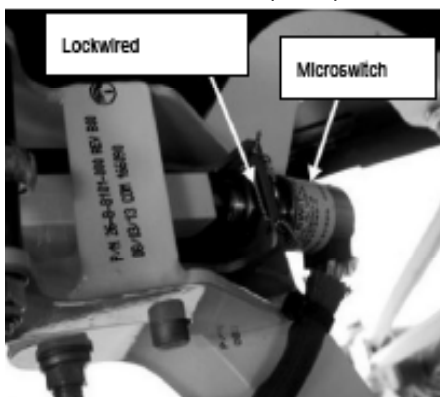
Photograph 25. Position of DOWN microswitch in the NLG

The UP/DOWN microswitches are controlled by the gear configuration specified by the pilot through the gear lever switch, which turns on the corresponding light and actuates the pump.

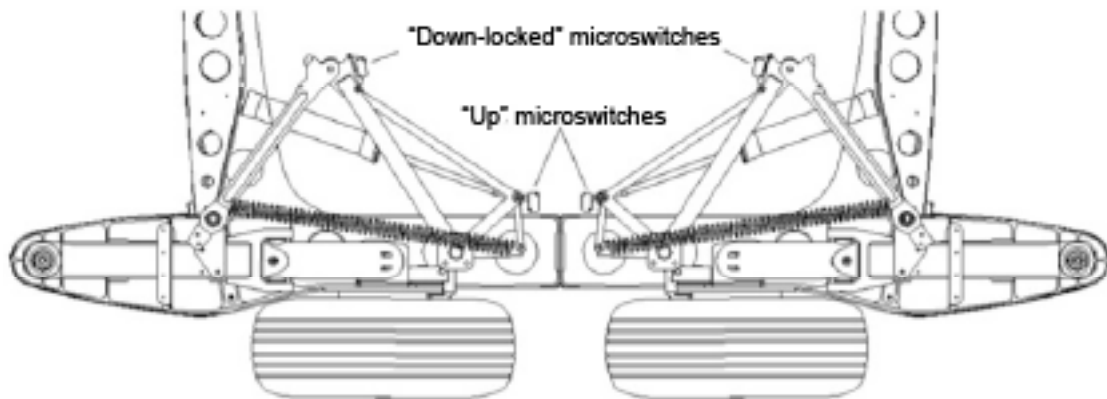
Figure 6. Positions of the microswitches in the MLG

The dual-contact microswitches for the position of the leg are positioned on each leg to detect the DOWN AND LOCKED and UP positions.

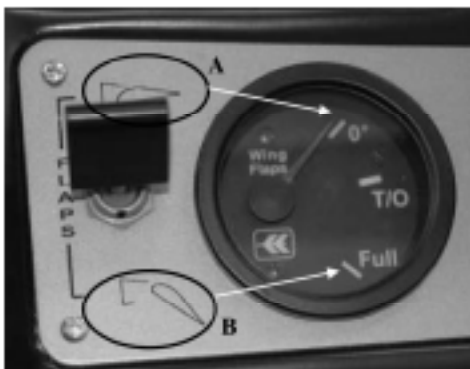
Photograph 26: Flap control and indication

The acoustic warning system consists of a horn or aural signal that alerts the pilot when the gear lever is in the UP position and at least one of the two throttle levers and/or the flaps are in the IDLE and LAND position, respectively. That is how it is described in the AFM, without specifying if the LAND position for the flaps could mean both the T/O and FULL (land) positions, as shown in the analog flap position indicator on the instrument panel (Photograph 26).

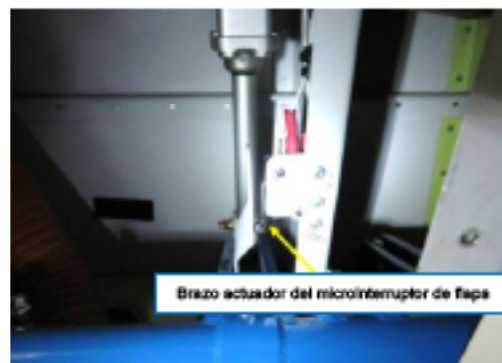
Photograph 27: Flap position microswitch of the gear warning system

The system is designed to generate an aural warning every time the flaps are lowered to the landing position and the gear is not down and locked. The system's sensor is activated by way of a microswitch located at the top of the center cockpit panel, based on the position of the flaps (Photograph 27).
