## **Report** **IN-014/2019**

Incident involving a Boeing  
737-800 aircraft, registration  
G-TAWA, at Lanzarote Airport on  
25 March 2019

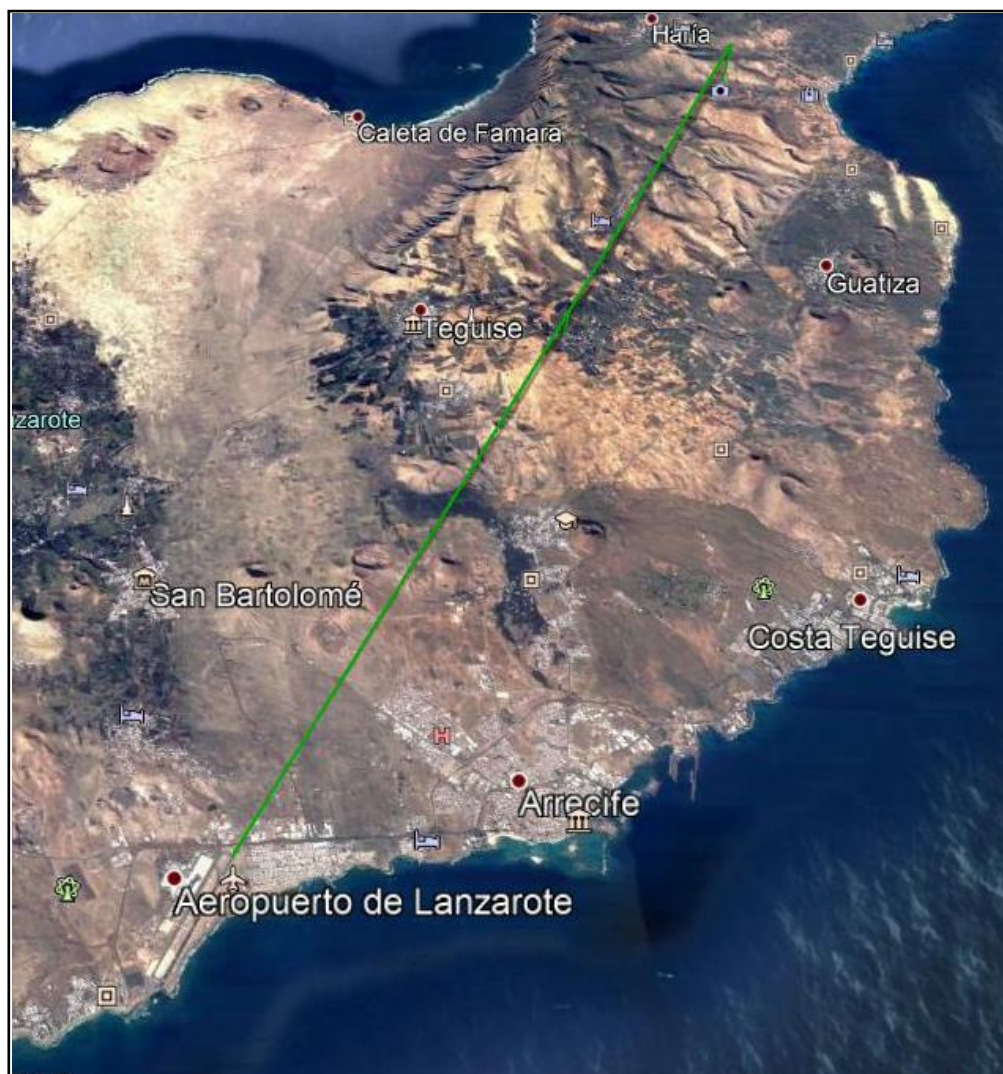
Illustration 3: Image of the terrain that is flown over during the VOR A approach (indicated by a green line)

The orography that is flown over during the approach to runway 21 at Lanzarote airport (See Annexe II) is characterised by:

- a. the rising terrain level and
- b. the height of volcanic formations.

The pilot is assisted by the visual PAPI gradient indicator system to facilitate the final descent to runway 21. The uneven terrain necessitates a 3.7-degree<sup>6</sup> gradient, which means the approach to landing on runway 21 is steeper than standard approach angles.
