# Technical report IN-014/2022

Incident involving a Cessna 560 XL aircraft,  
registration D-CNOC, on 24 March 2022 at  
Seville Airport (Seville, Spain)

## IN-014/2022

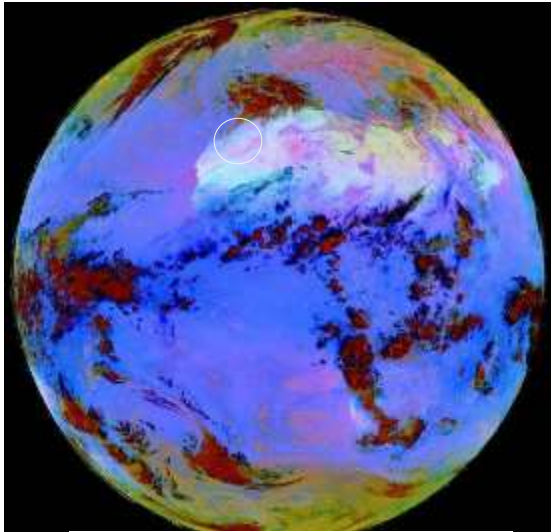
*Image 13: 23 March at 18 h*

The EUMETSAT satellite provides images in RGB (red, green and blue) taken on 23 and 24 March, showing the evolution of the dust intrusion. The presence of dust is associated with the colour pink/magenta. On 24 March at 0 h, the Iberian Peninsula (marked with a white circle) is affected by a dust intrusion.
