**COMISIÓN DE  
INVESTIGACIÓN  
DE ACCIDENTES  
E INCIDENTES DE  
AVIACIÓN CIVIL**

## **Report IN-015/2018**

Incident involving a DIAMOND  
DA20-C1 aircraft, registration  
EC-MQT, at the La Axarquía  
aerodrome in Vélez-Málaga  
(Málaga) on 9 May 2018

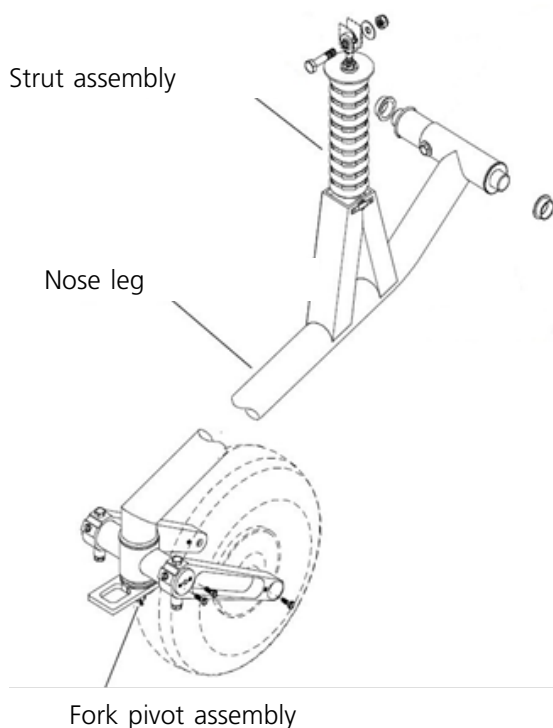
Figure 2: nose landing gear

In particular, the nose gear has a single welded tubular steel bar that is fixed to the engine mount by a stud, and a rotating wheel. The attachment of this bar consists of an elastomer spring that provides damping (Figure 2).

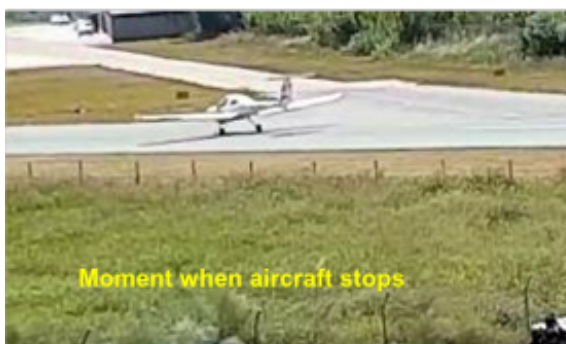
Series of photographs 10: Emergency landing sequence

Lastly, photographs of the emergency landing taken from the tower at the aerodrome and the runway are provided below.

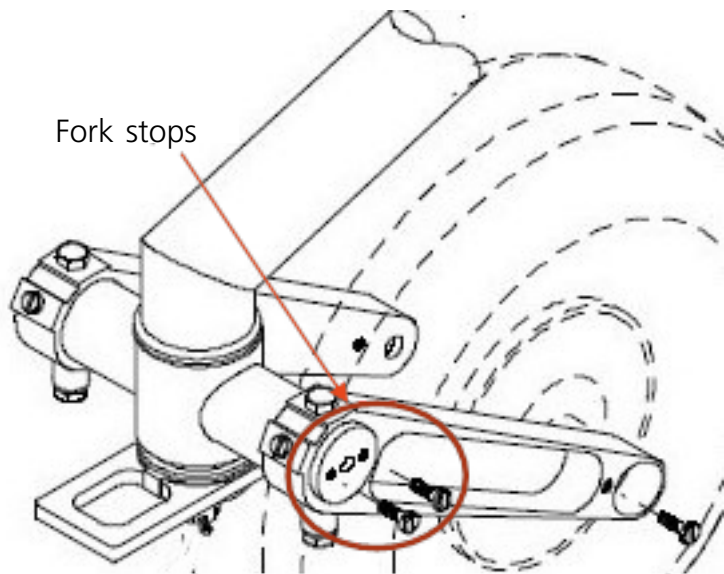
Figure 7: Nose wheel fork attachment

The nose wheel fork assembly that detached during the aborted landing was recovered, but the nuts, washers and other components used to secure it to the nose gear were not.

The stops on the sides of the fork, which are attached with screws, as shown in the IPC in Figure 7, were also not found.
