# Technical report

## IN-019/2022

Incident on 31 March 2022 involving a Boeing 737-8AS aircraft operated by Ryanair, registration EI-DLC, at Adolfo Suárez Madrid-Barajas Airport

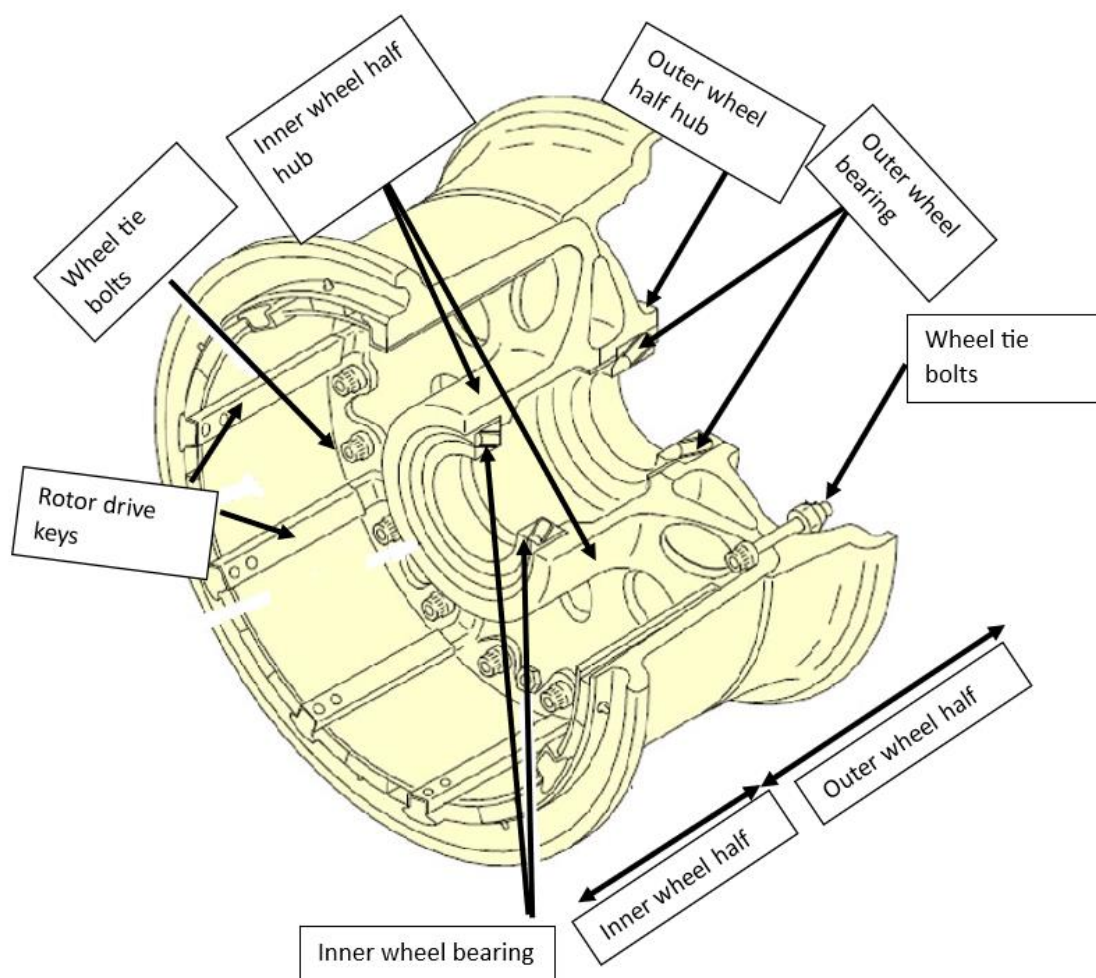
Figure 1 – Sketch of the BOEING 737-8AS wheel.

- As a general rule, a major wheel overhaul is required every 24 months or 1800 cycles.
- The following maintenance task is of note as it involves the inspection of an area very close to the one in which the fracture originated (see figure 7). It requires non-destructive testing of the internal bearing bore in the hub of the inner wheel half:
  - NDT inspection of the inner and outer wheel halves (code 32-40-14-000-025-A01): When the bearing cup or bearing cup and sleeve assembly is removed from wheel half, use eddy current, ultrasound, or fluorescent penetrant inspection to examine the bearing bore inside diameter and corner radius for possible indications. This should be carried out during
