**COMISIÓN DE  
INVESTIGACIÓN  
DE ACCIDENTES  
E INCIDENTES DE  
AVIACIÓN CIVIL**

## **Report IN-020-2017**

Incident involving an ATR  
72-212A aircraft, registration  
EC-KKQ, operated by Swiftair,  
at flight level 170 in the vicinity  
of reporting point NARGO  
(Albacete-Spain)  
on 9 September 2017

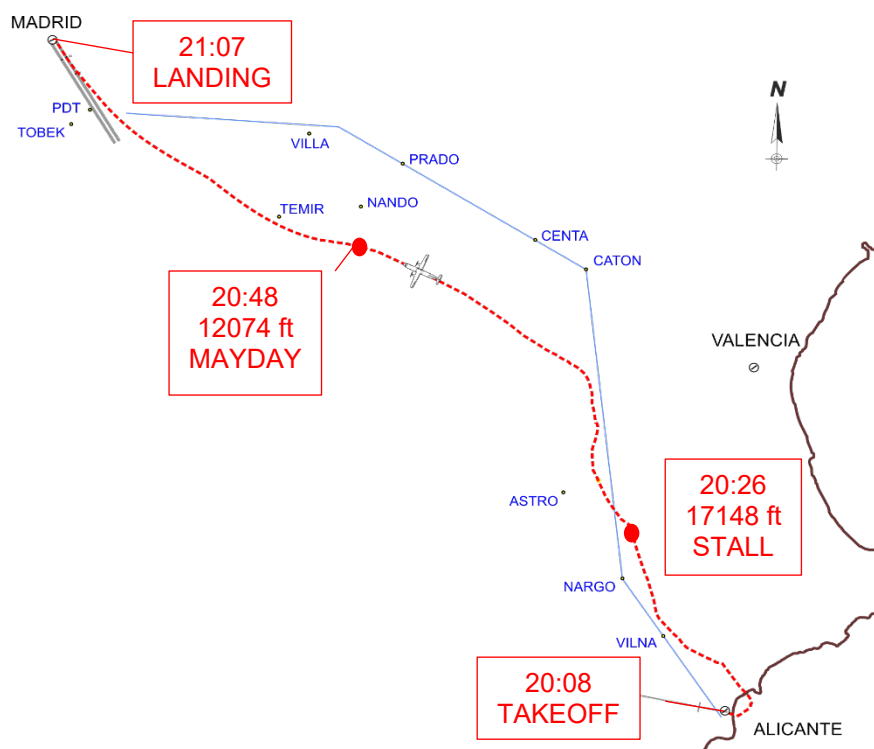
Figure 1. Full flight path of aircraft EC-KKQ

Eight minutes into the flight, with the aircraft passing FL100 (10023 ft) and climbing to FL170 (its authorized level), the temperature TAT reached a value 7° C<sup>2</sup>. Two minutes later, with the TAT at 2.7° C and climbing at a speed of 175 kt<sup>3</sup> at 12516 ft, the crew turned the anti-icing systems on (ANTI ICING ON). Within 28 s, the aircraft's ice build-up

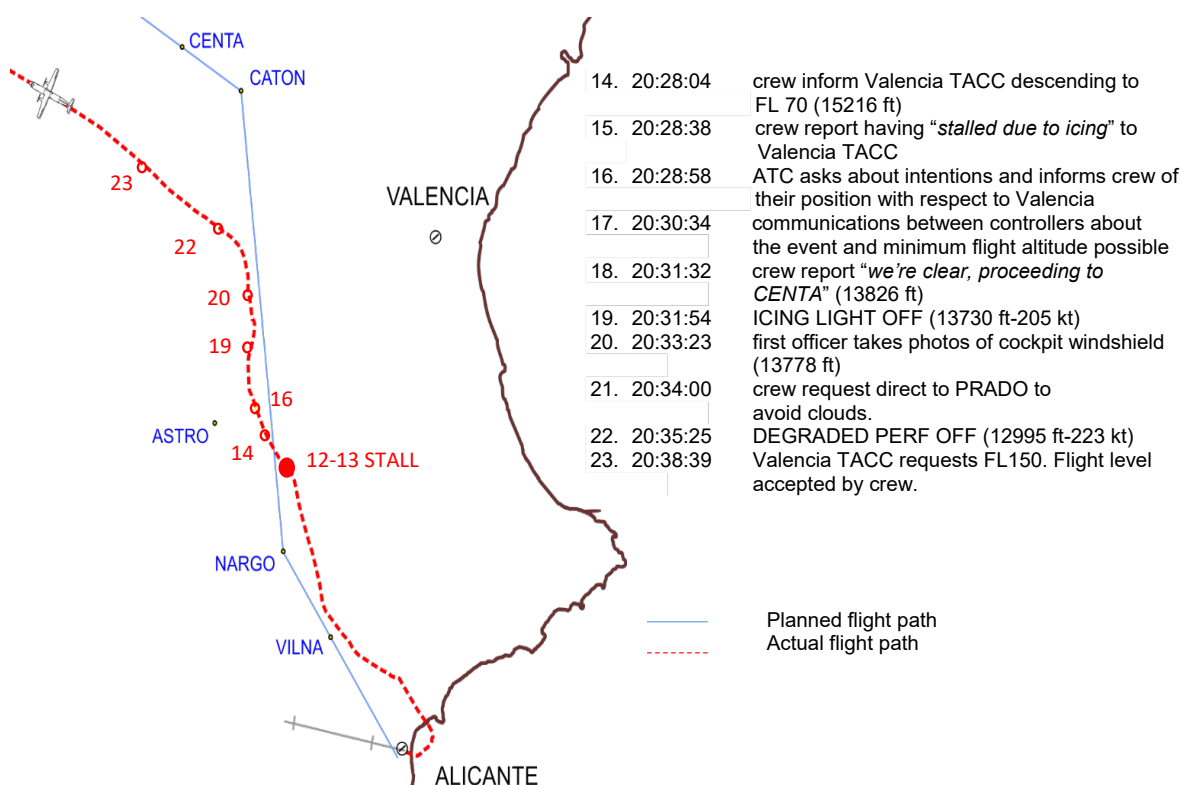
Figure 3. Flight path after the event (10 min of flight time)

At 20:42:26, after the controller asked if the icing situation was solved, the crew reported they had taken on a lot of ice, that something was wrong, the problem was still present but they were stable. Five minutes later, at 20:47:22, the crew reported they had not solved the problem yet and requested to descend. At 20:48:25, they reported a MAYDAY and requested direct to Madrid due to continuing "problems with the controls".

Two hours before the incident, at 18:35:33, an aircraft (RAM969C) reported moderate icing at point ASTRO (marked in Figure 3) to the Valencia TACC. It was at 16500 ft, cleared to FL190 and it requested to stay at FL170 due to icing. This information was not known by the crew of EC-KKQ.

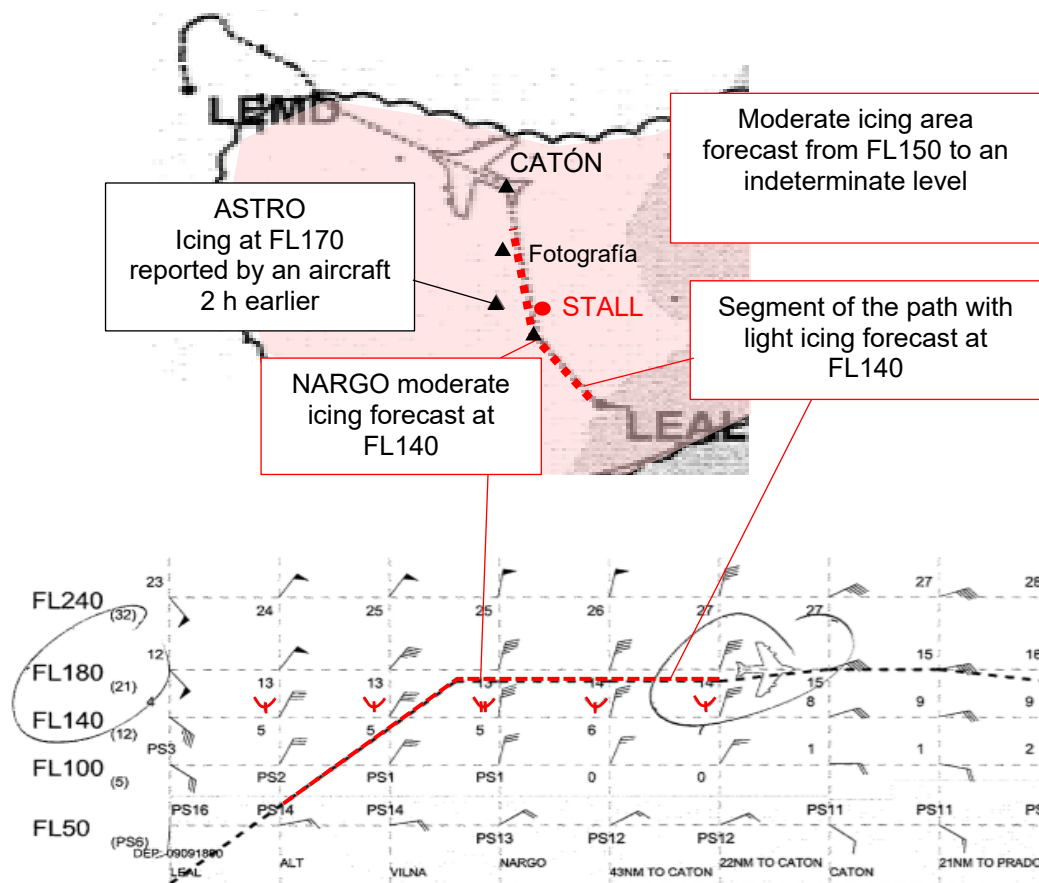
Figure 4. Information on icing forecast

- Moderate icing and turbulence at FL150 and above from takeoff until Castejón (medium/high level significant weather chart).
- Light icing at FL140 from Alicante until 22 NM before CATON (vertical cross-section map). Moderate icing at FL140 at NARGO (vertical cross-section map).
