Report IN-022/2019

Accident involving a CESSNA
560XL-XLS+, registration
D-CGAA, at Alicante-Elche
Airport (Spain), on 30 May 2019

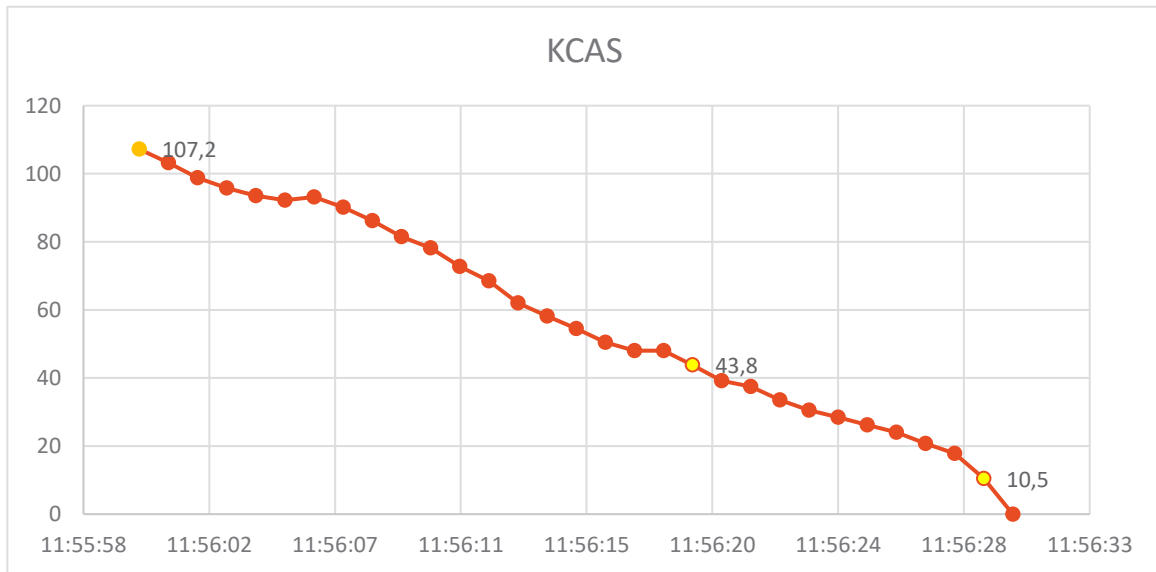
Figure 3: Speed of the aircraft during landing roll-out

- The aircraft touched down at 11:56:00 at a speed of 107.2 KCAS. None of the hydraulic systems were operating at that point.
- According to the BRAKE PRESS LOW recorder parameter, the low brake pressure message was displayed momentarily for the first time at 11:52:43 and then continuously, from 11:56:19 to the end of the FDR recording. At all other times, it showed normal values. When the warning reactivated at 11:56:19, the aircraft's heading was 107°, and the KCAS speed was 43.8 kts.
- The aircraft came to a stop at 11:56:30.
- The four parameters called BRAKE PEDAL 11, 12, 21 and 22, correspond respectively to the pilot's pedals 11 (left) and 12 (right) and the co-pilot's 21 (left) and 22 (right). No values were recorded during the flight for any of them, possibly, according to the CIAIAC laboratory, because the recorder was not configured to log them.

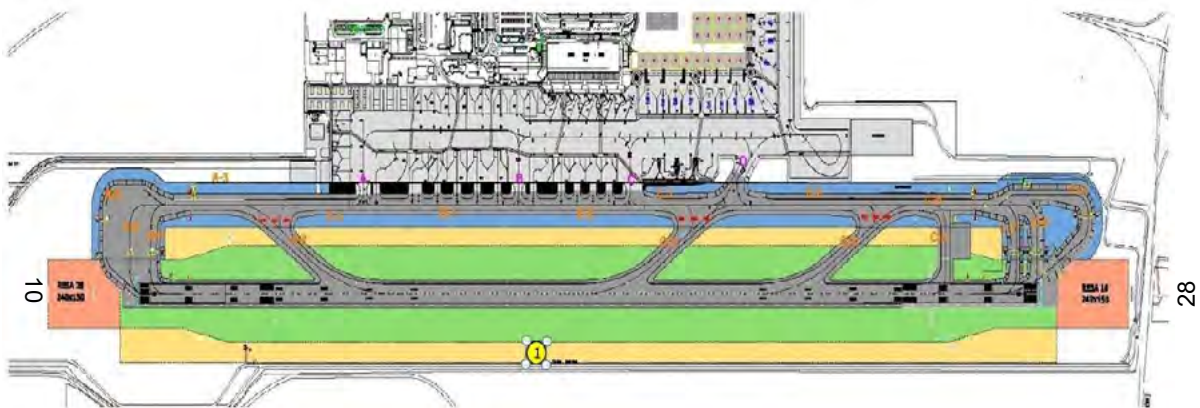
Figure 6: Location of the aircraft after the incident

The yellow circle (1) in figure 6 shows the aircraft’s final position on the runway’s unpaved side strip.

The main landing gear had lost its left tyre, and the right was partially detached. The rims of both wheels, which were damaged and deformed, had sunk into the ground and parts were missing.

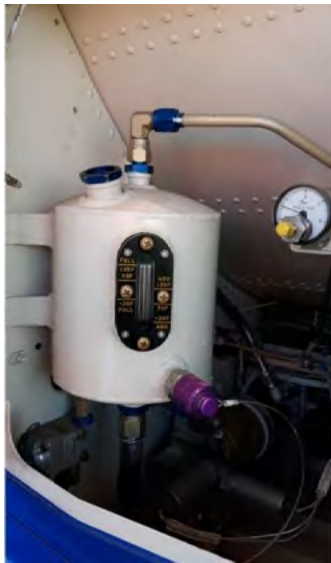
Left Photograph 15: Brake system accumulator

- The remaining control surfaces were in good condition. It should be noted that the rudder was deflected to the left.
- Normal brake system: The hydraulic brake system reservoir was empty, the pressure indicated on the system gauge was 600 psi.
- Emergency Brake System: the pneumatic system brake accumulator pressure was 1600 psi (normal pressure is between 1800 and 2050 psi).

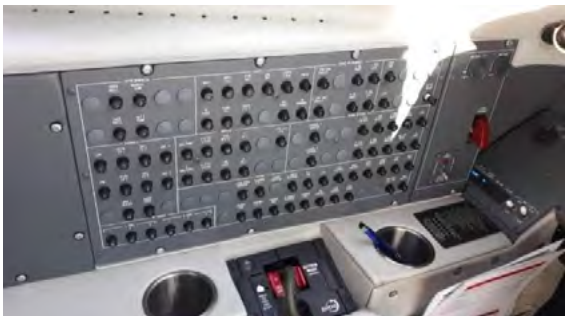
Photograph 20: LH CB panel

- Emergency brake lever activated.
- Position of left panel circuit breakers (CB): the only one popped is the FLT HR Meter (flight hour meter).
- Position of right panel circuit breakers (CB): two popped breakers found, RADAR and MASTER APU.

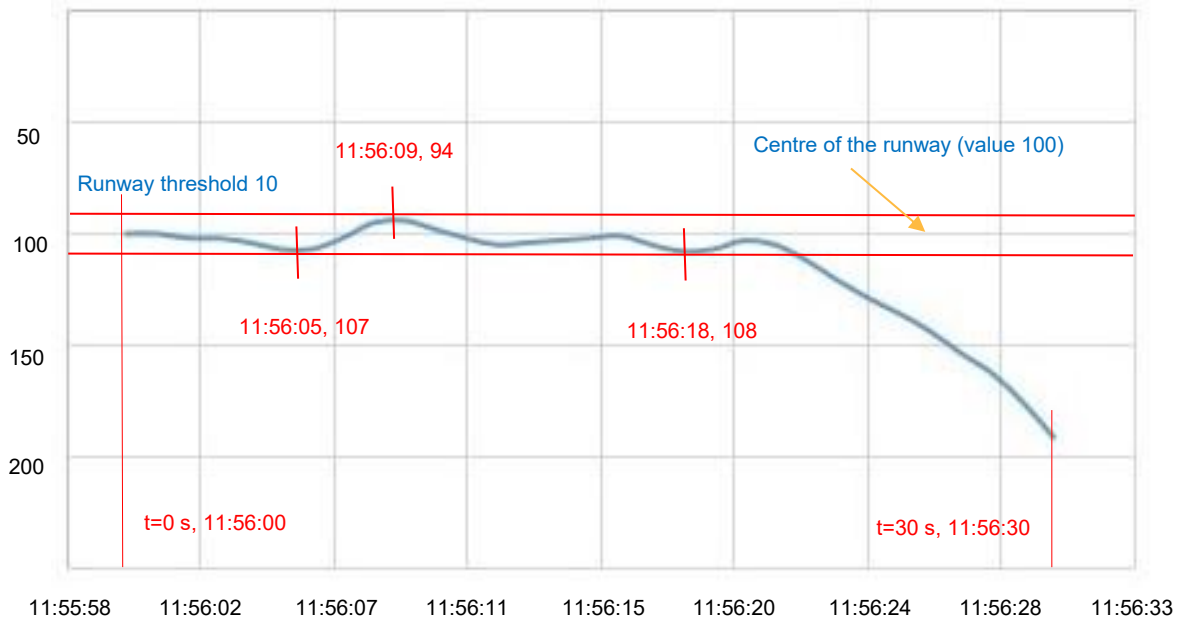
Figure 7: Trajectory of the aircraft during landing roll-out

The duration of the landing roll-out was thirty seconds. Touchdown occurred at 11:56:00 UTC, and the aircraft stopped at 11:56:30 UTC.

In seconds 23 and 24, a new significant rudder deflection to the left was recorded, this time accompanied by lateral accelerations. The ANTISKID FAIL warning was displayed in second 24.
