Report IN-030/2018

Incident involving an Airbus
A320-214 aircraft, registration
EC-JFN, at Adolfo Suárez
Madrid-Barajas Airport
on 3 July 2018

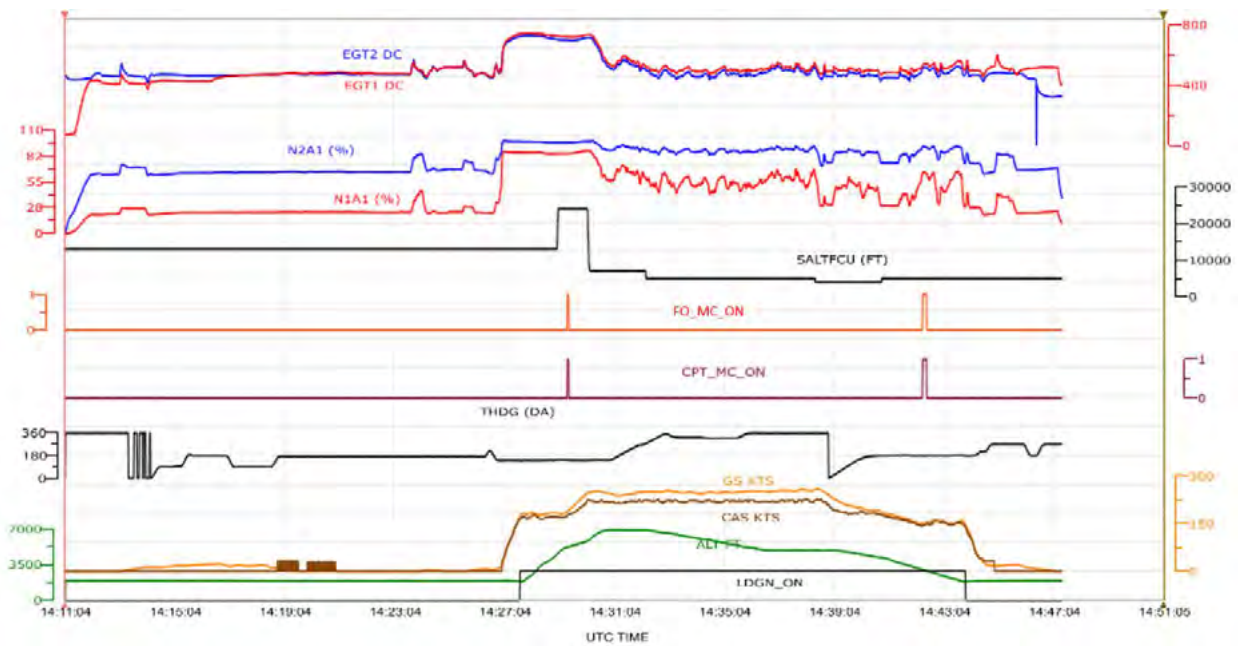
Figure 2: Aircraft's FDR records during the flight

- At 14:42:10 UTC: crossing 1200 ft RA, A/THR was disconnected.
- At 14:42:14 UTC: Master Caution triggered during nine seconds.
- At 14:42:18 UTC: crossing 1150 ft RA, both APs were disengaged. Master Warning triggered during two seconds. CPT was pilot flying.

- At 14:43:44 UTC: aircraft touchdown on LEMD runway 18R. GW was 64.9T > MLW (64.5T). Overweight: +0.4T.
- At 14:47:20 UTC: recording ends.

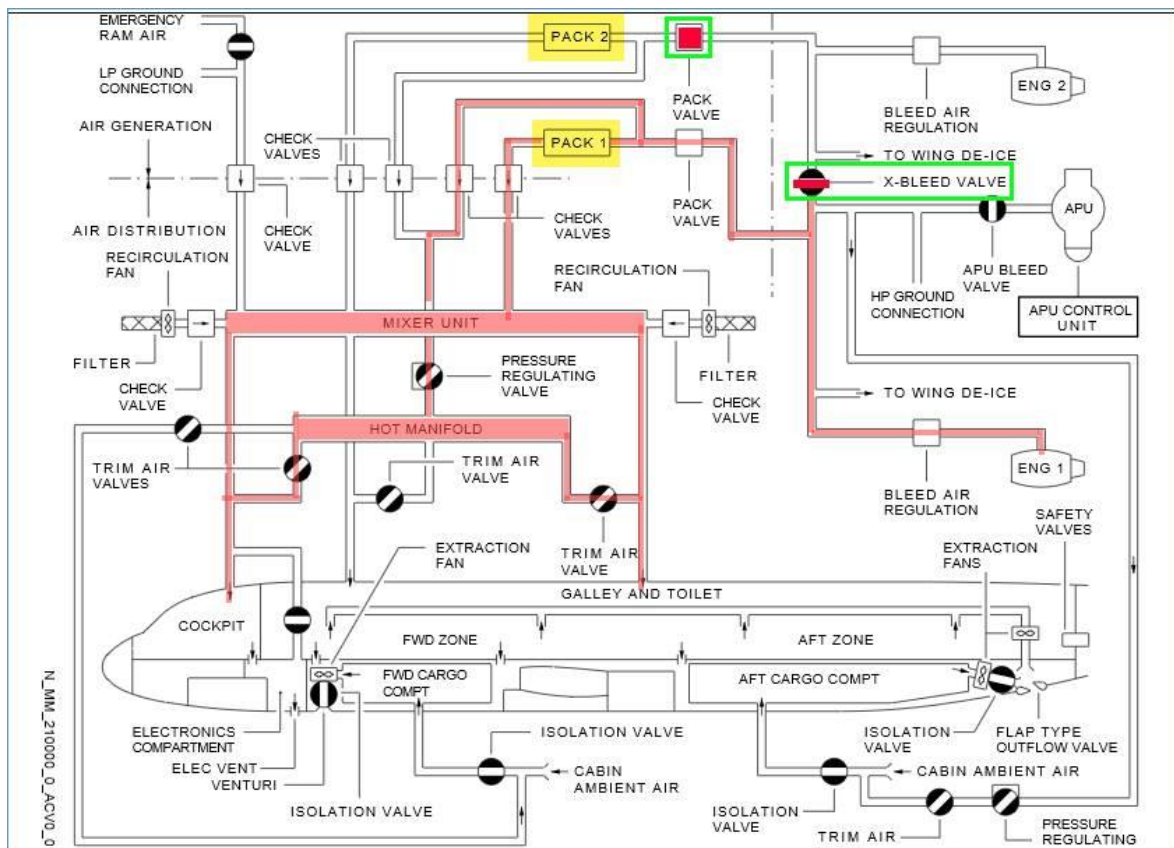
Figure 4. Engine 2 Air Conditioning System

The data from the FDR confirms that the X-bleed valve was closed throughout the flight. The bypass valve of pack 2 was also closed throughout the flight. These two valves are shown in Figure 4 below, marked in red with a green box around them.

As can be observed, in this configuration, engine 1 was supplying pack 1 while engine 2 and pack 2 were isolated from the air conditioning system. Therefore, the smell must have been generated by engine/system 1.
