**COMISIÓN DE  
INVESTIGACIÓN  
DE ACCIDENTES  
E INCIDENTES DE  
AVIACIÓN CIVIL**

## **Report IN-031/2018**

Incident involving several aircraft  
in the airspace of the Madrid CTR  
(control zone) on 27 May 2018

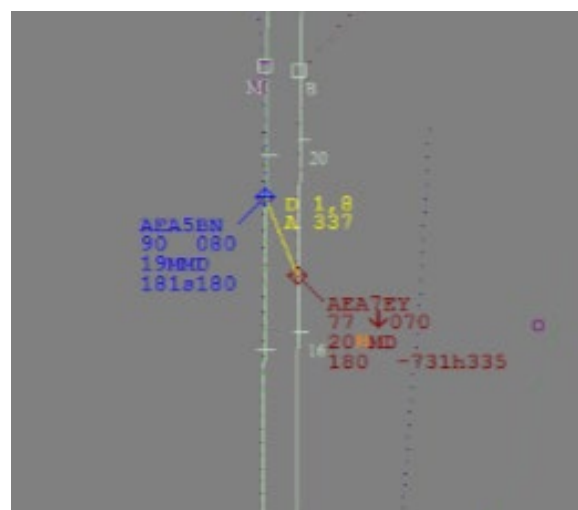
Illustration 19: Positions of the aircraft with callsigns AEA5BN and AEA7EY at 21:58:24

As noted in the previous section, loss of separation D refers to that involving the Boeing 737-800, registration EC-LXV and callsign AEA5BN, and the Airbus A330-200, registration EC-LVL and callsign AEA7EY.
