Report IN-031/2020

Incident involving a BOEING B737-800 aircraft operated by RYANAIR, registration EI-EFJ, and lighting vehicle 'Balizamiento 3' operated by AENA, on runway 24R at Palma de Mallorca Airport, on 19 July 2020

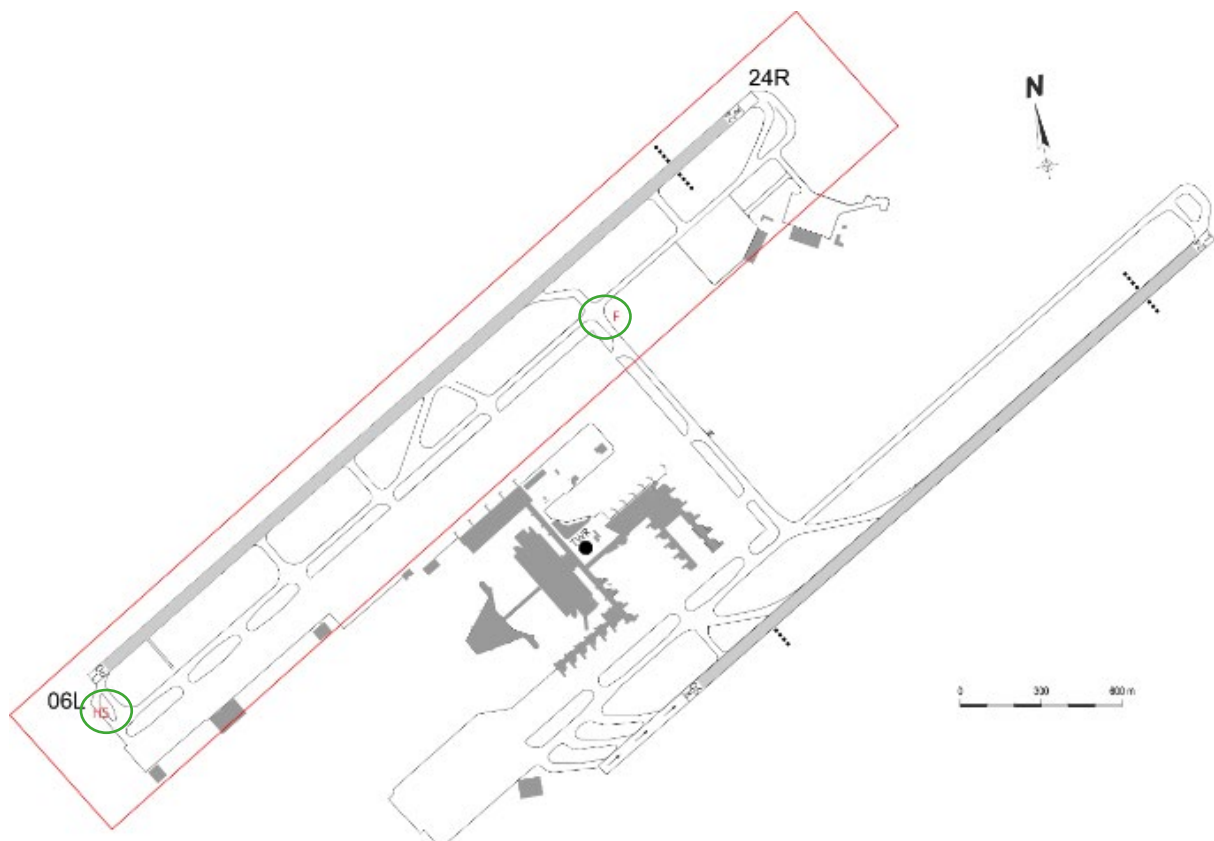
Fig. 1. Layout of Palma de Mallorca Airport.
The manoeuvring area where the incident took place is highlighted in red
and holding point H5 and gate F are highlighted in green
