**COMISIÓN DE  
INVESTIGACIÓN  
DE ACCIDENTES  
E INCIDENTES DE  
AVIACIÓN CIVIL**

## **Report IN-033/2019**

Incident on 16 July 2019 involving a Boeing 737-800 aircraft operated by Air Europa, registration EC-LYR, and a Boeing 737-8AS aircraft operated by Ryanair, registration EI-FRP, to the south of Écija (Seville)

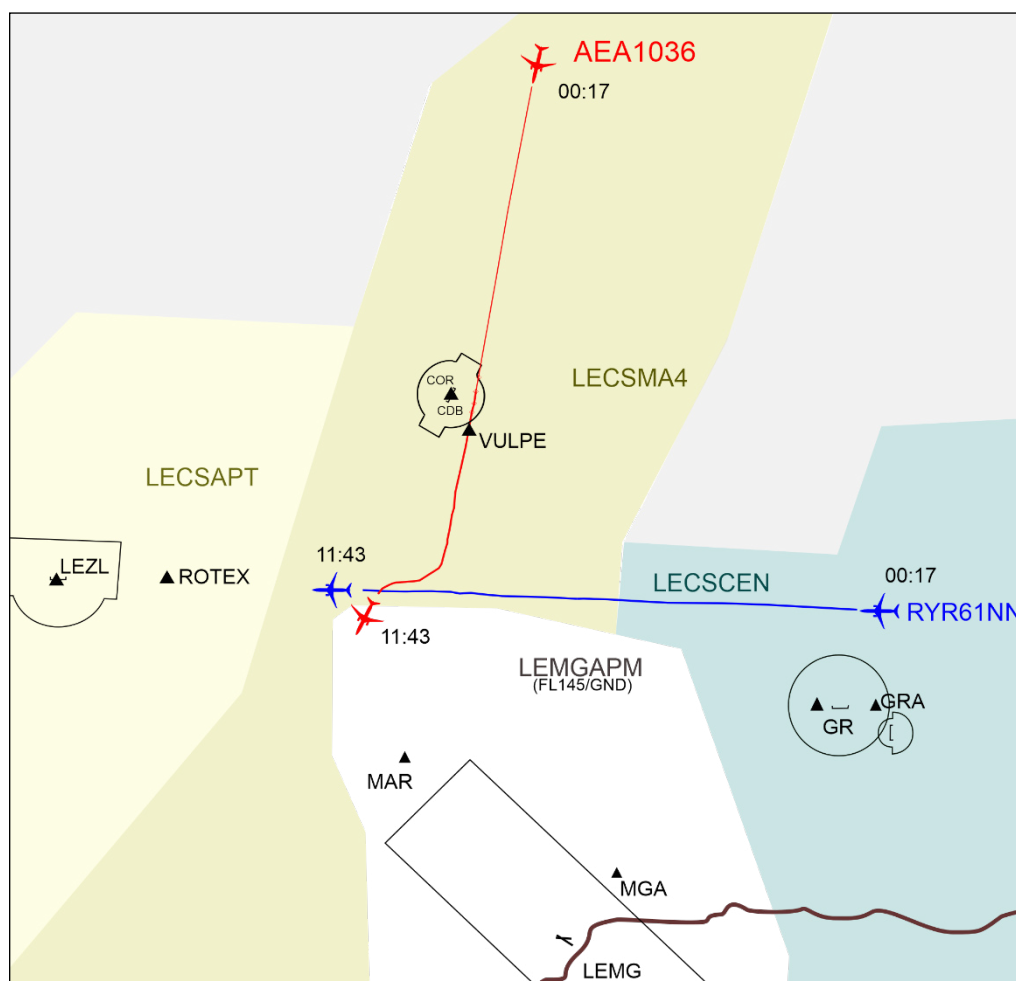
Despite the fact that 29 seconds before the loss of separation occurred, the air control system STCA-PAC proximity alert activated, the controllers of the different units failed to coordinate in time to prevent an infringement of the regulatory separation distance, which occurred at 13:11:02. In the end, the aircraft crossed paths at a minimum distance of 1.3 NM horizontally and 0 ft vertically, at 13:11:17.

Illustration 1: Overview of the trajectories of both aircraft and the affected control sectors

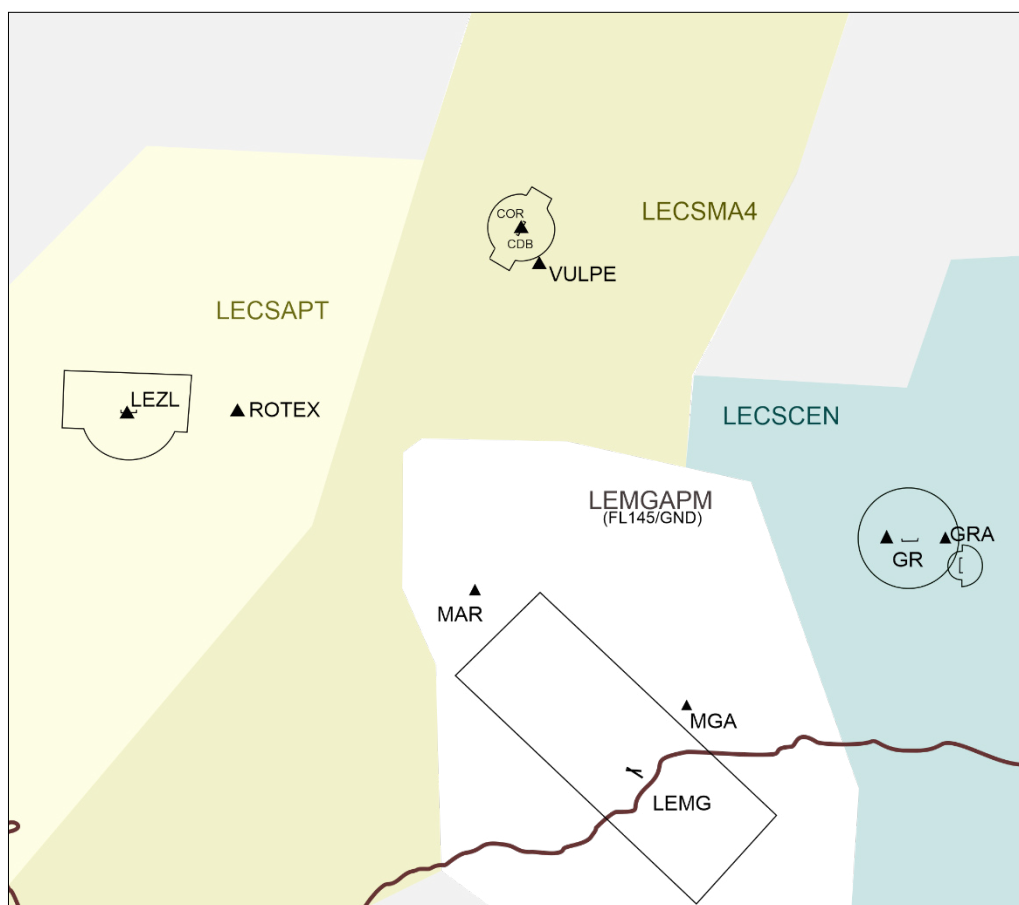
The LECSCEN sector was a route sector for the RYR61NN aircraft that was flying east to west. This aircraft was subsequently transferred to the collateral route sector, LECSMA4, which later handed it over to the LECSAPT sector for its approach to Seville Airport.

Illustration 3: Configuration of the sectors involved during the incident

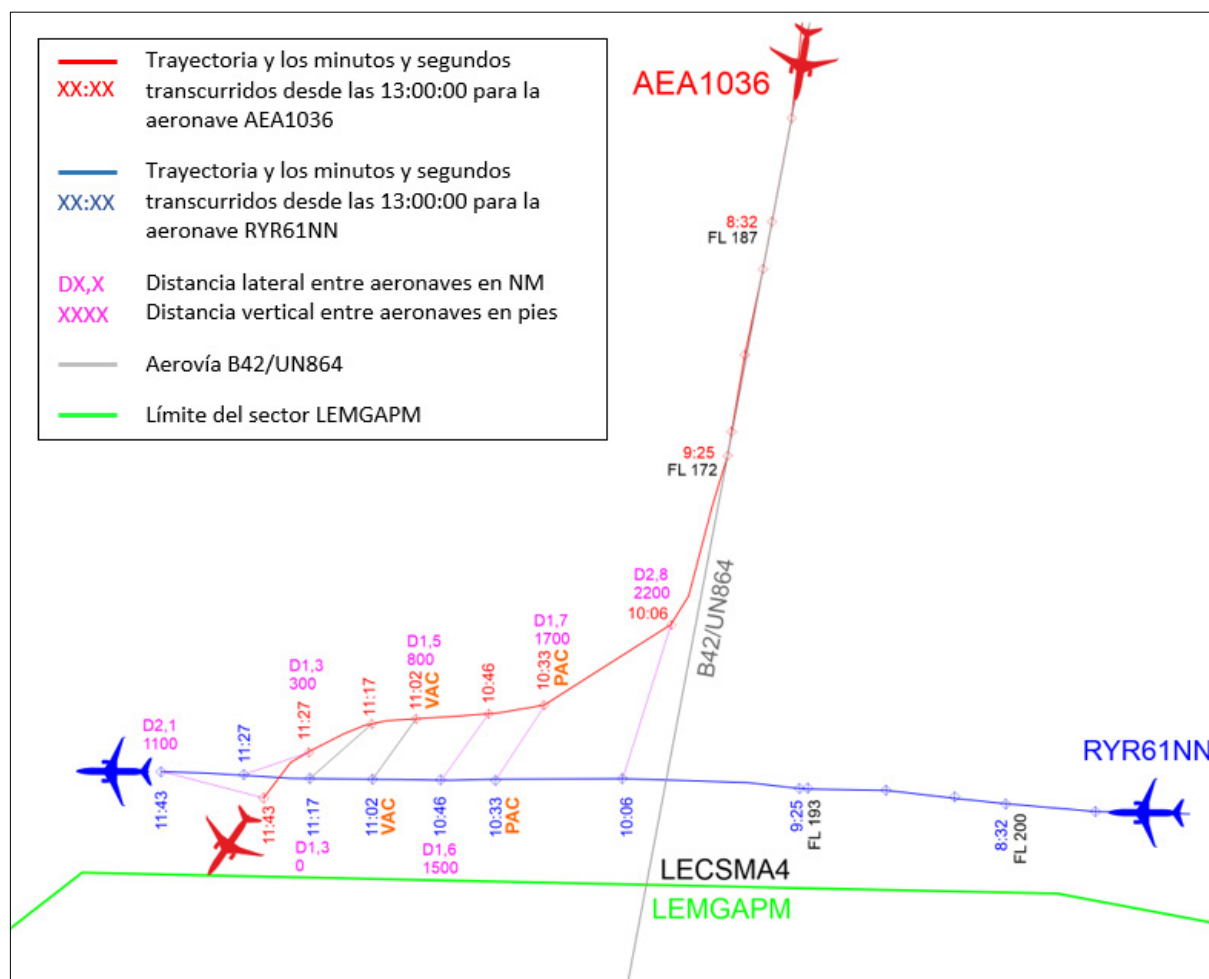
Illustration 16: Trajectory of both aircraft and their positions at different times

At 13:11:02, the first violation of the prescribed minimum separation occurred with the aircraft being 1.5 NM and 800 ft apart, activating the STCA-VAC function between them. The ROD of the RYR61NN aircraft was almost three times higher than that of the AEA1036 aircraft (3263 v 1113 ft/min).

In conclusion, we have determined the loss of separation was caused by the LECSMA4 sector controller's early transfer of the RYR61NN aircraft to the collateral sector before it was free for descent due to the prior turn of the AEA1036 aircraft.

REC 37/21: It is recommended that Enaire makes the necessary changes to ensure that LECS and LEMG APP controllers do not instruct aircraft to turn before they are in their area of responsibility unless there has been prior coordination between the units.
