**COMISIÓN DE
INVESTIGACIÓN
DE ACCIDENTES
E INCIDENTES DE
AVIACIÓN CIVIL**

Report IN-040/2018

Incident involving an Airbus A320, registration EC-MDZ, operated by Vueling Airlines, S.A., at the Bilbao Airport (Vizcaya, Spain) on 25 October 2018

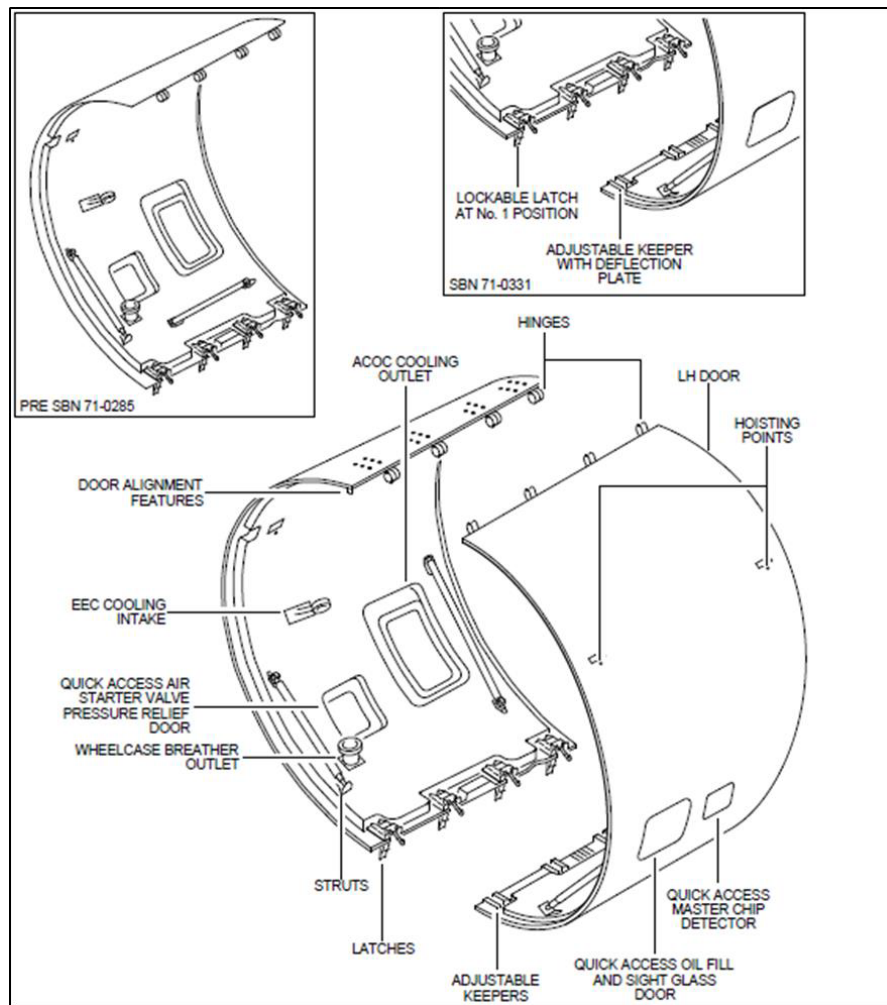
Fig. 4: General diagram of the cowls and their main parts

The fan cowls on the engine consist of two semi-cylindrical sections installed between the inlet nose cowl and the translating thrust reverser cowl. Each semi-circular cowl is approximately 1.3 m wide and 3.1 m high, measured around the circumference. They are made of an aluminum honeycomb material with a carbon fiber coating. The left panel weighs 42 kg and the right one 47 kg.

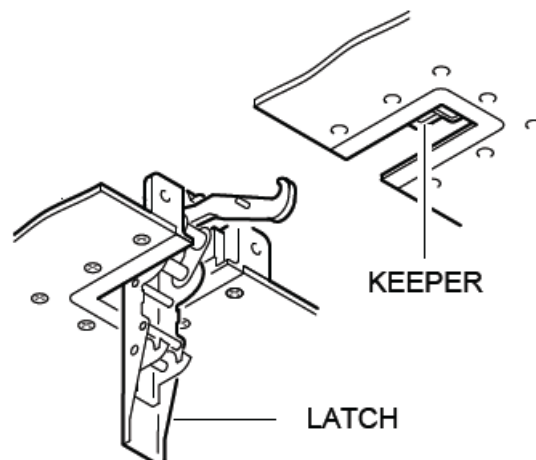
Fig. 5: Close-up of the latch-keeper system

Each cowl is coupled to the engine pylon at the top using four screwed hinges. At the bottom, each cowl is coupled and attached to the other cowl using four latches. Each latch moves a hook that engages a keeper that is installed on the other cowl (see figure below).

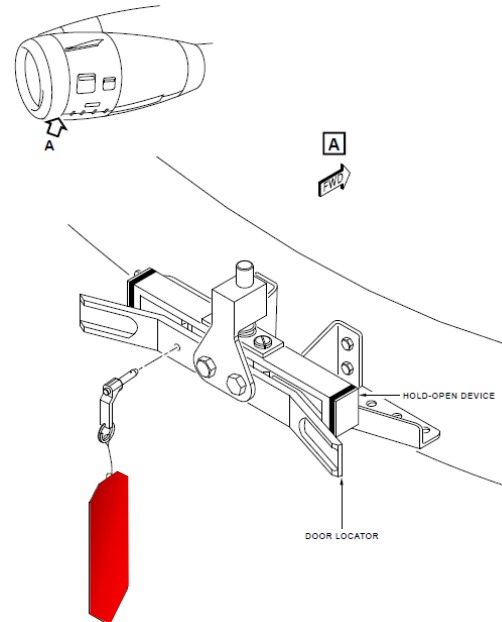
Fig. 7: Fan cowl flag attached

As indicated earlier, the AMT has to document the opening of the cowls in the logbook.

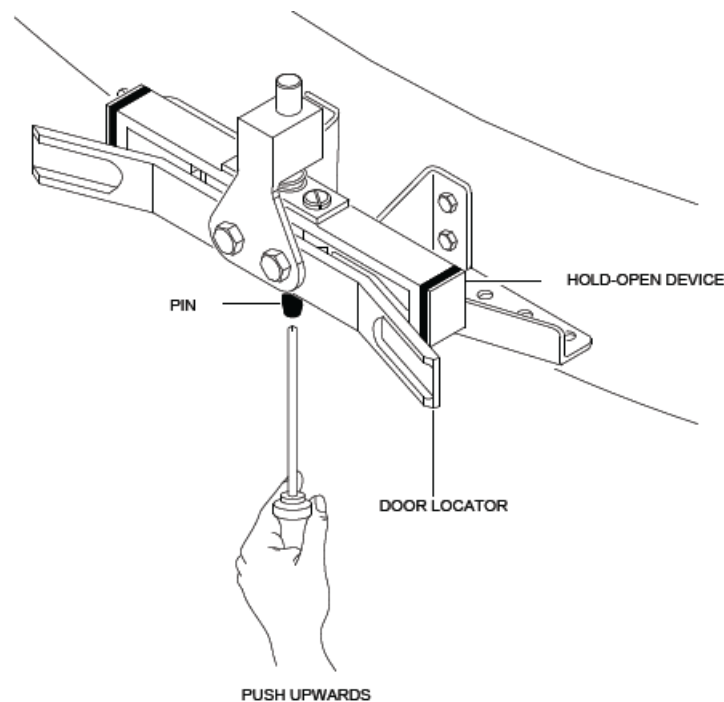
Fig. 8: Close-up of the safety pin and its operation to close the cowl

To fully close the cowls, the AMT has to lie down and push up on a safety pin (located where the two cowls come together, at the front end, in the direction of motion of the aircraft). When this pin is pressed, the two cowls drop and the edges of their panels touch, making it possible to close the four latches.

In the above position, a latch is manually lined up with the corresponding keeper. The closing lever is pushed toward the cowl, causing a distinctive sound. The latch is now closed even though the handle is not flush with the cowl and is visible from underneath.

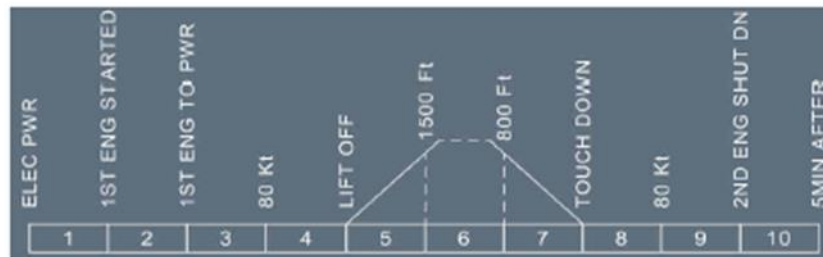
Fig. 9: Number assigned to each phase of flight for identification purposes

Note that the LGCIU2 fault message occurred in phase 5, which is between rotation and 1500 ft AGL. The following messages sent to the CFDS were generated 48 minutes later, after landing in Barcelona. They were in phases 8 and 9, meaning between touchdown and 80 kt on the landing run for phase 8, and from there to second engine shutdown for phase 9.

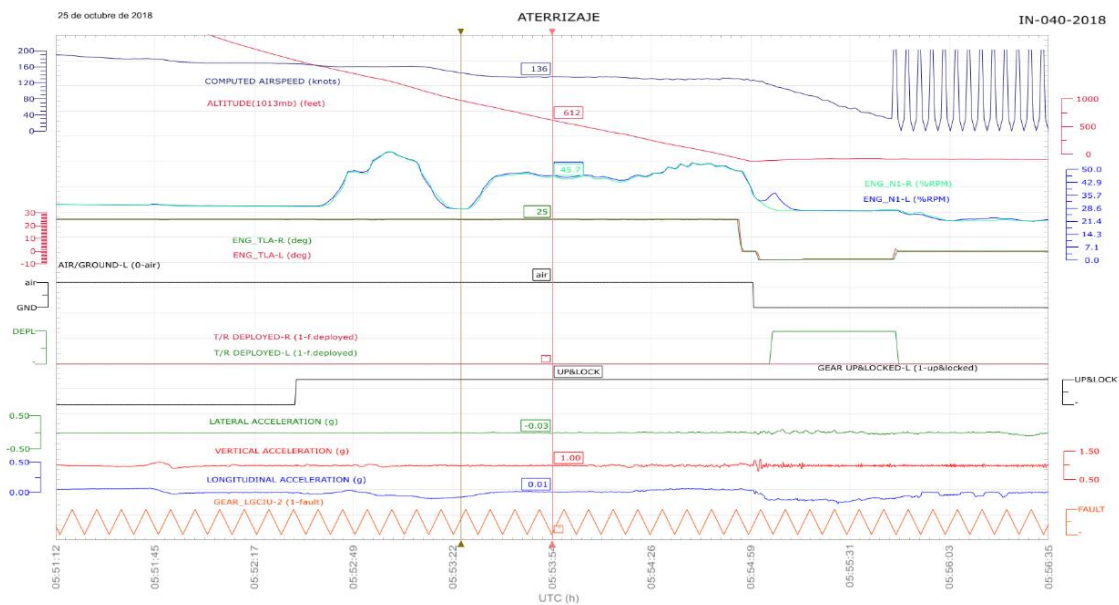
Fig. 12: Parameters of interest during landing phase

It should be noted that the parameters contained in the FDR pertaining to the operation of the two engines during the incident flight were analyzed. No significant differences were found in their performances.

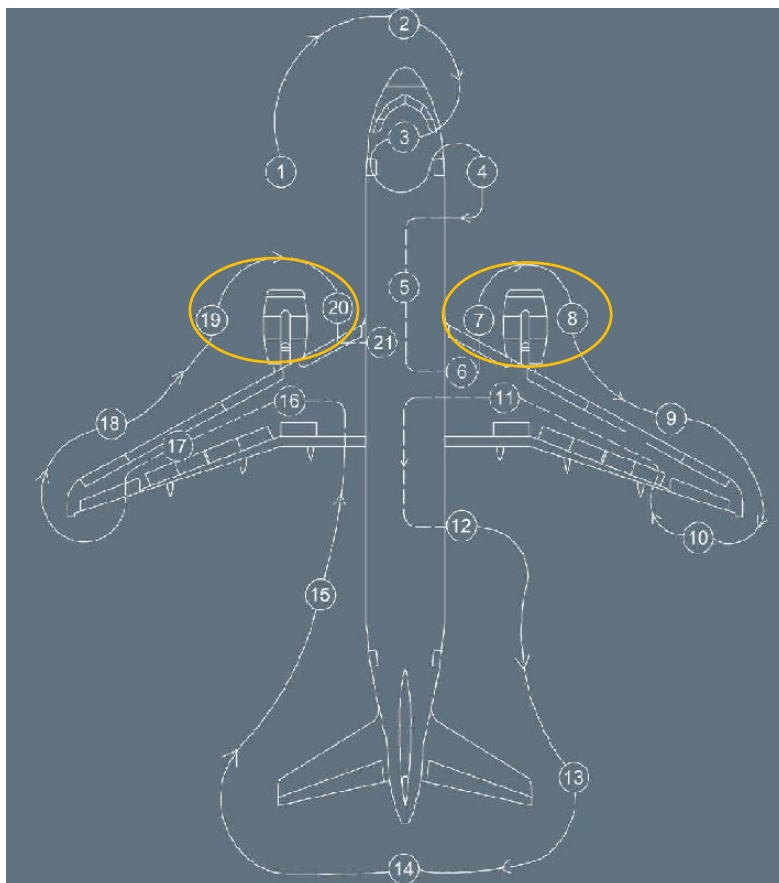
Fig. 20: Pre-flight exterior inspection, with areas of interest

Points 7, 8, 19 and 20 of the procedure specify the following (pertaining to the engine cowl):
