## Report IN-040/2019

Incident involving a Sikorsky  
S-76 C+ aircraft, registration  
EC-JES, over the Vigo estuary  
(Pontevedra) on 26 July 2019

On 26 July 2019 the SIKORSKY S76 C+ helicopter, registration EC-JES, was involved in an incident when the crew inadvertently descended the aircraft to an altitude of 22 ft above sea level during a training exercise over the Vigo estuary.

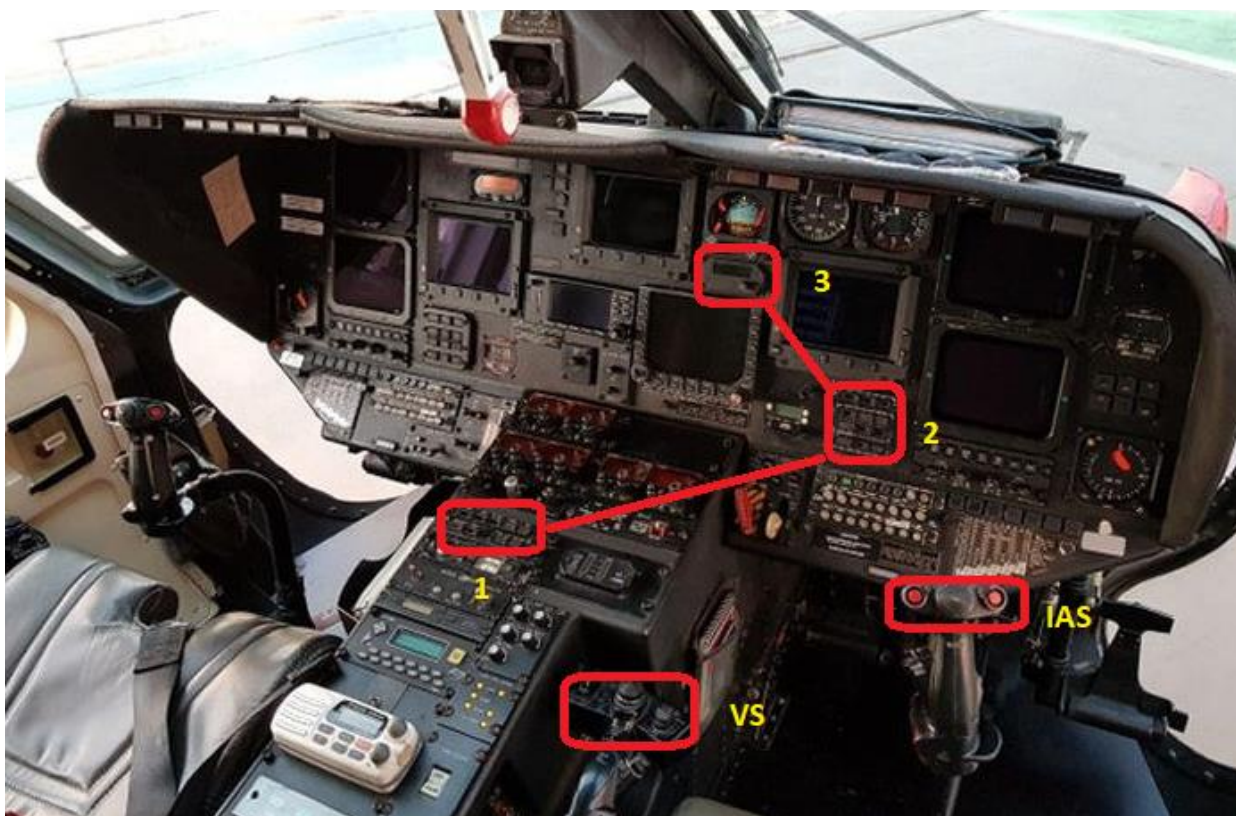
Fig. 10. - Sequence of actions SPZ-7600

With regard to the use of the SPZ-7600 system controls, pilots initially select the ATT and FD1/2 modes on the PC-700 (1), then select several FD modes on the MS-700 (2). Before the descent, they select 500 ft of altitude on the AL-300 (3) to descend and maintain that height over the estuary, followed by the ALT PRE Mode on the MS-700 (2) and the desired descent rate of 800 ft followed by V/ S mode on the MS-700 (2). The VS figures and altitude are programmed into the AL-300 from the collective control lever.

With regard to the use of the AP and FD and their different modes, it must be taken into account that whenever an automatically controlled altitude change is made, the VS and ALT-PRE MODES are used simultaneously. This makes it possible to descend or ascend at a constant vertical speed until the predetermined altitude is reached. That altitude will then be maintained until the pilot modifies the conditions. Caution must be taken to ensure that the different aircraft control modes are activated in the selected FD, which must correspond to the pilot at the controls.
