# Technical report IN-044/2020

Incident involving a Boeing 737-800 aircraft, registration EI-EBC, and a Beechcraft B200 aircraft, registration EC-MUP on 23 October 2020 at Málaga Airport

CIVIL AVIATION ACCIDENT AND INCIDENT INVESTIGATION COMMISSION

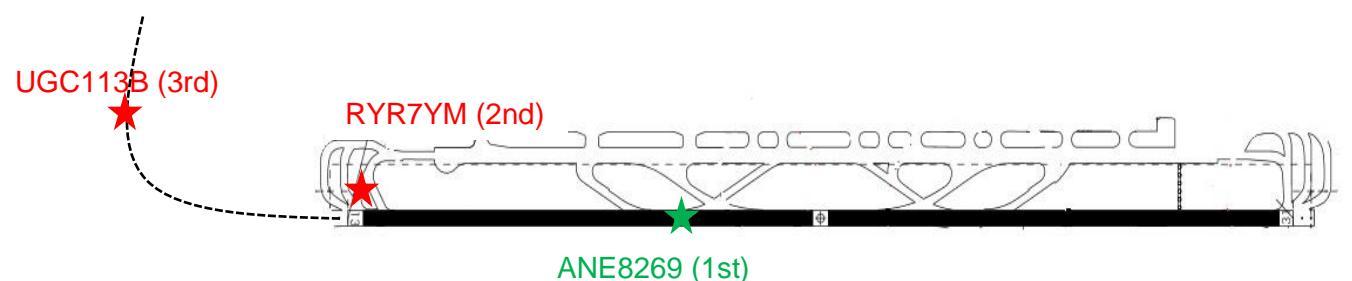
Illustration 8 Position of aircraft at 16:16:00

At 16:16:00 UTC, the trace shows aircraft RYR7YM moving beyond holding point HN-1R to line up at the head of runway 13. The first aircraft in the sequence, ANE8269, is landing on the first third of the runway. The third aircraft in the sequence, UGC113B, is on visual approach midway along the base leg of the aerodrome circuit.

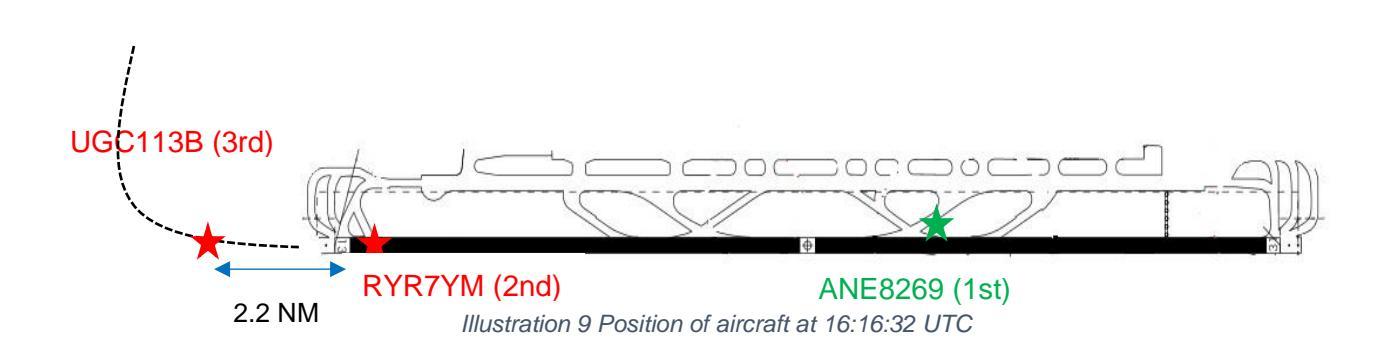
At 16:16:32 UTC, the trace shows aircraft RYR7YM aligned at the head of runway 13. The first aircraft in the sequence, ANE8269, is leaving the runway via the exit taxiway. The third aircraft in the sequence, UGC113B, is on short final at 2.2 NM from the threshold of the runway.

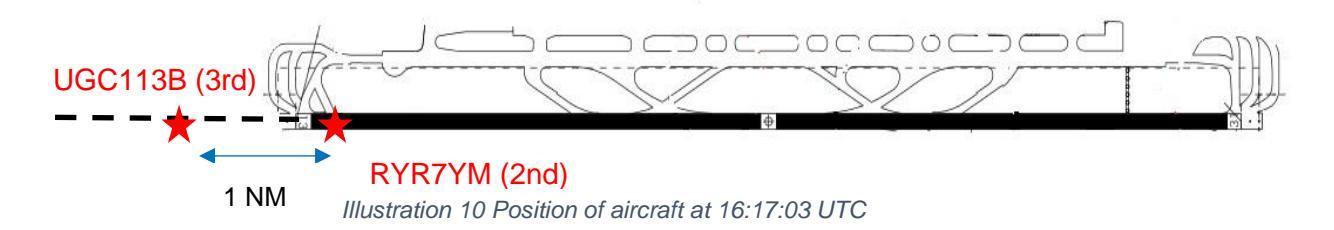
At 16:17:03 UTC, the trace shows aircraft RYR7YM initiating its take-off run at a speed of 20 kt. Aircraft UGC113B is on short final at 1 NM from the threshold of the runway, flying at a speed of 130 kt.

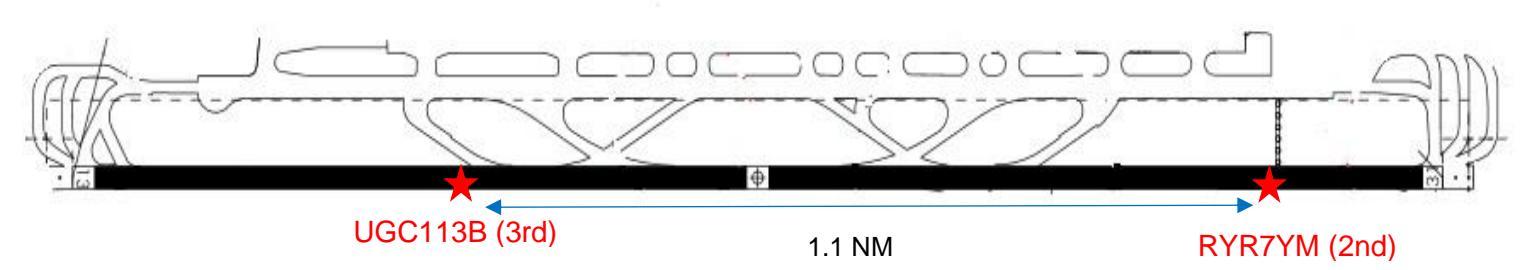
Illustration 13 Position of aircraft at 16:17:49 UTC

At 16:17:49 UTC, the trace shows aircraft RYR7YM climbing on take-off to 500 ft AMSL and aircraft UGC113B landing on the first third of the runway. At this point, the horizontal separation between the aircraft was 1.1 NM.

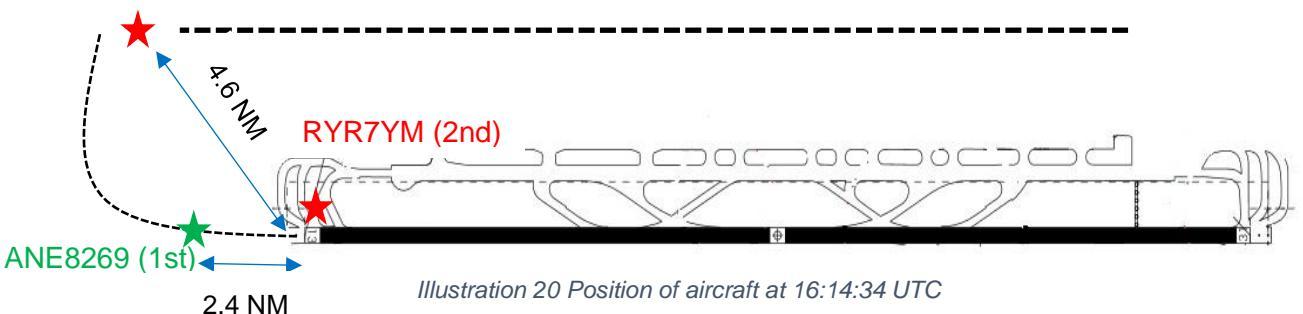
The LCL position controller planned to take advantage of the gap between two visual approaches to clear the take-off of the EI-EBC aircraft with callsign RYR7YM. The following figure shows the relative positions of the aircraft at 16:14:34 UTC, when the air traffic controller instructed the second aircraft in the sequence, RYR7YM, to line up and hold on runway 13 behind the traffic on final. At that moment, the first aircraft in the sequence was 2.4 NM from the threshold of runway 13 on final, and the third aircraft in the sequence was completing the downwind leg of the visual approach.

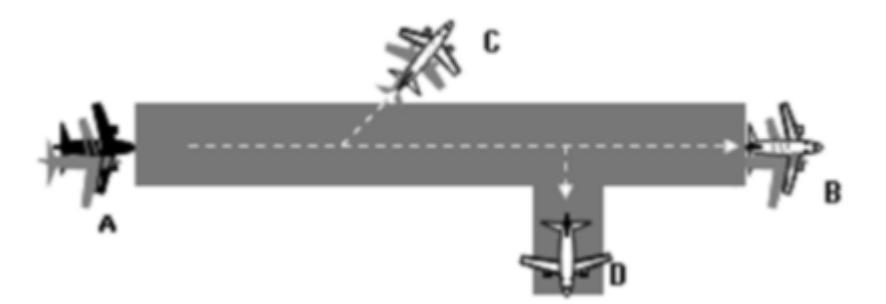
Illustration 23 Definition of free runway in the Air Traffic Regulations

In the incident being analysed, the air traffic controller did not heed any of the three aforementioned instructions or provision 4.5.10.1.1 of the Air Traffic Regulations, which establishes the following:

The air traffic controller authorised the approaching aircraft to land when it was over the runway threshold, thereby allowing it to cross the threshold when the aircraft taking off was still on the runway initiating rotation, with no degree of assurance that regulatory separation could be maintained. The air traffic controller failed to anticipate the required separation between the aircraft.

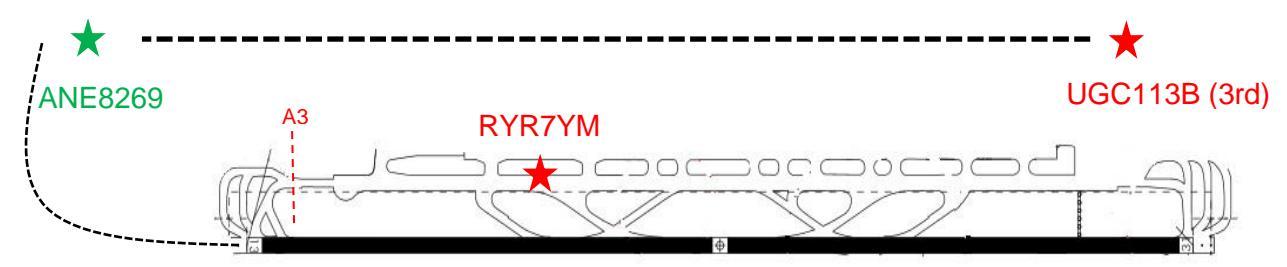
Illustration 25 Operational scenario of the incident

In the operational scenario that occurred in this incident, the radar trace shows three traffics in the sequence for runway 13:

- 1st aircraft [ANE8269] lands not involved in the incident.
- 2nd aircraft [RYR7YM] taxis
- 3rd aircraft [UGC113B] lands

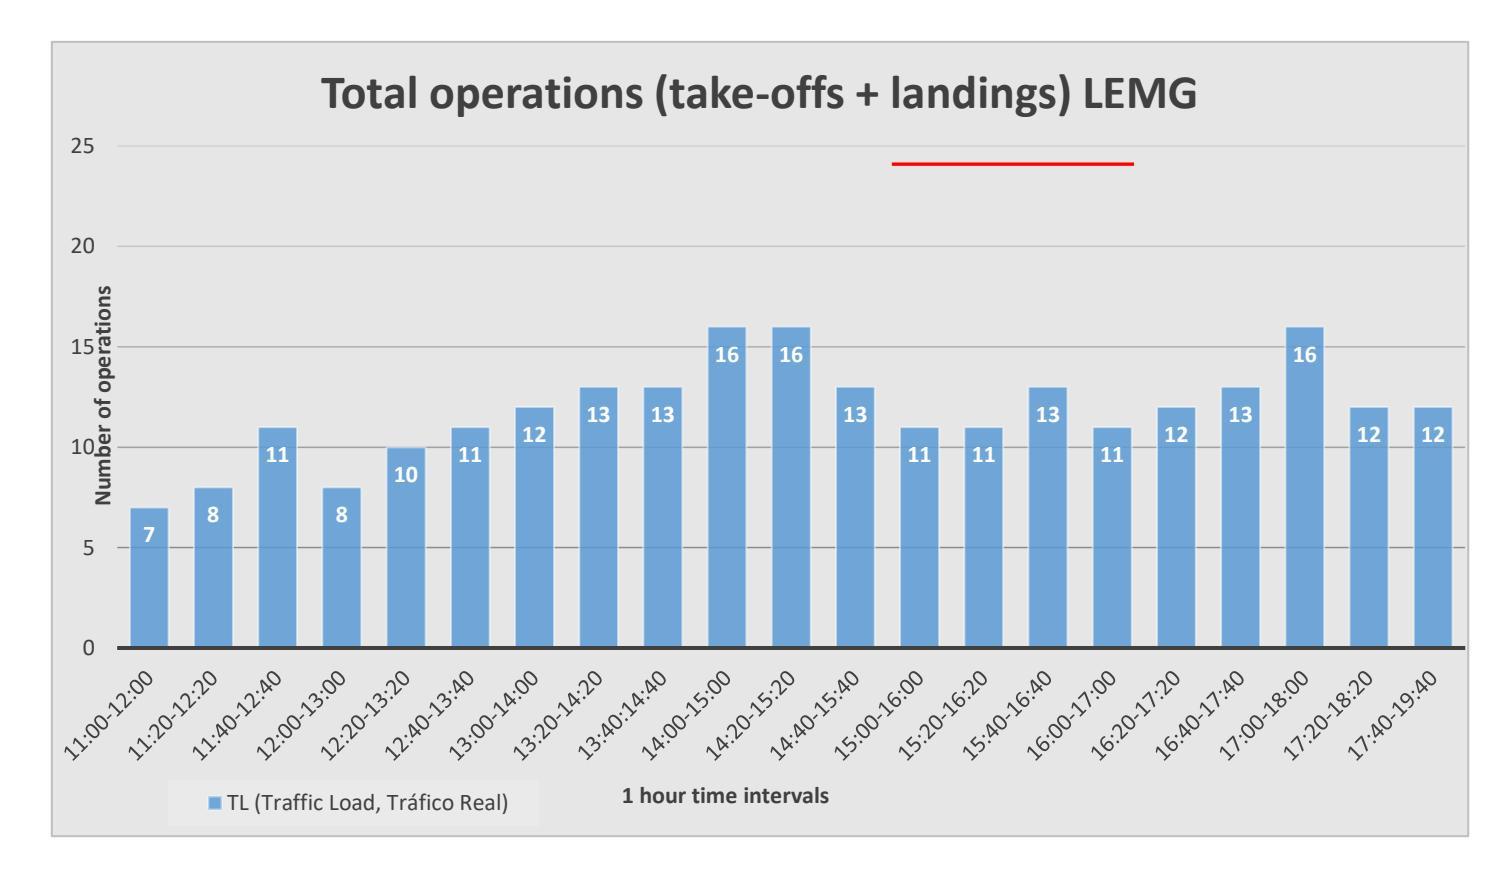
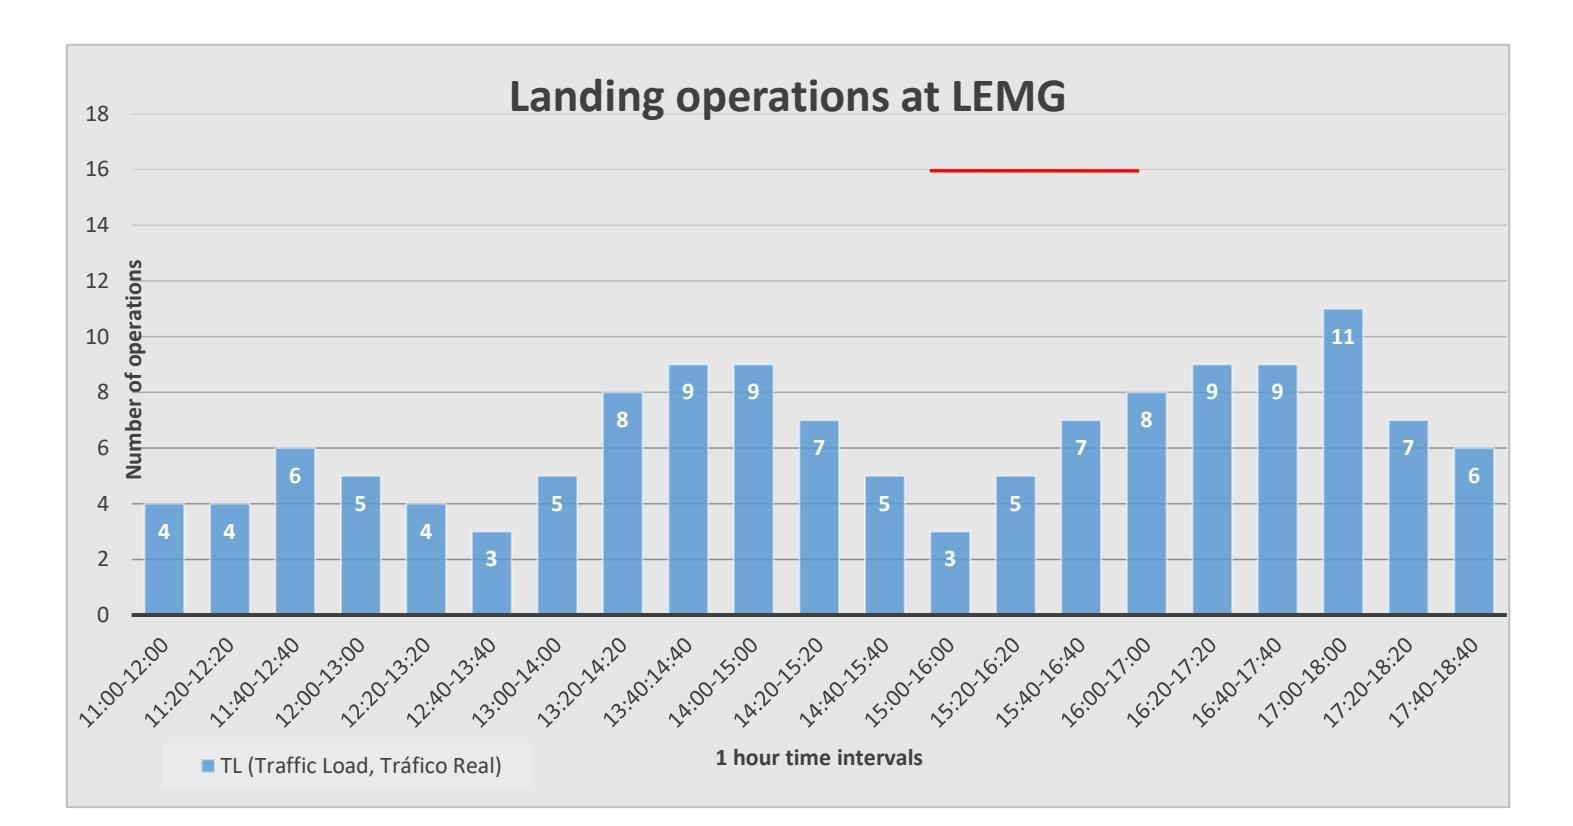
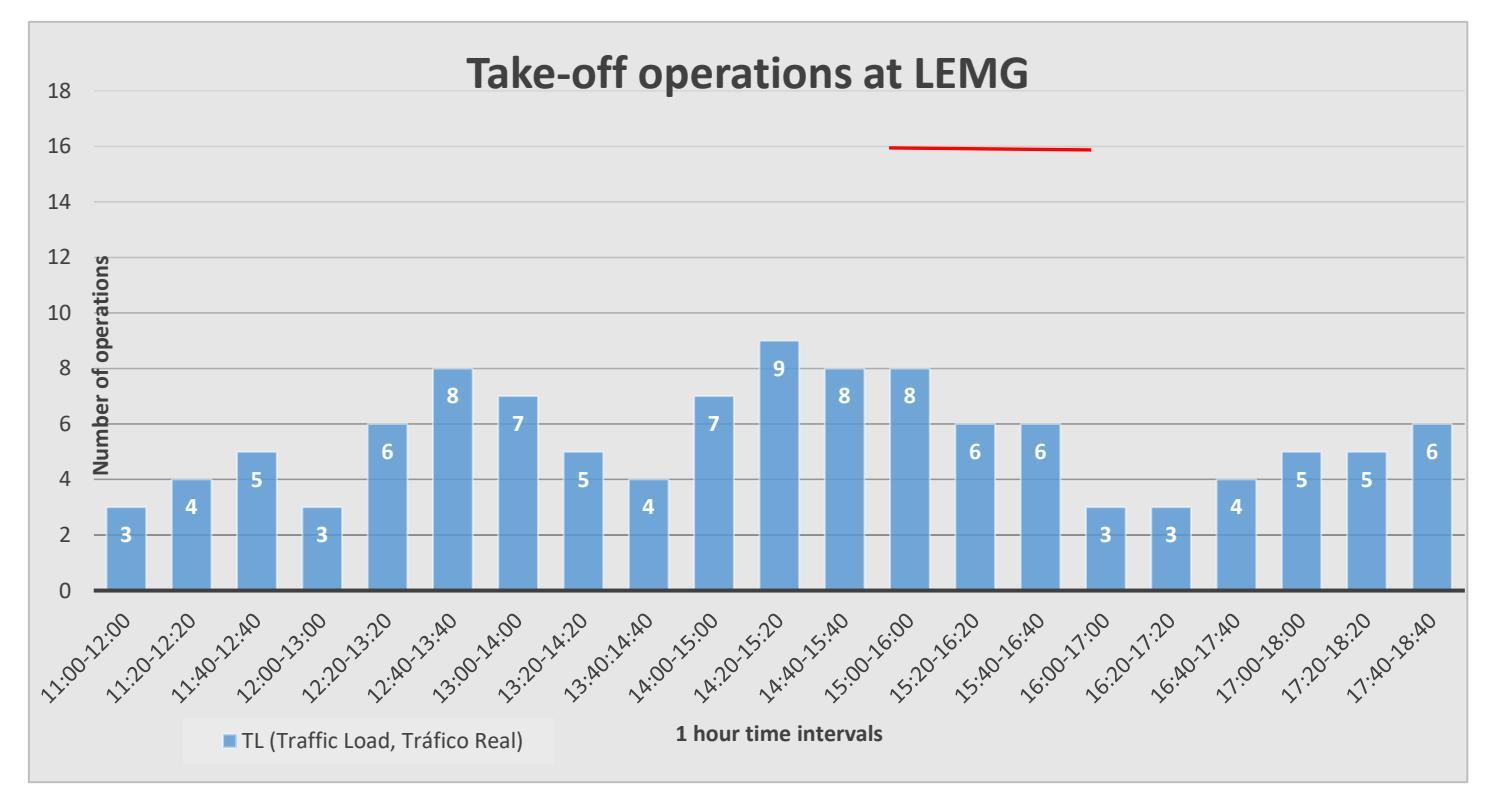
In the graphs, the red horizontal line represents the capacity limit in the time slots in which only 2 control positions were open. The following can be observed:

• At the time of the incident (16:15 UTC), the actual traffic, both in terms of take-offs, landings and total operations, did not exceed the capacity limit for two open tower control positions.
