Report IN-052/2019

Incident involving an ATR 72-212
A aircraft, registration EC-MPI,
operated by Canarias Airlines at
the Tenerife North Airport (GCXO)
on 15 October 2019

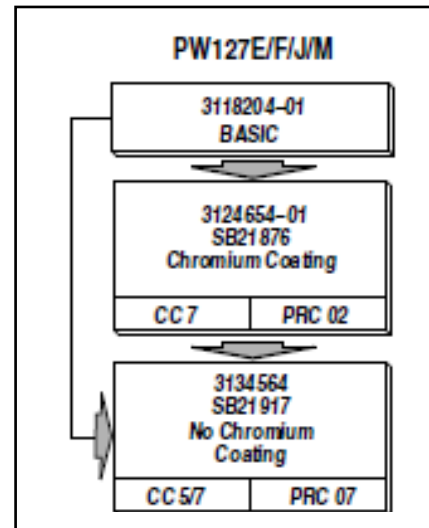
Figure 4. Diagram of service bulletins (SB)

The blades in the turbine's first power stage had P/N 3123943-01, and in the second stage they had P/N 3124654-01.

The latter were installed as per Service Bulletin 21876, issued in July 2015, and featured a chromium coating on the leading edge of the blades improve resistance to corrosion caused by sulfidation.

In November 2017, Pratt & Whitney Canada published SB 21917, the latest revision to which (No. 7) is from 20 March 2019. This SB was published because the protective layer on the leading edge of the blades proposed in SB 21876 is not ideal for increasing the durability of the blades due to corrosion problems, and the SB recommends replacing the blades with PN 3124654-01 (which affect engine ED-1404) with other blades with PN 3134564. The SB recommends doing this when the engine is removed and accessible. However, the engine had never been dismantled.

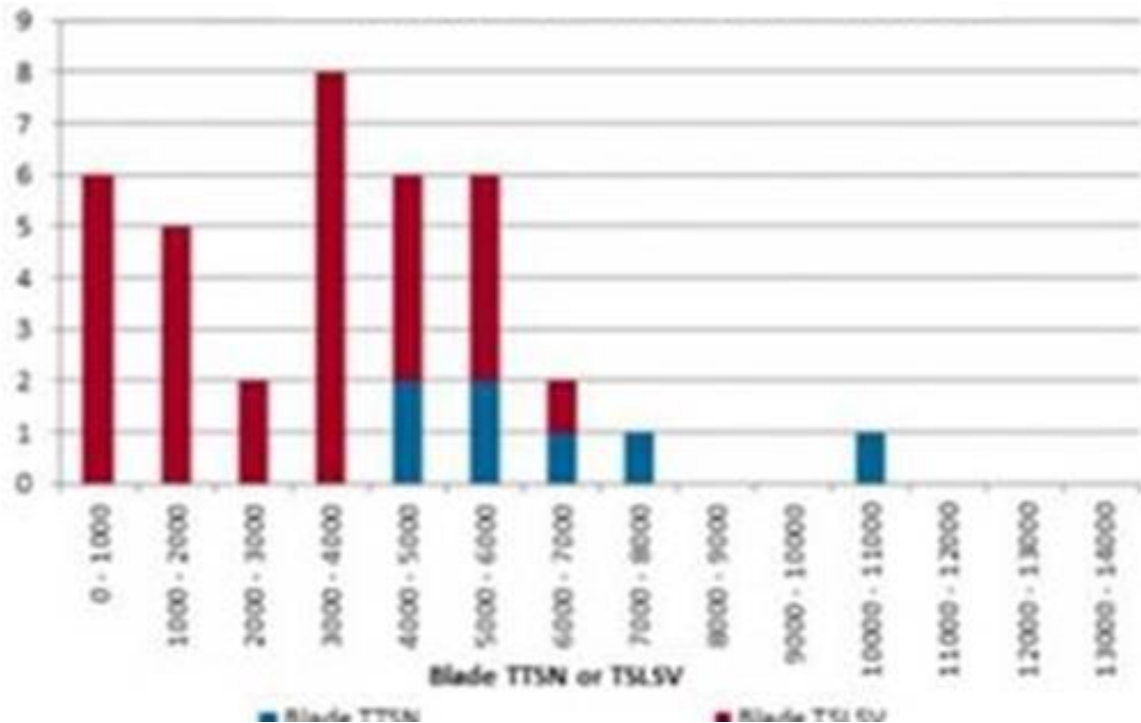
Figure 10. Events involving blades on PW100 engines between 2005 and 2015

In addition to the above cases, the graphs below show failure data for PT2 recorded by P&WC through the end of 2014 (37 incidents).
