## Report IN-063/2019

Incident involving an AIRBUS A320-214, registration EI-IKL, operated by ALITALIA, and a BOEING B737-8AS, registration EI-ENN, operated by RYANAIR, 58 NM east-southeast (ESE) of the Madrid-Barajas Airport (SPAIN) on 7 September 2019

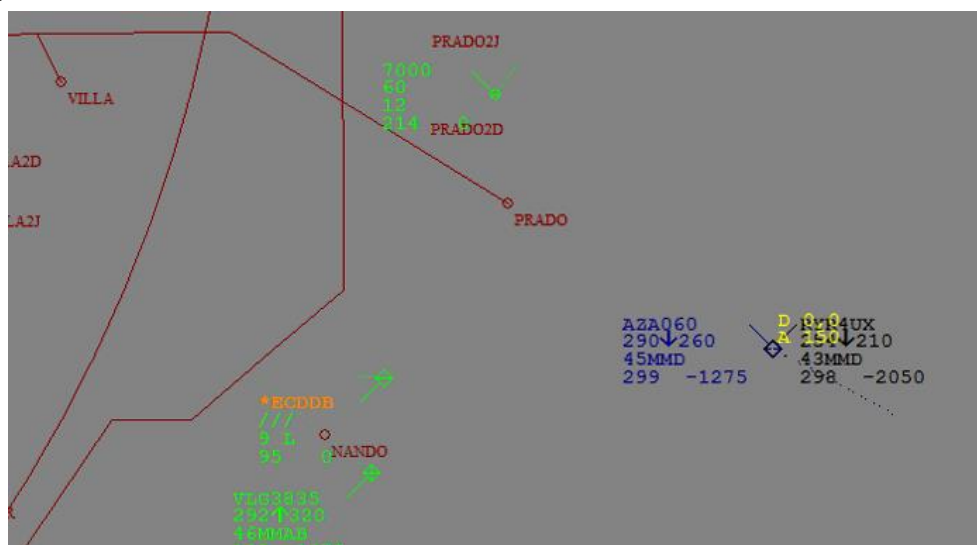
Fig. 2 Palestra image for 13:56:17

At the same time, AZA060 was en route to PRADO point and descending through FL290 to FL260 at a rate of descent of -1275 fpm. Just below it was RYR4UX, on course to the same point and descending through FL254 to FL210, at a rate of descent of -2050 fpm.

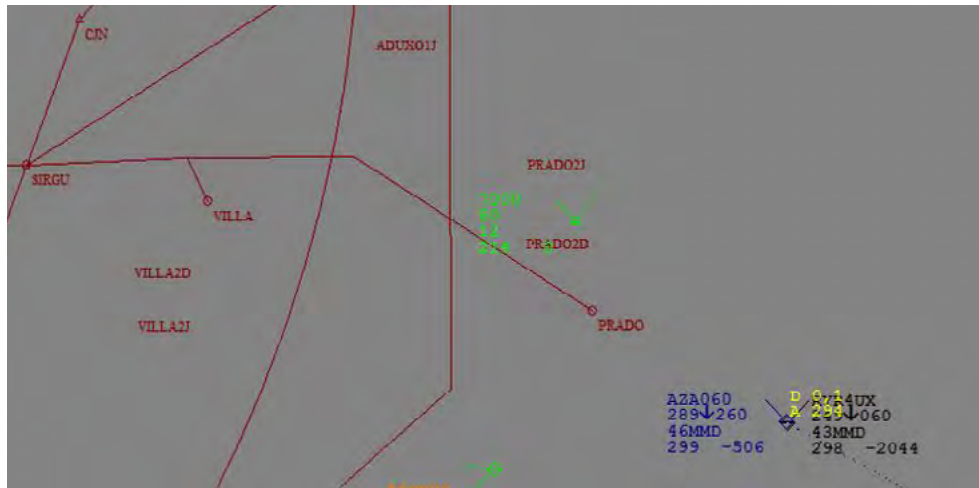
Fig. 3 Palestra image for 13:56:31

At this same time, AZA060 was on course to ASBIN point (IAF), descending through FL289 to FL260 at a rate of descent of -506 fpm. RYR4UX was 0.1 NM away, on course to PRADO point and descending through FL249 to 6000 ft at a rate of descent of -2044 fpm.

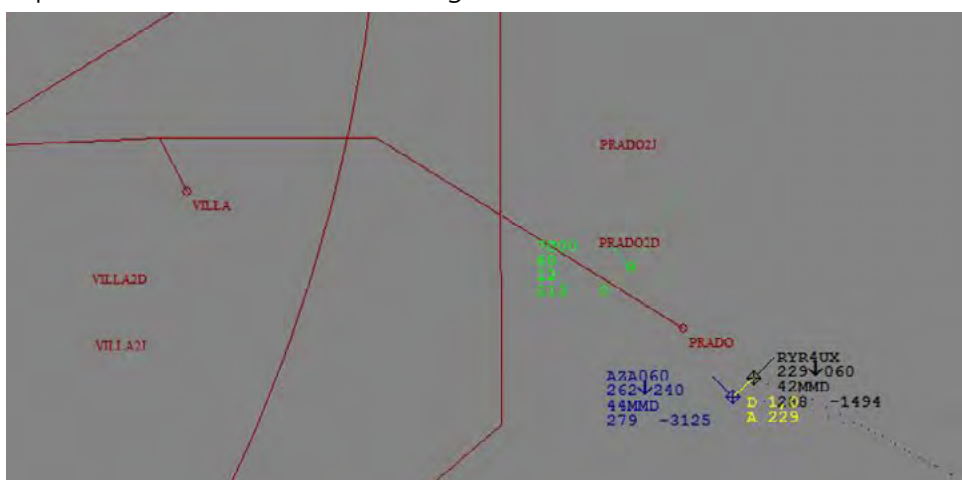
Fig. 4 Palestra image for 13:57:36

At the same time, AZA060 was on course to ASBIN point (IAF) at FL262 and descending to FL240 at a rate of descent of -3125 fpm. RYR4UX was 1.0 NM away, on course to the same point at FL229 and descending to 6000 ft at a rate of descent of -1494 fpm.

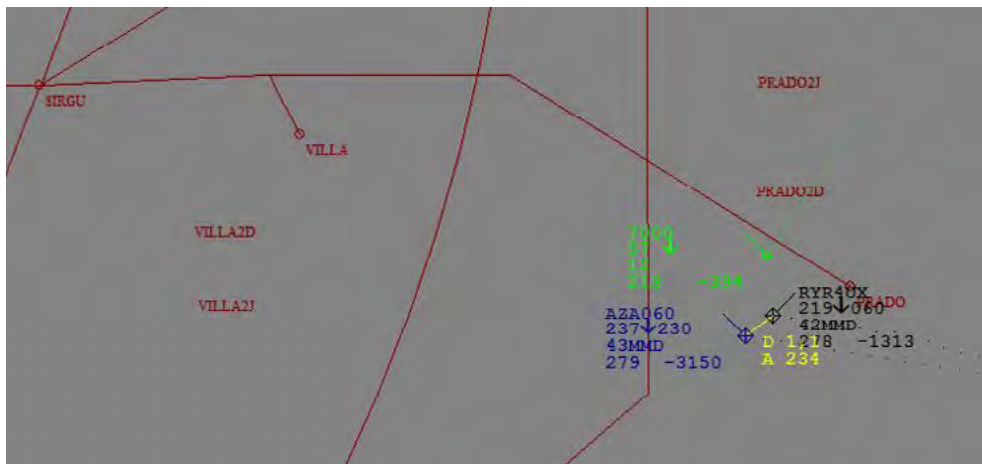
Fig. 5 Palestra image for 13:58:22

At 13:58:22, AZA060 was on course to ASBIN point (IAF) at FL237 and descending to FL230 at a rate of descent of -3150 fpm. RYR4UX was 1.1 NM away, on course to the same point at FL219 and descending to 6000 ft at a rate of descent of -1313 fpm.

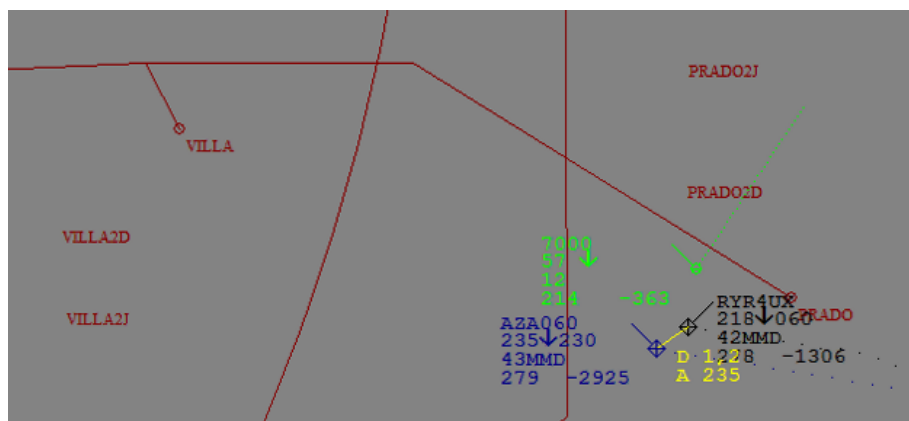
Fig. 6 Palestra image for 13:58:28

At 13:58:28, AZA060 was on course to ASBIN point (IAF) at FL235 and descending to FL230 at a rate of descent of -2925 fpm. RYR4UX was 1.2 NM away, on course to the same point at FL218 and descending to 6000 ft at a rate of descent of -1306 fpm.

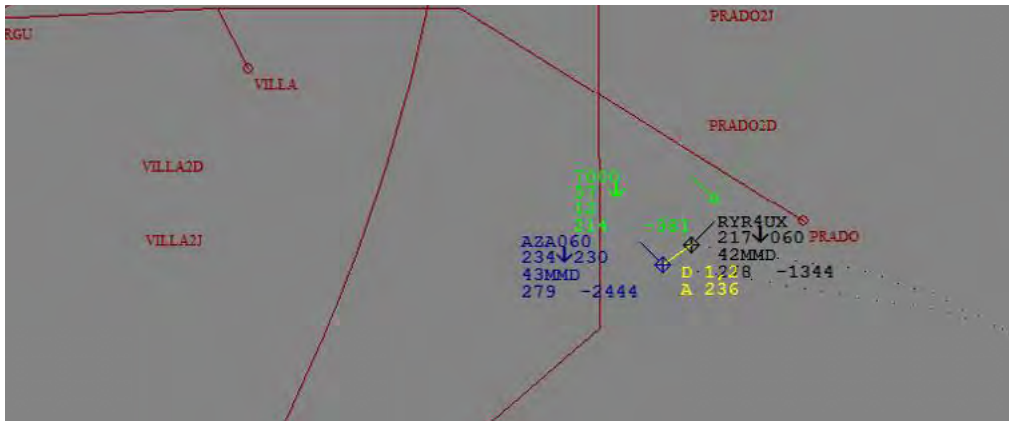
Fig. 7 Palestra image for 13:58:33

At the same time, AZA060 was en route to ASBIN point (IAF) at FL234 and descending to FL230 (note that the controller issued the instruction at this time, which is why CFL 140 had not yet been entered on the label) at a rate of descent of -2444 fpm. RYR4UX was 1.2 NM away, en route to the same point at FL217 and descending to 6000 ft at a rate of descent of -1344 fpm.

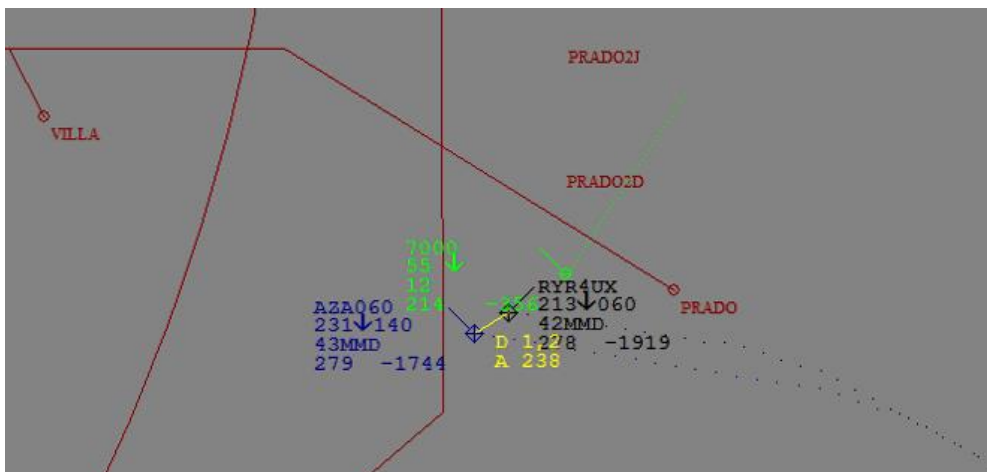
Fig. 8 Palestra image for 13:58:39

At 13:58:39, AZA060 was en route to ASBIN point (IAF) at FL231 and descending to FL140 at a rate of descent of -1744 fpm. RYR4UX was 1.2 NM away, en route to the same point at FL213 and descending to 6000 ft at a rate of descent of -1919 fpm.

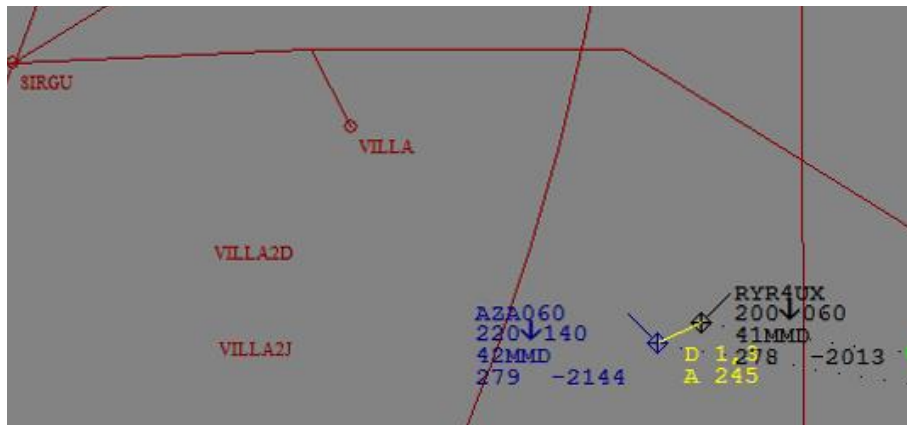
Fig. 9 Palestra image for 13:59:19

At the same time, AZA060 was en route to ASBIN point (IAF) at FL220 and descending to FL140 at a rate of descent of -2144 fpm. RYR4UX was 1.3 NM away, en route to the same point at FL200 and descending to 6000 ft at a rate of descent of -2013 fpm.

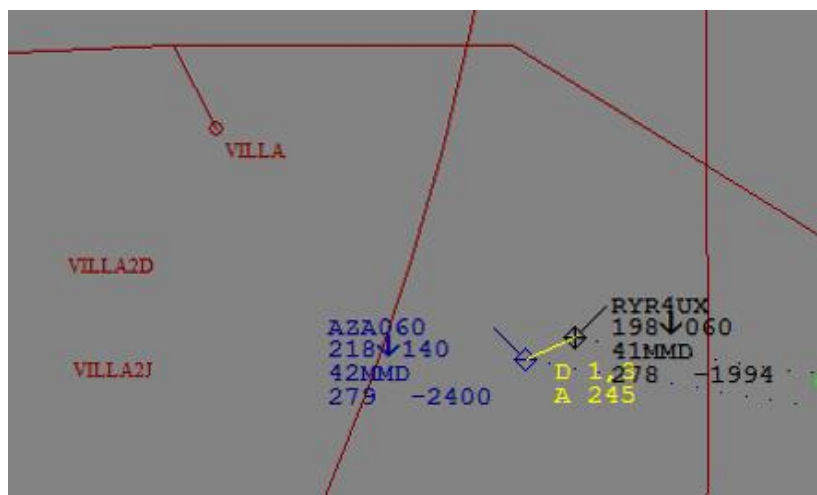
Fig. 10 Palestra image for 13:59:27

At the same time, AZA060 was en route to ASBIN point (IAF) at FL218 and descending to FL140 at a rate of descent of -2400 fpm. RYR4UX was 1.3 NM away, en route to the same point at FL198 and descending to 6000 ft at a rate of descent of -1994 fpm.

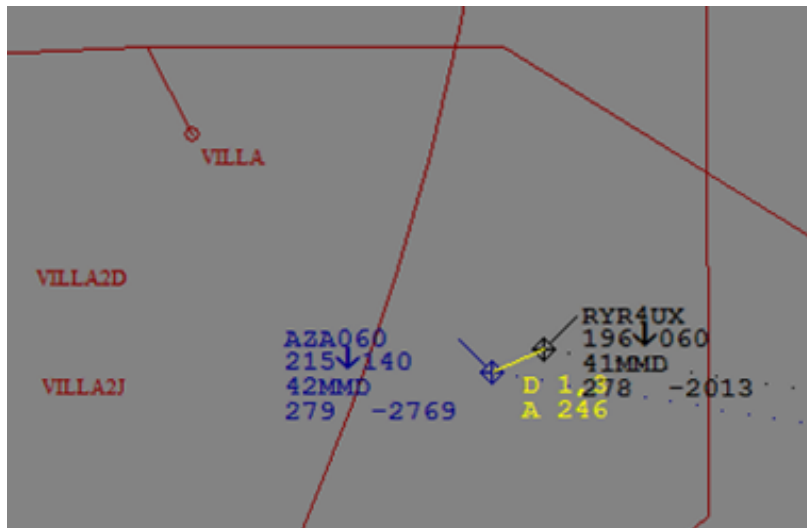
Fig. 11 Palestra image for 13:59:33

At the same time, AZA060 was en route to ASBIN point (IAF) at FL215 and descending to FL140 at a rate of descent of -2769 fpm. RYR4UX was 1.3 NM away, en route to the same point at FL196 and descending to 6000 ft at a rate of descent of -2013 fpm.

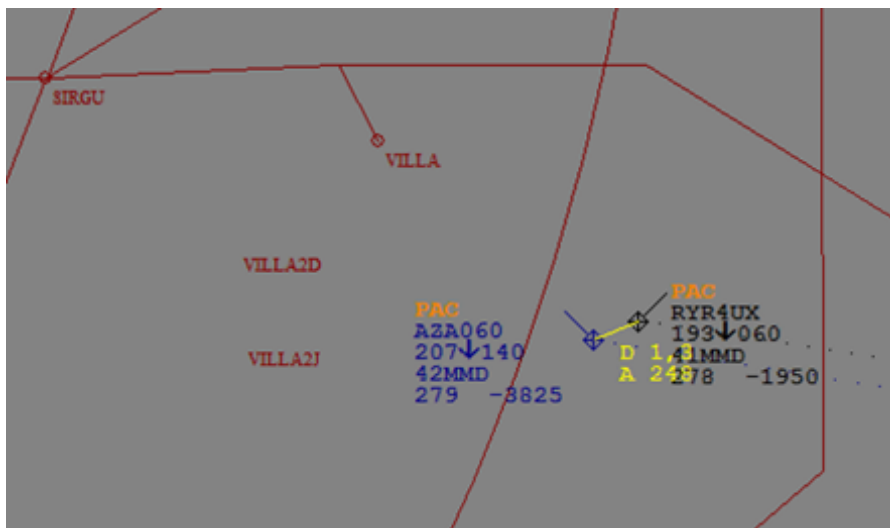
Fig. 13 Palestra image for 13:59:39

At 13:59:39, AZA060 was en route to ASBIN point (IAF) at FL207 and descending to FL140 at a rate of descent of -3825 fpm. RYR4UX was en route to the same point at FL193 and descending to 6000 ft at a rate of descent of -1950 fpm. The two aircraft were 1.3 NM and 1400 ft apart.

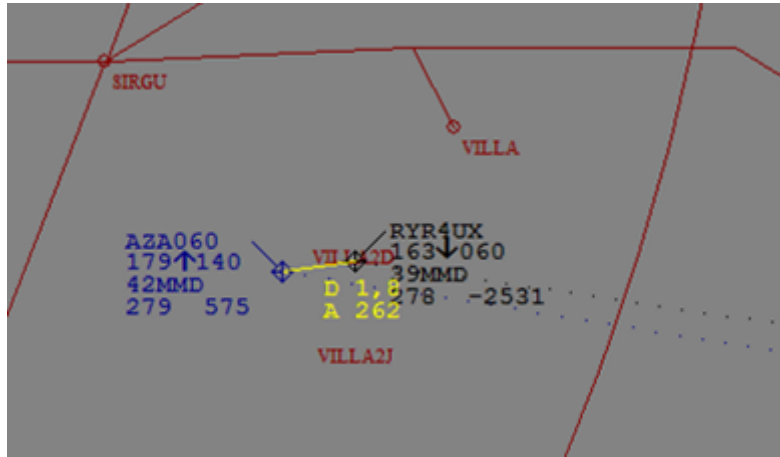
Fig. 21 Palestra image for 14:01:05

At 14:01:05, AZA060 was on course to ASBIN point (IAF) and cleared to descend to FL170 (note that CFL 170 had not yet been entered into the label). It began climbing through FL179 at a rate of climb of +575 fpm. RYR4UX was en route to the same point at FL163 and descending to 6000 ft at a rate of descent of -2531 fpm.

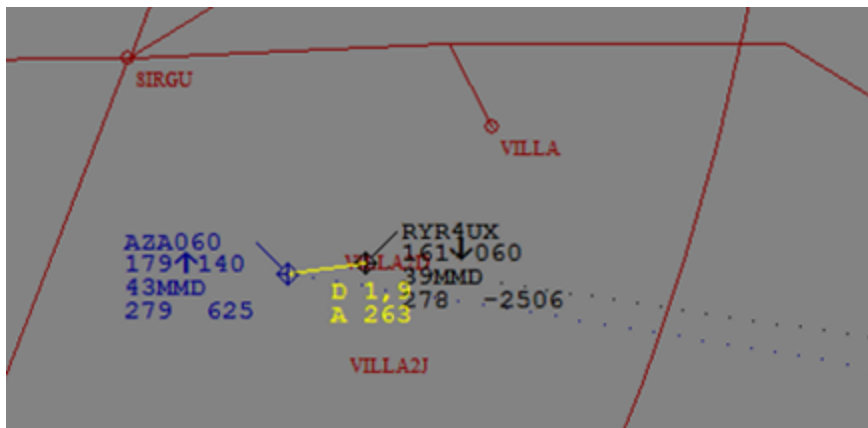
Fig. 22 Palestra image for 14:01:10

At the same time, AZA060 was en route to ASBIN point (IAF) still at FL179 and cleared to descend to FL170 (note that CFL 170 had not been entered yet into the label) at a rate of climb of +625 fpm. RYR4UX was en route to the same point at FL161 and descending to 6000 ft at a rate of descent of -2506 fpm.

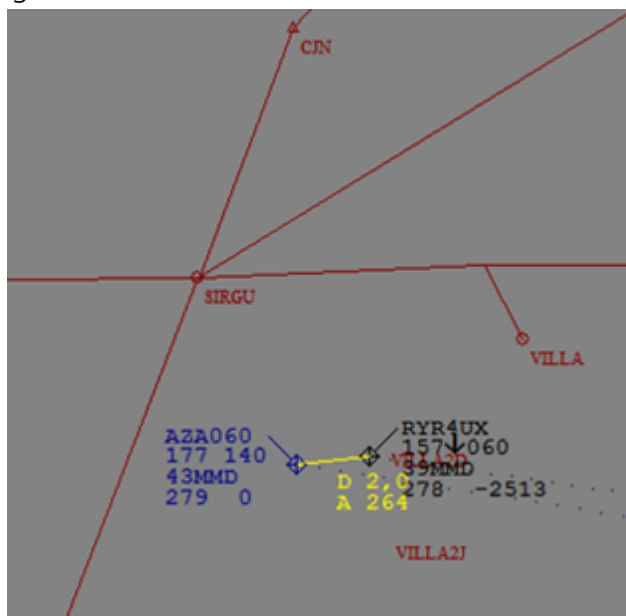
Fig. 23 Palestra image for 14:01:22

At the same time, AZA060 was en route to ASBIN point (IAF) again descending through FL177 at a zero rate of descent and cleared to descend to FL170 (note that CFL 170 had not yet been entered into the label). RYR4UX was en route to the same point at FL157 and descending to 6000 ft at a rate of descent of -2513 fpm.

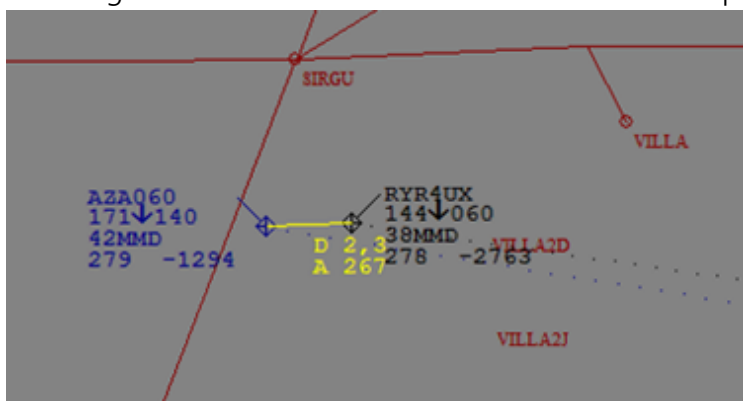
Fig. 24 Palestra image for 14:01:54

At the same time, AZA060 was on course to ASBIN point (IAF) at FL171 and descending to FL140 at a rate of descent of -1294 fpm. RYR4UX was en route to the same point at FL144 and descending to 6000 ft at a rate of descent of -2763 fpm.

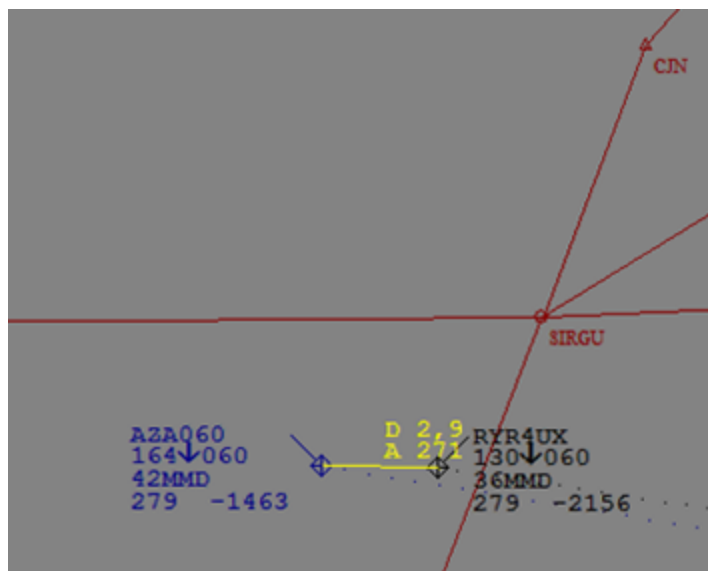
Fig. 25 Palestra image for 14:02:33

At 14:02:33, AZA060 was en route to ASBIN point (IAF) at FL164 and descending to 6000 ft at a rate of descent of -1463 fpm. RYR4UX was en route to the same point at FL130 and descending to 6000 ft at a rate of descent of -2156 fpm.
