COMISIÓN DE
INVESTIGACIÓN
DE ACCIDENTES
E INCIDENTES DE
AVIACIÓN CIVIL

Report IN-010/2017

Incident involving an AIRBUS 330-243 aircraft, registration G-VYGL, operated by AirTanker Ltd at the Tenerife South airport on 27 June 2017.

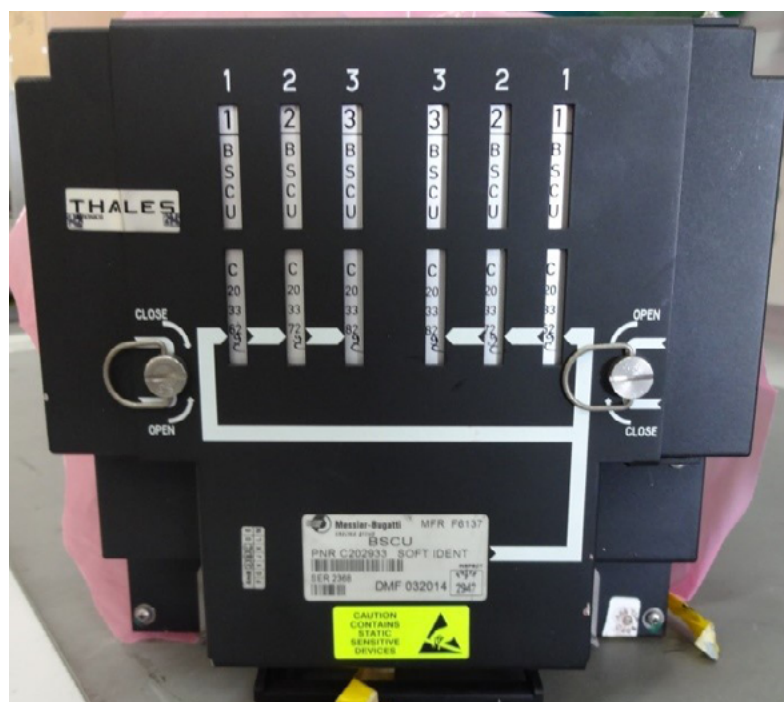
Figure 9. Braking and steering control unit

The braking and steering control unit (BSCU) was removed, along with the servo valves and tachometers from the wheels, in order to have them analyzed by the manufacturer.

The BSCU is shown in Figure 9.

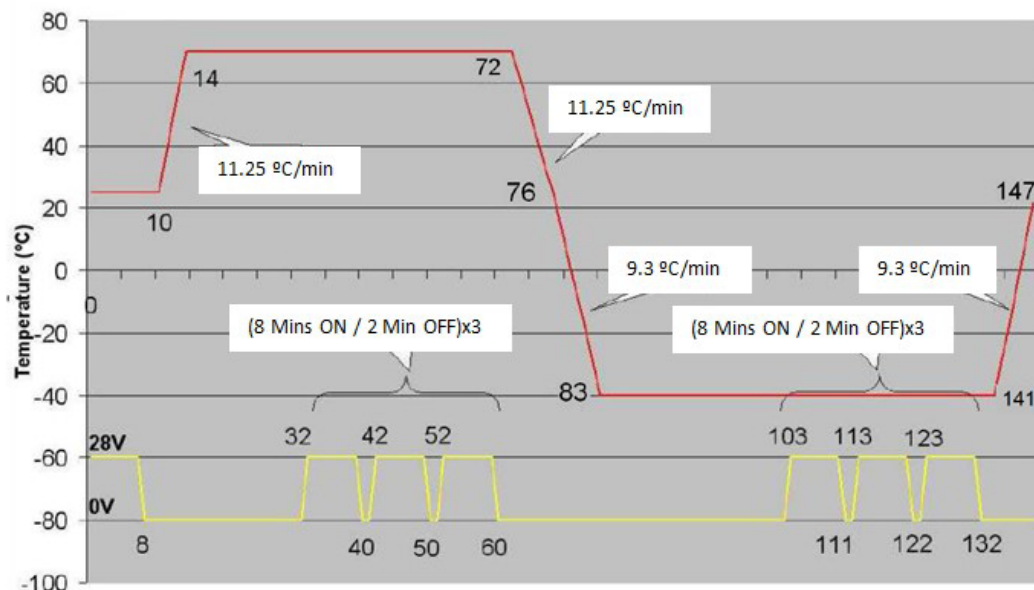
Figure 12. Temperature cycle

Each cycle lasts approximately 2.45 h. Figure 12 shows the change in temperature during one such cycle.

No abnormalities were detected in the unit's operation during the test.

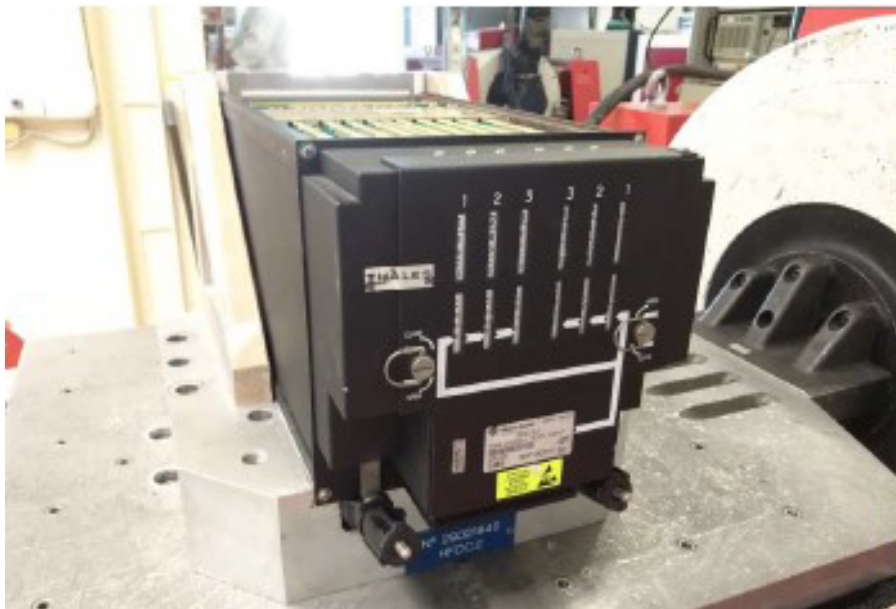
Figure 13. BSCU on vibration bench

The unit was subjected to the usual vibration test employed during the manufacturing process by removing the top and bottom panels and attaching the unit to a vibration bench, as shown in Figure 13.

After this the unit was energized and, after 5 minutes, it was vibrated perpendicular to its longitudinal axis for 20 minutes.
