**REPUBLIC OF CYPRUS
MARINE ACCIDENT AND INCIDENT
INVESTIGATION COMMITTEE**

Investigation Report No: 91E/2017

Very Serious Marine Casualty

**Death of ORDINARY SEAMAN (O/S)
on M/V “DENIA CIUTAT CREATIVA”
on 18/07/2017
at Barcelona Port**

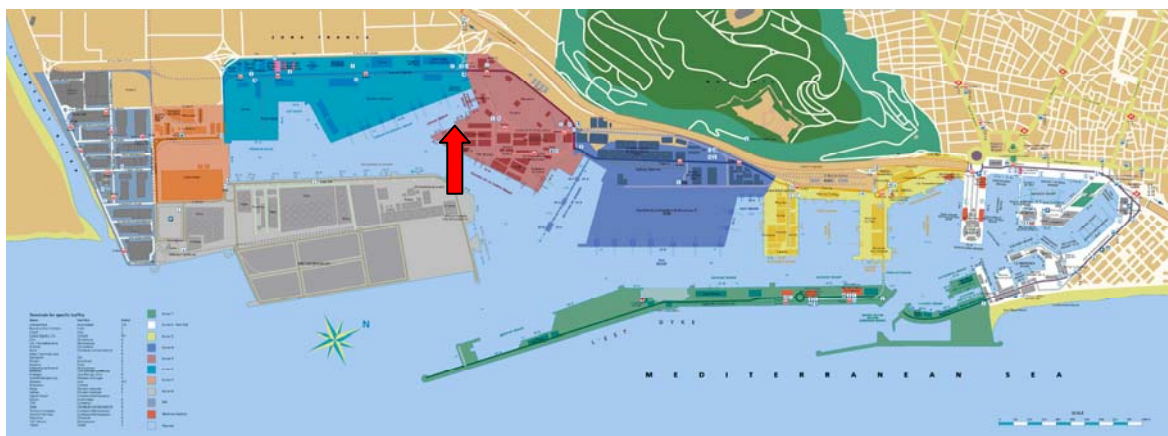
Figure 2: Layout of Barcelona Port showing accident location

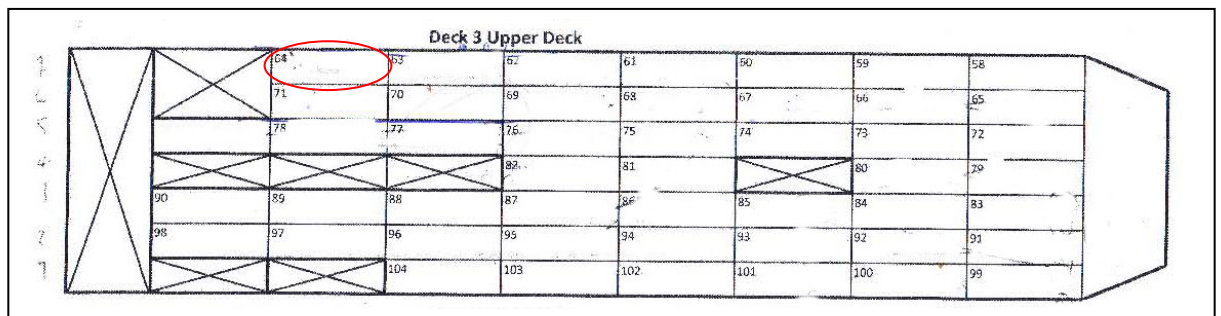
2. The driver received initial instructions by the vessel’s Chief Officer, who was at the stern ramp/door, to drive the truck to Upper Deck (Deck 3). The vessel’s Bosun, who was the recipient of the truck on Deck 3, instructed the stevedore driver to park the truck at the aftermost parking position of Lane 7 port side (vehicle position 64). No other vehicles had been parked in the vicinity.

Figure 3: Designated final parking position of the truck on Upper Deck (Deck 3)

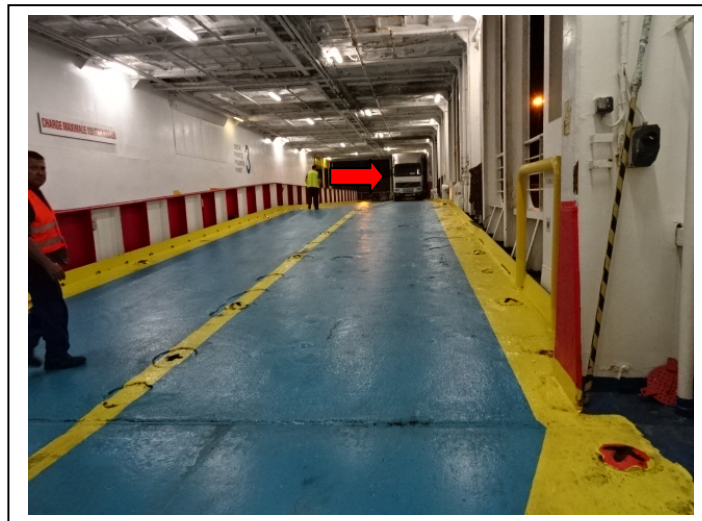
21. Officials disembarked the vessel and deceased person was transferred to the Institute of Legal Medicine (18/07/2017-23:58) ([Police Statement](#))
22. Crew commenced cargo operation (19/07/2017-00:15) ([Police Statement](#)). The truck was parked at its final parking position 64 and sailed with the vessel.

Figure 9: Truck final position before departure

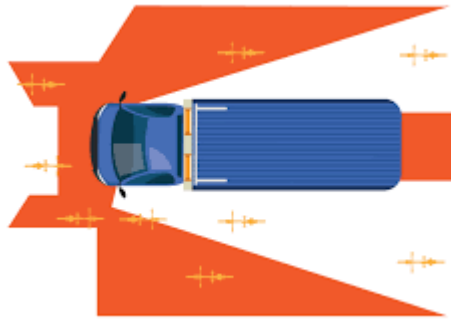
- he did not see the O/S at any time of the operation;
- he was aware of the broken right upper mirror (“plain rear view mirror”) and he informed the foreman of the fact before getting into the vessel. The foreman asked him if he had any problem with that and he let him go ahead after he confirmed that he had no problem.
- In order to control the right side of the truck during manoeuvring, he utilized the intact lower right mirror (“wide angle rear view mirror”) which is a small mirror showing objects closer. That was adequate to get the right side of the truck controlled.

Figure 17: Schematic diagram for mirrors blind sectors (similar truck)
