# SUMMARY REPORT

**TORM REPUBLICAN**  
**Occupational accident on 3 December 2013**

**This marine accident summary report is issued on 10 July 2014**

**Case number: 2013026421**

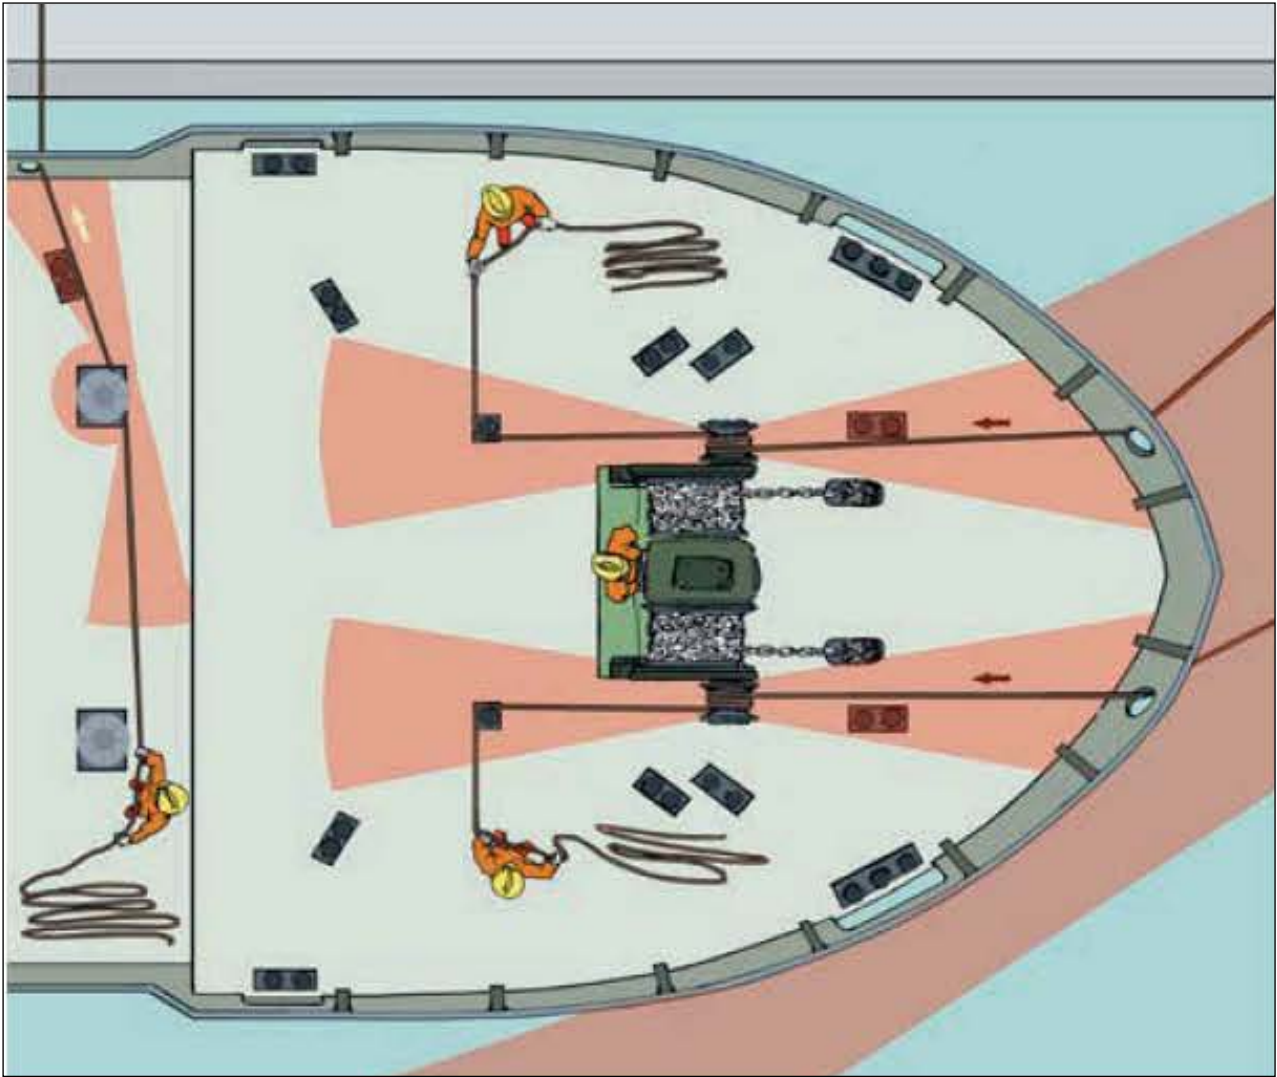
When mooring lines break, they will snap back to the point to which they are fixed, i.e. winches, bollards, rollers or bitts. Snap back zones<sup>3</sup> are the areas which constitute the most likely and therefore dangerous locations for a person to be in if a mooring line breaks. Snap back zones are usually painted on the deck describing an angle, indicating the area to avoid (figure 7).

Figure 7: Example of snap back zones  
Source: Seahealth.dk

The snap back zones are generally defined considering the elasticity of the lines used, the angles and leads which are commonly used on board and the predominant expected 'behaviour' of a parting mooring line. The possible area of the snap back zone of the rope when it recoils will increase in breadth

the further it travels from the point of breakage. The end of the broken rope may also recoil past the point to which it is secured to a distance almost equal to the remaining length. A mooring line which is leading around a pedestal roller will whip back in a wide arc as it returns to the point to which it is secured.
