Technical report

ULM A-002/2023

Accident on 27 January 2023 involving a TECNAM P-92 ECHO aircraft, registration EC-KNB, operated by Ignagua Center, S.L., at Casarrubios del Monte Aerodrome (Toledo, Spain)

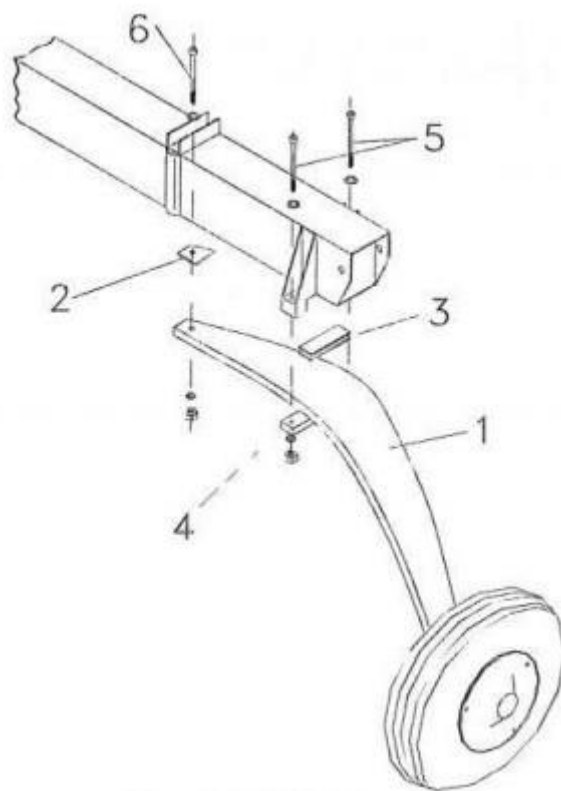
Fig. no. 2.- Leaf spring attachment

The leaf spring is attached to the underside of the fuselage through the main beam with three bolts and stop nuts, two lateral bolts (5) to secure the clamp plate (4) to the edge of the beam, and a central bolt (6), which secures the inboard end, closest to the axis of the aircraft. Two pieces of leather shim (2, 3) are inserted between the leaf spring and the beam to cushion the connection between the two.

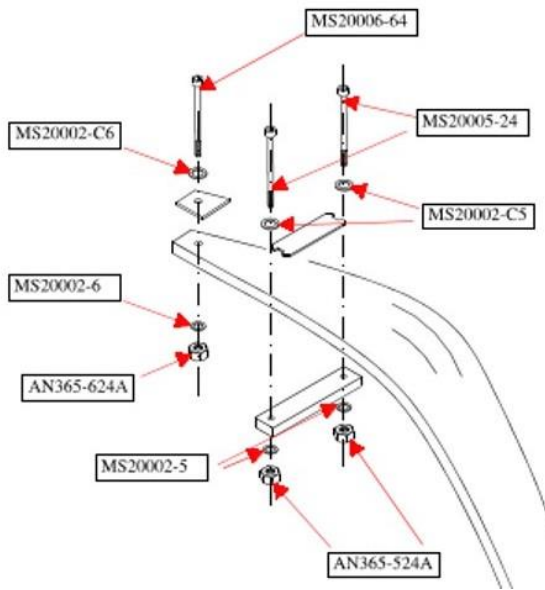
Fig. no. 3.- Part numbers of the main landing gear attachment system

The current valid part numbers, quantities and required tightening torques are shown in Figure 3 and the table in Figure 4.

It should be noted that in addition to applying the recommended tightening torques to ensure the correct attachment of the leg to the fuselage, the manufacturer also recommends the nuts be replaced one by one, without applying the final torque until they have all been replaced. Thus, the correct torque should be applied after fitting all the nuts. This practice has been proven to reduce the risk of the main landing gear leg detaching.

According to the aircraft manufacturer, the use of any bolts other than those recommended may result in vibrations at the landing gear attachment point and cause the nuts to become loose, compromising the connection.
