# **TECHNICAL REPORT**

## **ULM-A-009/2023**

### **Accident on 11 June 2023 involving a VOL-9 SKY RANGER aircraft, registration EC-FR3, in the municipality of Majadahonda (Madrid, Spain)**

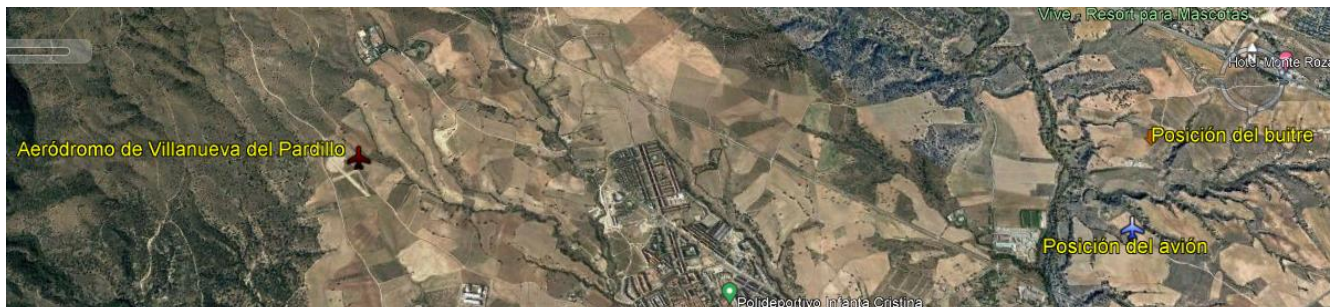
The vulture and the top part of the cockpit that had detached were located 670 m north of the aircraft, on either side of a forest road.

**Figure 1 Final position of the aircraft in relation to the aerodrome and the vulture**
