Technical report

ULM A-010/2020

Accident on 13 July 2020 involving a
DYNALI H3 'EASY FLYER' aircraft with
registration EC- GS5, in Ontígola (Toledo)

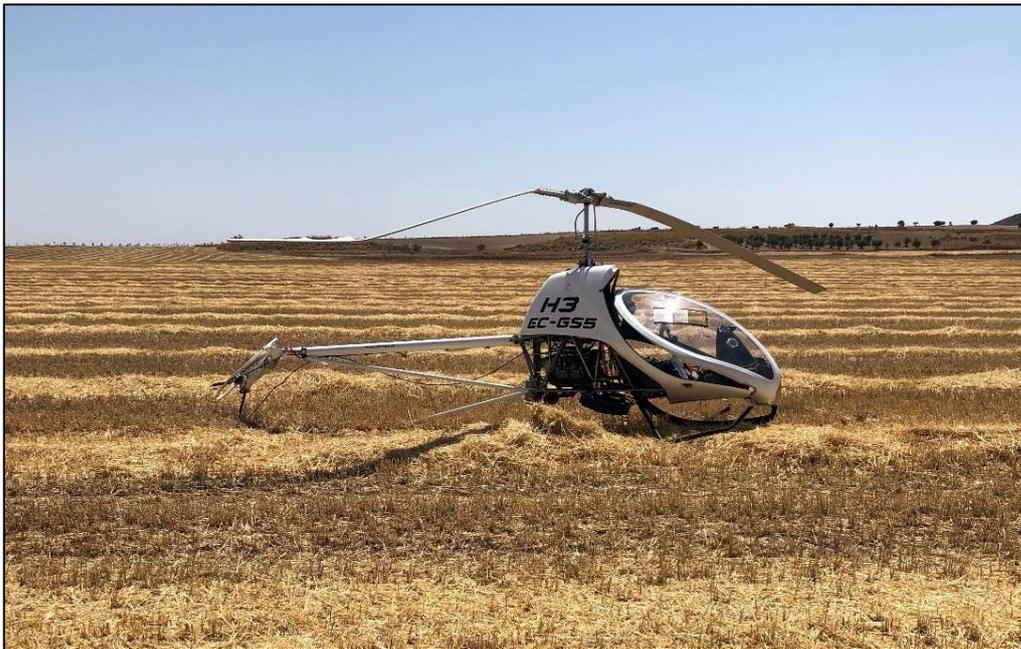
Image 8: Dynali H3 at the accident site

The mast had a large crack in its final third, where it had been bent and torn to the point of almost detaching. This gash was about 30 cm long. There were marks and scratches covering an area of the same length on the tip of one of the main rotor blades.
