ULM A-005/2019

REPORT

Accident involving an ULM EVEKTOR EV-97 EUROSTAR SL aircraft, registration EC-LSP, on 24 February 2019 at La Nava-Corral de Ayllón Aerodrome, in the municipality of Corral de Ayllón (Segovia – Spain).

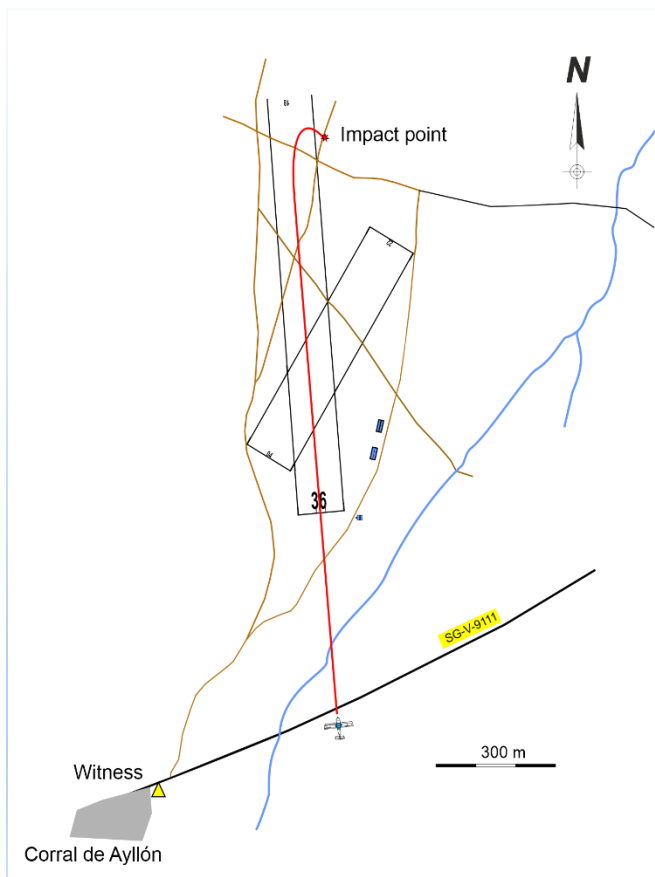
Figure 1.- Aircraft trajectory.

Figure 1 shows the aircraft trajectory, based on the information provided by the witness and its final position.
