Report ULM A-013/2020

Accident involving a TECNAM
P96-G aircraft, registration
EC-ZEK, on 27 September 2020,
at the La Juliana Aerodrome
(Seville)

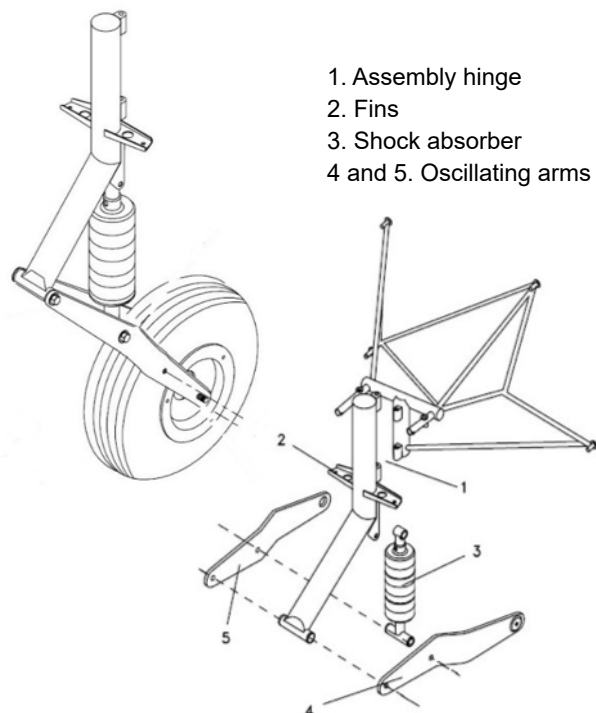
Figure 2. Exploded-view diagram of the nose gear leg

The fractures seen in fragment 1 are typical of those caused by overstress due to material fatigue, with a smooth, progressive fracture zone and an instantaneous or sudden fracture zone with a rougher or crystalline appearance.

The fractures seen in fragment 2 (see detail in photograph 7) appear more worn and flatter than fragment 1.

Fragments 3 and 4 are from the intermediate part of the leg where its angle changes. Fragment 3 is the part that holds the shock absorber and fragment 4 is the part that hinges the leg to the engine mount, which fractured close to the two horizontal fins.

The fractures seen in fragments 3 and 4 show corrosion, an angled breakage and deformation (photographs 7 and 9).

Figure 2 shows an exploded-view diagram of the nose gear leg taken from the aircraft's AMM, which clearly identifies the four fragments found after the accident.
