Air Accident Investigation Unit Ireland

FORMAL REPORT

ACCIDENT
Fairchild Aircraft Corporation
SA 227-BC Metro III, EC-ITP
Cork Airport, Ireland
10 February 2011

AAIU Report No: 2014-001
State File No: IRL00911013
Report Format: Formal Report
Published: 28 January 2014

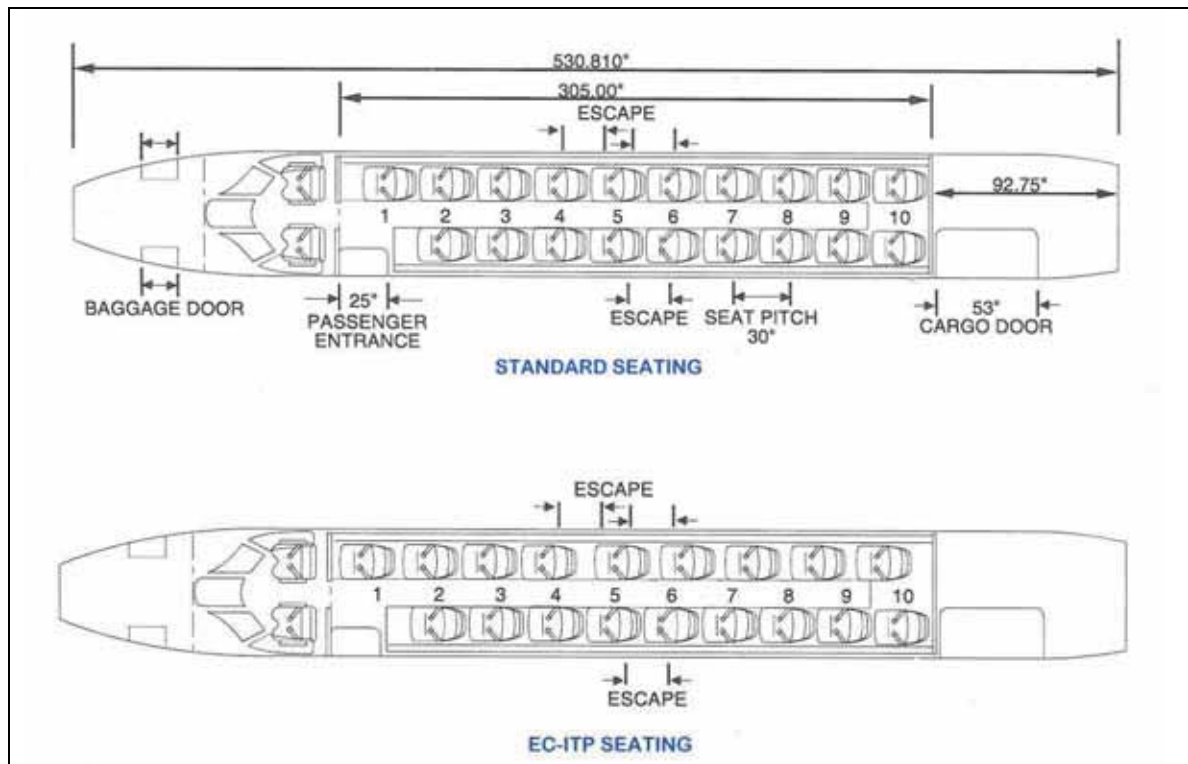
The seat pitch on the right-hand side commenced at 20 inches with a pitch of 38 inches provided adjacent to the aft emergency (escape) exit at the position of seat 5R. Seats behind 5R to the aft bulkhead were arranged with a pitch of 33 inches (**Figure No. 4**).

Figure No. 4: Standard 19-seat passenger layout and non-standard 18-seat layout as found on EC-ITP (*adapted from SA 227 AFM*)

AFS personnel removed all but two of the passenger seats to gain access to the casualties. In most cases the aisle-side seat legs were cut; some of the seats were forcibly wrenched free resulting in twists and fractures to the seat legs. Following recovery of the wreckage to the AAIU facility, the seats were examined. The Investigation compared the cut and fractured seat legs on the removed seats and established the location of each passenger seat in the cabin prior to the accident. The examination revealed a non-standard layout and seat pitch on the right hand side of the aircraft (**Figure No. 4**).

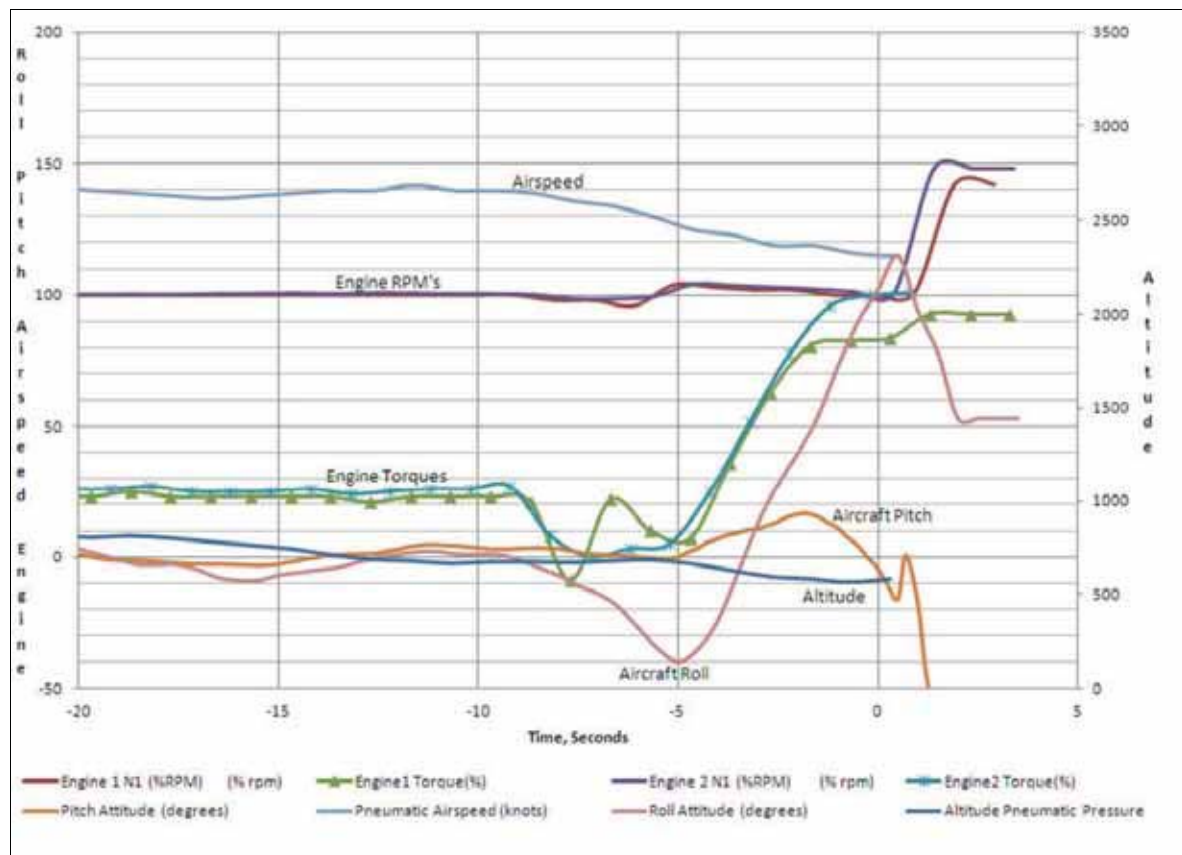
The graph in **Figure No. 5** shows the final 20 seconds of relevant parameters recovered from FDR data. Aircraft heading, not shown for clarity, was consistent with the roll readings. Until approximately 9 seconds before impact, the indicated airspeed recorded by the FDR was consistent with engine power settings and expected aircraft performance. The first significant event was a reduction of delivered engine torque from both engines, commencing approximately 9 seconds before impact, accompanied by a decrease in airspeed.

Figure No. 5: FDR data for final 20 seconds of recording

Effect (3) is evident at several times in the recorded data. During the period from -20 to -10 seconds (**Figure 5, 5a**), engine No. 2 torque was generally approximately 4% higher than that for No. 1 engine. During the time when the data indicates the power levers were brought below the Flight Idle stop (Beta range), the FDR recorded a minimum torque value of -9 % for No. 1 engine, while the minimum recorded torque value for No. 2 engine was 0%.

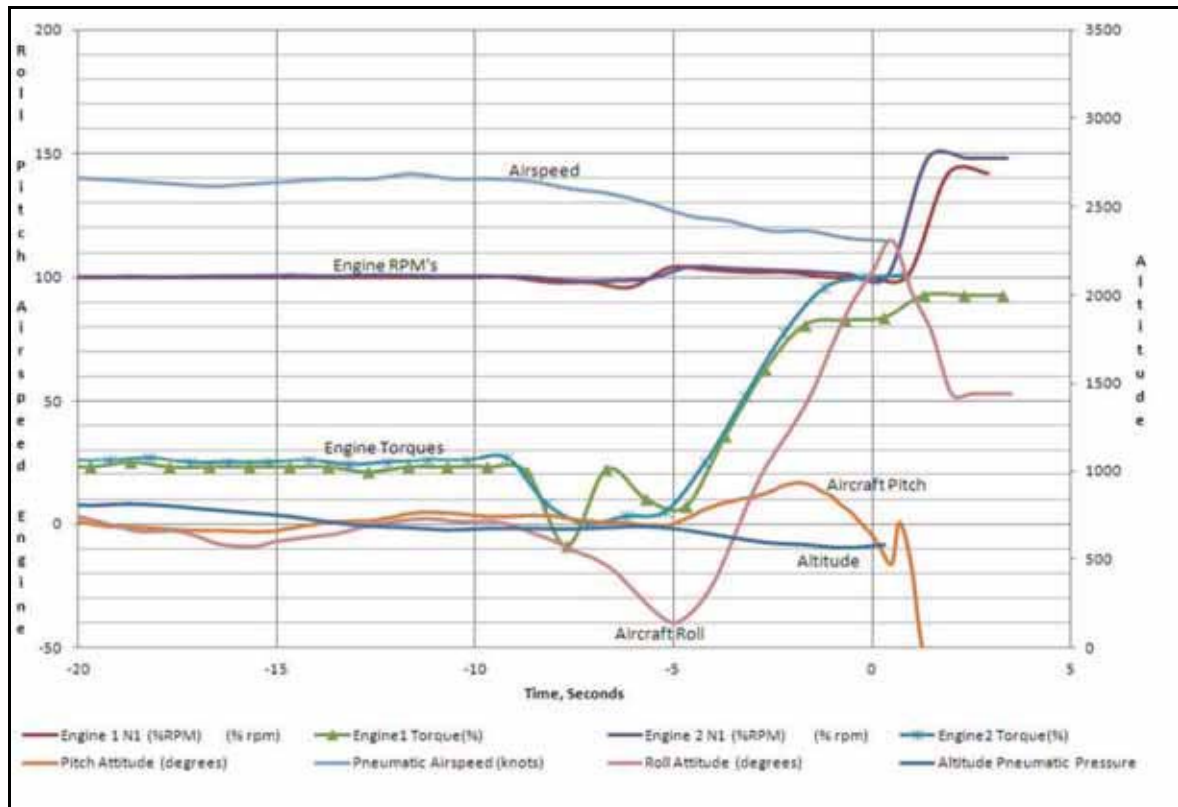
Relevant FDR parameters for the final 20 seconds of the flight are illustrated in **Figure No. 5a** (this is a reproduction of **Figure No. 5** to assist the reader).

Figure No. 5a: FDR Data for final 20 seconds of recording

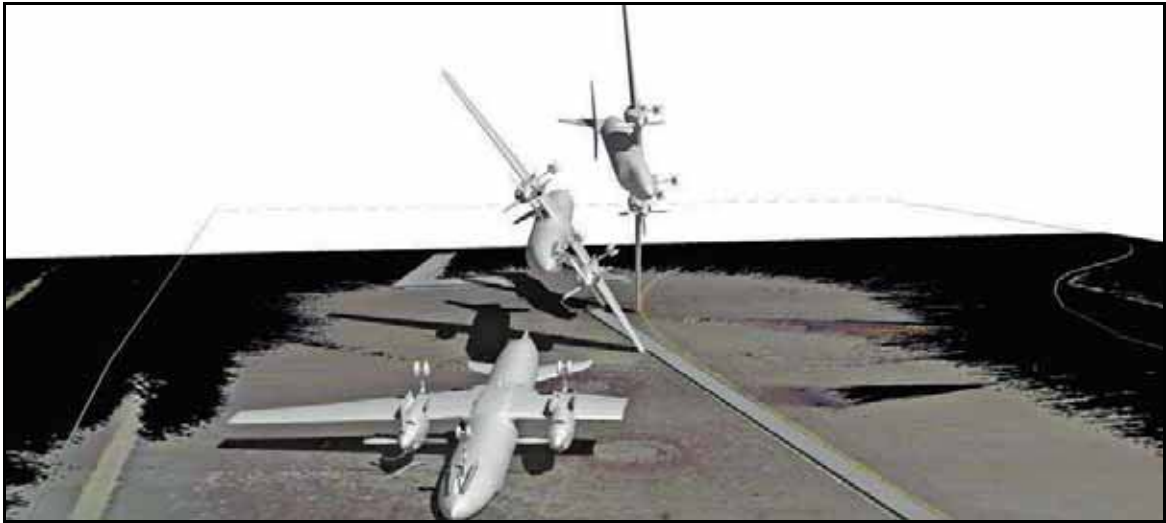
Impact evidence showed that the aircraft first contacted the runway surface with the right wingtip. At that moment the aircraft was at a roll angle of 97 degrees to the right, following which it continued to roll right, impacting the runway surface in an inverted position (**Graphic No. 5**).

Graphic No. 5: Reconstruction of initial impact sequence

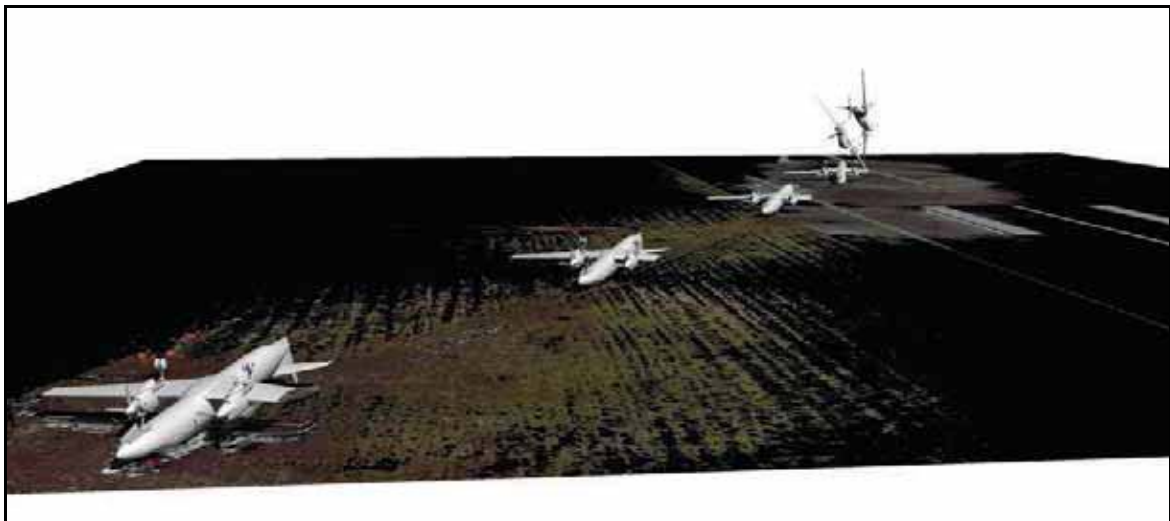
Three of the right propeller blades detached as contact was made with the runway surface and were found at various distances from the main wreckage. The aircraft left the paved area and decelerated rapidly in the soft ground (**Graphic No. 6**). At this point the roof of the forward fuselage ruptured allowing a substantial quantity of soil to enter the cabin.

Graphic No. 6: Reconstruction of ground path to final resting place

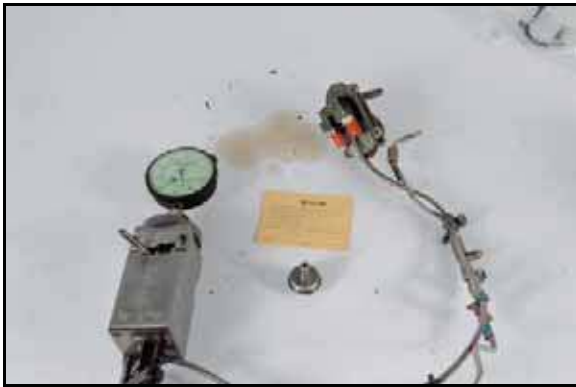
According to the component manufacturer, the P_{T2}/T_{T2} Sensor was produced in August 1999 and was not returned to the manufacturer for any subsequent maintenance. The P_{T2}/T_{T2} sensor bellows displacement was measured using measuring tool WT-51467 # 1 (**Photo No. 1**). The height of the bellows was measured from the inside of the outer flange to the center of the bellows stem measured was 0.947 inches at a room temperature of approximately 75°F (specification is 1.023 ± 0.002 inches at 75°F). This is consistent with the sensor reading a lower temperature value than actual. The height of the bellows being considerably shorter than required would be consistent with a breach within the system (**Photo No. 2**).

Bellows displacement measuring tool

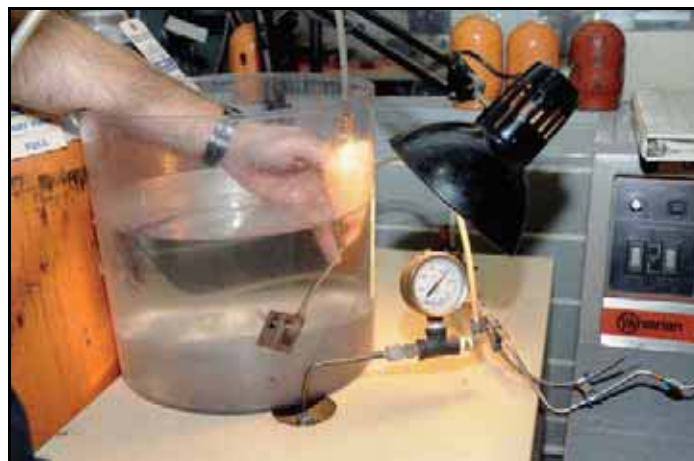
The P_{T2}/T_{T2} sensor was cut midway in the capillary tube to isolate the bellows from the probe to determine which end may be breached. Each half was pressured using helium, then dunked into a tank of Stoddard Fluid (MIL-F-7024 type II) (**Photo No. 3**).

Photo No. 3: P_{T2}/T_{T2} leak check test

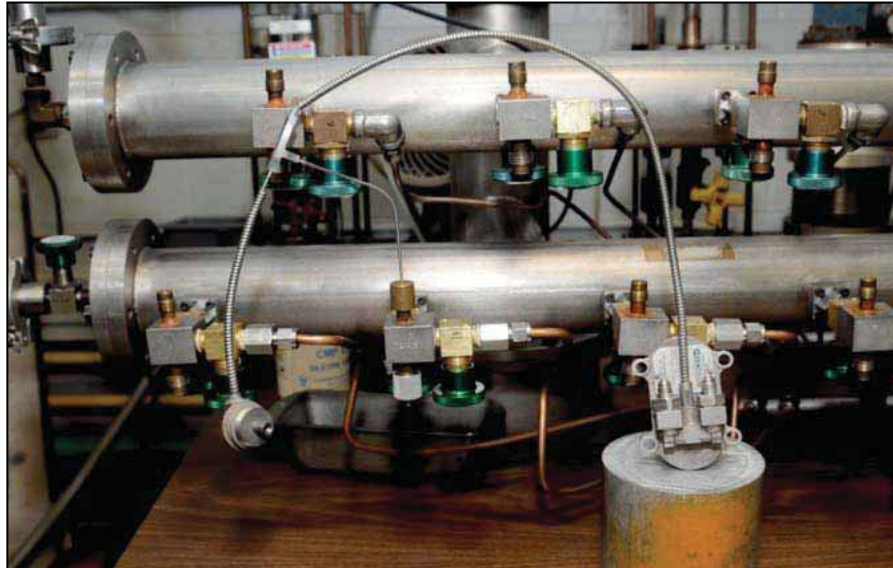
The modified P_{T_2}/T_{T_2} sensor was then put under vacuum to draw any air trapped out the system and then it was filled with N-butyl alcohol (**Photo No. 7**).

Photo No. 7: pressurizing the P_{T_2}/T_{T_2} sensor to determine leak rate

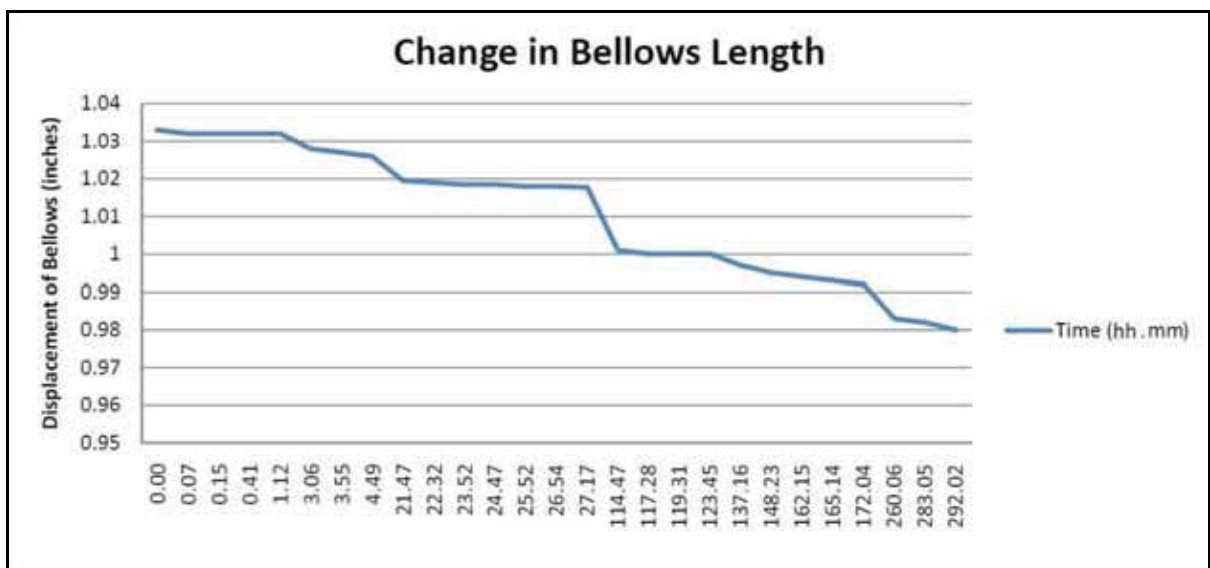
A 15-pound load was then applied to the bellows that simulates the load it would experience when attached to the engine. Under this load, the bellows displacement was measured to be 1.33-inches. The loss of internal pressure (bellows displacement) was monitored and recorded as a function of time (**Plot 1** and **Table 1**). The following displacements and times were recorded:

Plot 1: Bellows Length Change vs Time

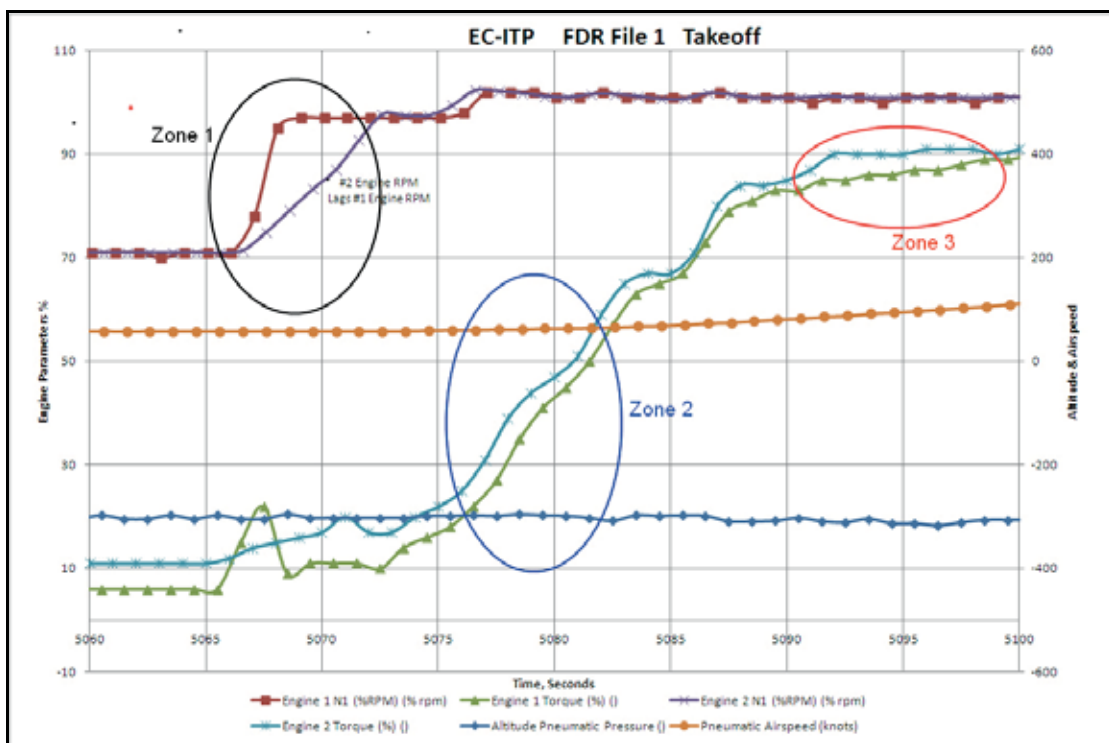
Figure No. 1 shows FDR recorded parameters from EC-ITP on a take-off several weeks before the accident flight indicating that the P_{T2}/T_{T2} anomaly existed at that time.

Figure No. 1: Previous Take-off FDR Parameters

In Zone 1, the two curves show the engine speeds measured in RPM for the No. 1 engine (red) and the No. 2 engine (purple). The curves show that when the speed levers were advanced from Low RPM to High RPM in preparation for take-off and the engine speeds increased from 70% to approximately 97%, the speed response of the No. 2 engine lagged behind that of the No. 1 engine by approximately 5 seconds.

The effects of this on EC-ITP can be seen in Zone 2 of **Figure No. 1**, where the engine torques increase as the power levers are advanced. Since, during this phase of engine operation, the fuel flow to engine No. 2 is higher due to the low temperature signal being transmitted by the shortened bellows, the torque of engine No. 2 advances ahead of that of engine No. 1.

This effect can be seen in Zone 3 of **Figure No. 1** where the engine torques are settling close to take-off values, the torque achieved by engine No. 2 is several percentage points greater than that for engine No. 1.

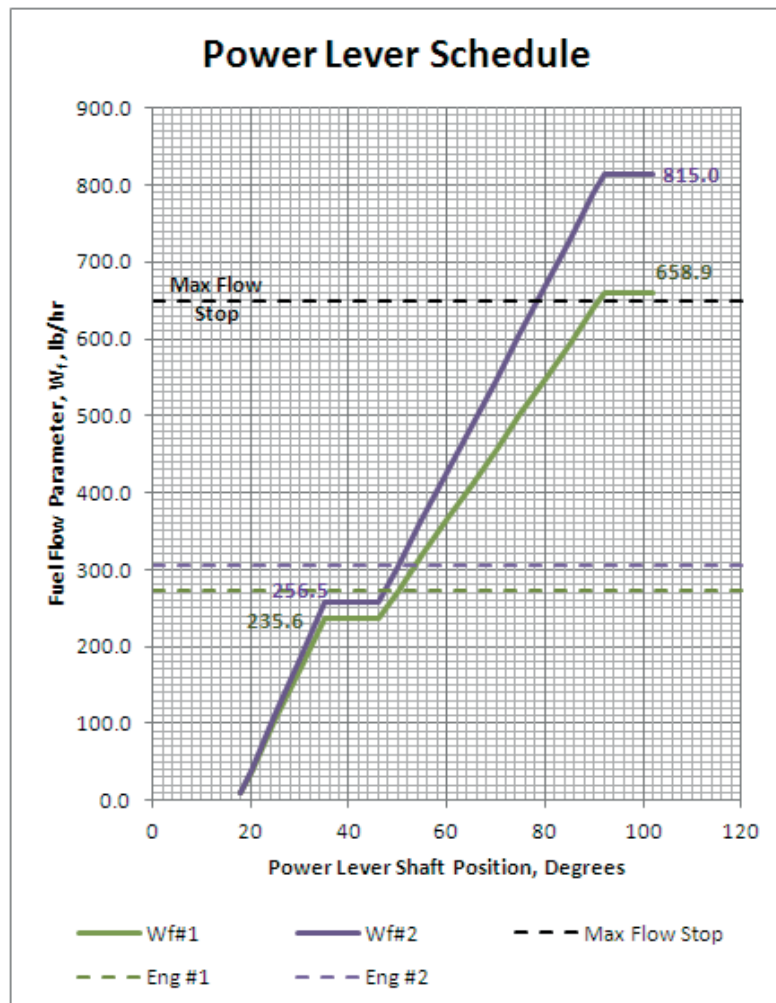
Figure No. 3 shows the comparative power lever schedules for the two engines on EC-ITP. The power lever position fuel flow schedule for engine No. 1 is shown in green, representing compensation for the correct inlet temperature as sensed by the normal P_{T2}/T_{T2} sensor. The schedule for engine No. 2 (in purple), shows fuel flow against power lever position compensated for the negative temperature bias being transmitted from the P_{T2}/T_{T2} sensor with the shortened bellows. It can be seen that, for a given power lever angle, No. 2 engine fuel flow is higher than that for No. 1 engine.

Figure No. 3: Power Lever Schedule for EC-ITP Engines (*Honeywell*)

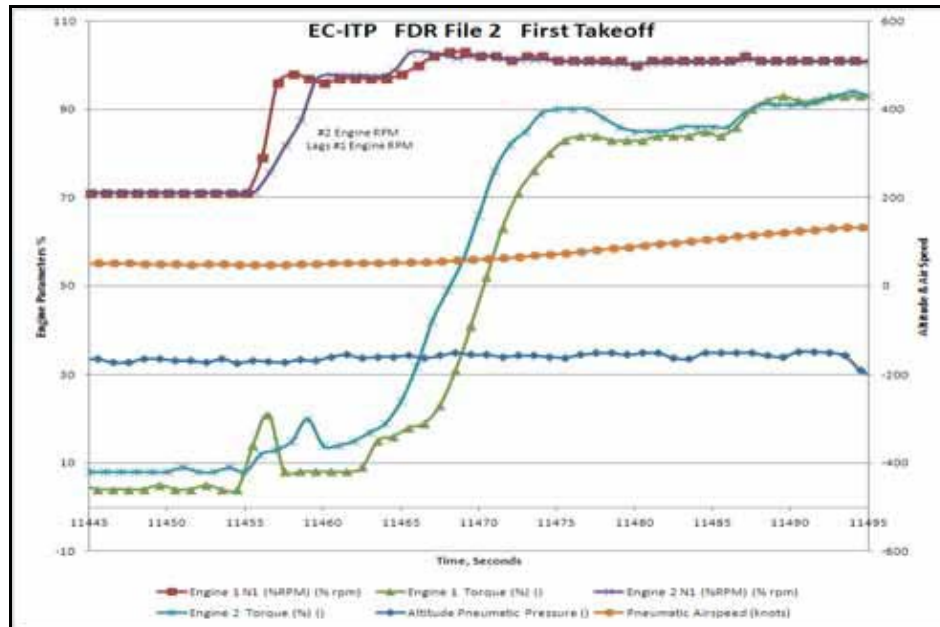
Figure No. 4 and **Figure No. 5** present FDR data for two further take-offs made by EC-ITP some weeks before the accident flight. Similar characteristics are seen, in that the engine No. 2 RPM lags that of engine No. 1 as the speed levers are advanced in each case. Also, the torque achieved by engine No. 2 advances ahead of that achieved by engine No. 1 and, particularly as seen in **Figure No. 5**, the No. 2 engine torque remains higher than that of No. 1 engine as the aircraft speed increases during its take-off run.

Figure No. 4: Sample of take-off FDR parameters weeks prior to accident

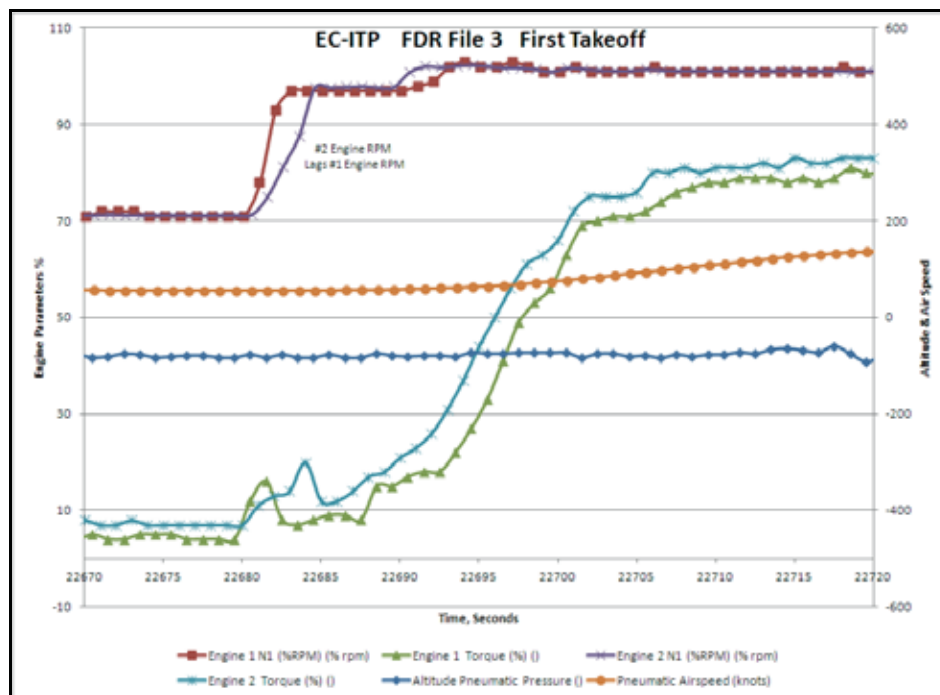
Figure No. 5: Additional sample of take-off FDR parameters weeks prior to accident

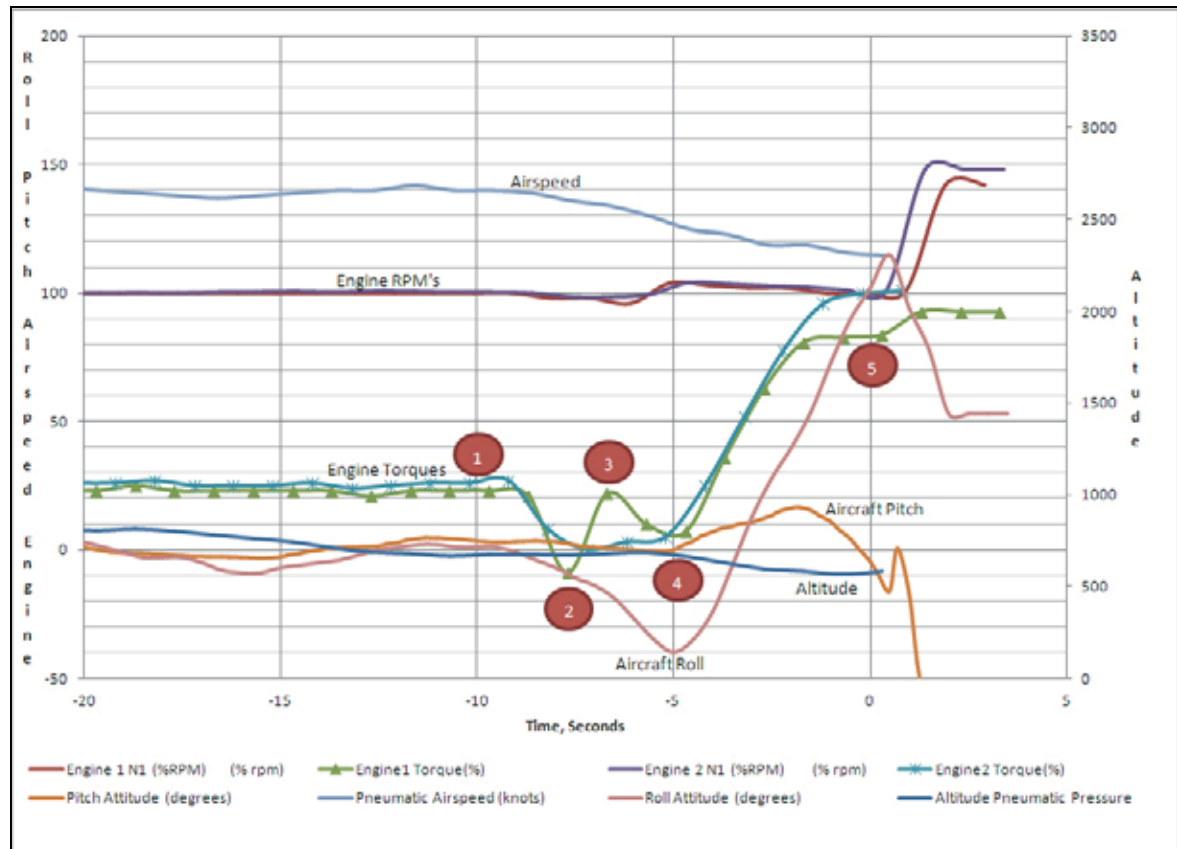
Figure No. 6 illustrates various FDR parameters recorded during the accident sequence. The x-axis represents time measured in seconds with the “0” point representing a time approximately one second before commencement of the impact sequence, when the values of recorded parameters became unreliable.

Figure No. 6: FDR Parameters during final approach (accident flight)

The data shows that, as the aircraft descended towards the runway during the time period from -20 secs to approximately -9 secs, the engine torque for the No. 1 engine was recorded at values generally in the range 21 to 23% while that for the No. 2 engine was in the range 25 to 27%. During this period, the engine speeds were recorded as 100% for No. 1 engine and at values in a range between 100.0% and 100.7% for No. 2 engine. These values are illustrated in **Figure No. 6** from the left hand axis until a time just after datapoint 1.

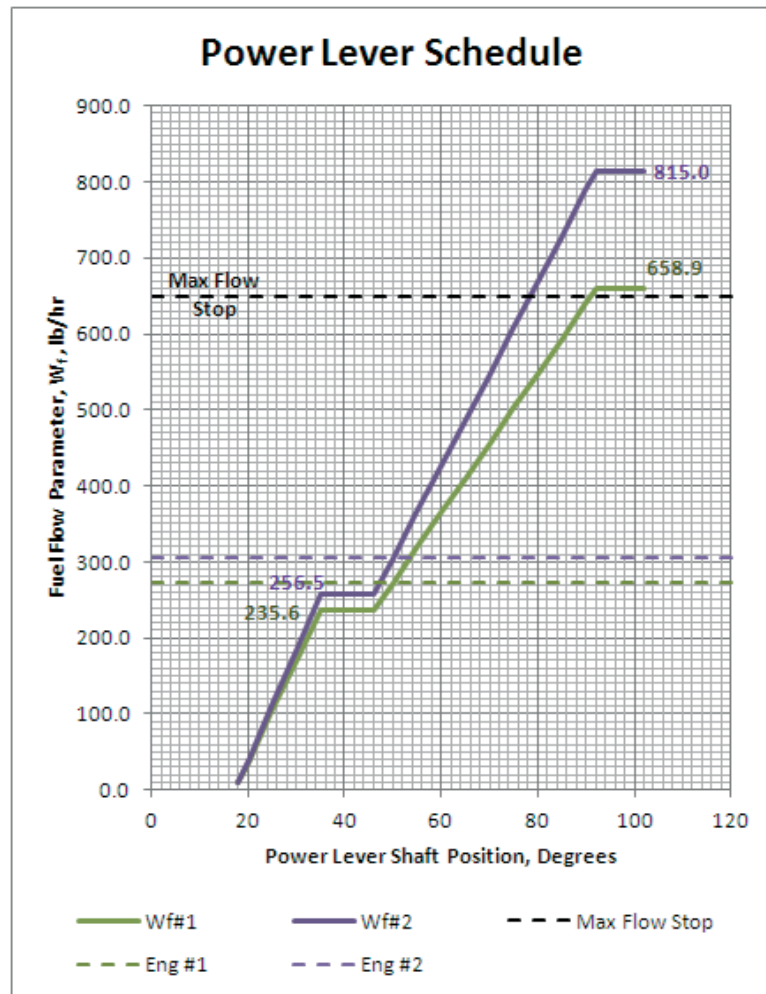
All of the above calculations take no account of the effects of the shortened P_{T2}/T_{T2} sensor bellows height and the consequent negative temperature bias. In order to calculate the power lever angle at those data points where the fuel flow was on the respective power lever schedule, it is necessary to use the curves shown in **Figure No. 7** (which is a reproduction of **Figure No. 3**) and takes into account the effects of the shortened bellows.

Figure No. 7: Fuel Flow/Power Lever Angle (PLA) Curves

In this figure, the curve of fuel flow (Wf#1) against PLA for the No. 1 engine, is shown in green while that for the No. 2 engine is shown in purple. If each of the fuel flow figures shown in **Table No. 3** is brought across to the applicable curve in **Figure No. 7**, then the equivalent power lever angles for each point can be derived. This data is shown for engines No. 1 and No. 2 in **Tables No. 4** and **No. 5** respectively.

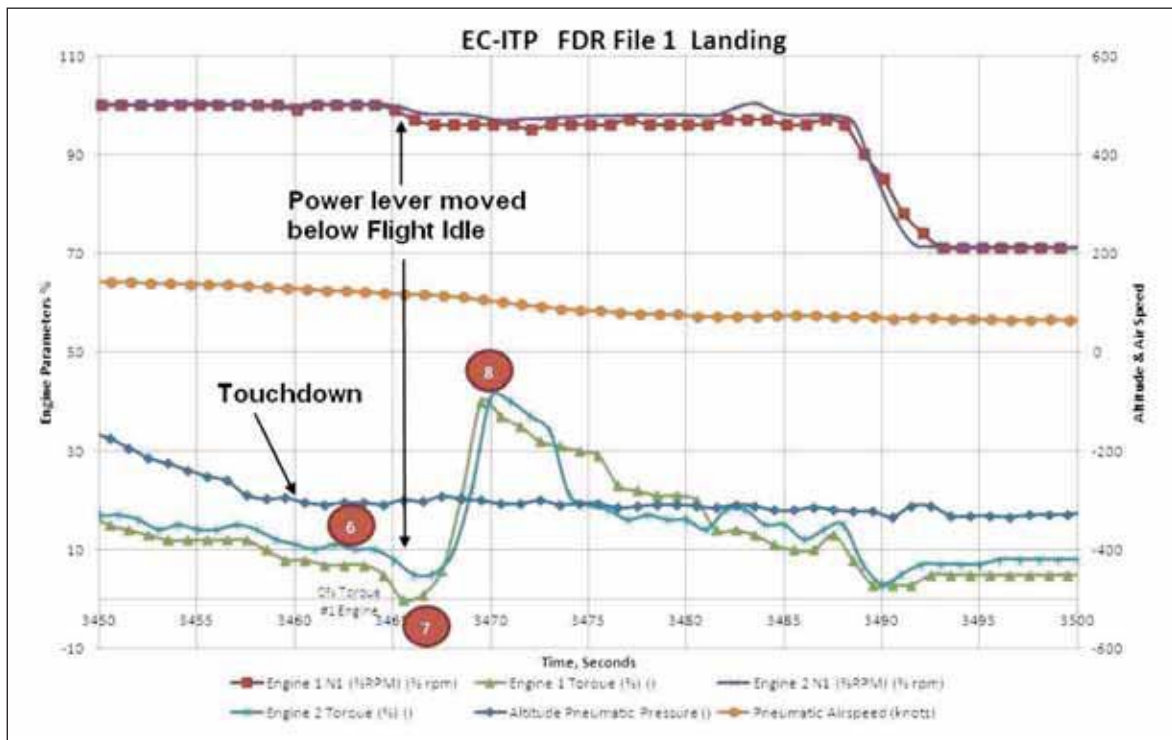
Figure No. 8: FDR Data from Previous Landing

The Investigation looked at a landing which had been made by EC-ITP at a Spanish airport several weeks before the accident, and for which FDR data was available. **Figure No. 8** illustrates the FDR data for this landing in similar format to that shown for the accident. Time in seconds is shown on the x-axis while the various engine parameters along with altitude and airspeed are shown on the y-axis. The touchdown occurred at FDR time reference 3460.

A similar analysis was carried out for this landing, and the manufacturer’s computer model was used to calculate the fuel flows at datapoints 6, 7 and 8 as shown in **Figure No. 8**. The data is shown for the No. 1 engine in **Table No. 6** and for No. 2 engine in **Table No. 7**.

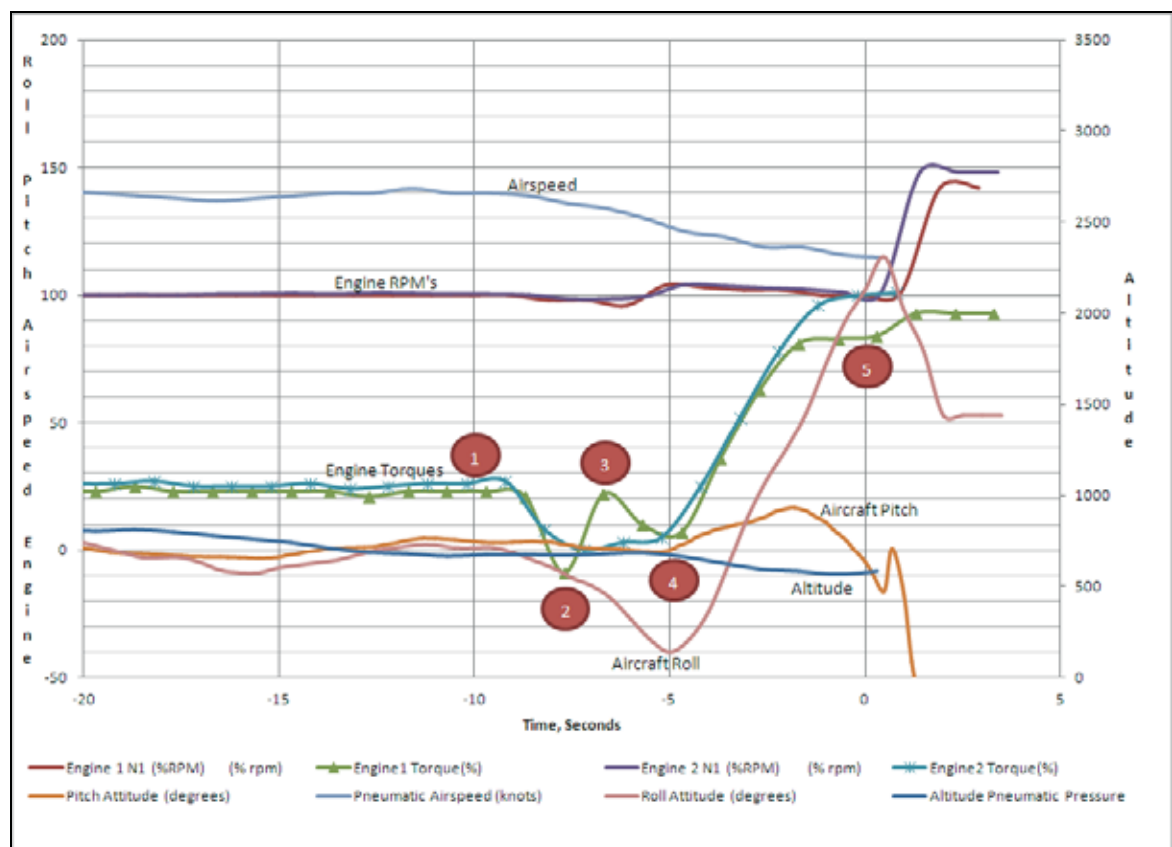
Figure No. 9: FDR Parameters during final approach (accident flight)

Regarding the final approach and the time period from -20 seconds to approximately -9 seconds, the engine torque for the No. 1 engine was recorded at values generally in the range 21 to 23% while that for the No. 2 engine was in the range 25 to 27%. During this period, the engine speeds were recorded as 100% for No. 1 engine and at values in a range between 100.0% and 100.7% for No. 2 engine, **Figure No. 9**.

The altitude can be seen to be slowly decreasing while the airspeed was being maintained around 140 kts. During this phase, the final approach appears to be stabilised with the speed levers set to High RPM and the power levers throttled back to low positive torque values consistent with values recorded during other approaches. The split between the torques of approximately 4% is consistent with the torque split identified throughout the FDR data where the torque output by No. 2 engine exceeded that of No. 1 engine due to the negative temperature bias caused by the shortened bellows of the P_{T2}/T_{T2} sensor on No. 2 engine.
