CIAIM-08/2017 REPORT

Grounding of the vessel TIDE NAVIGATOR at the Port of Vilanova i la Geltrú on 2 August 2016

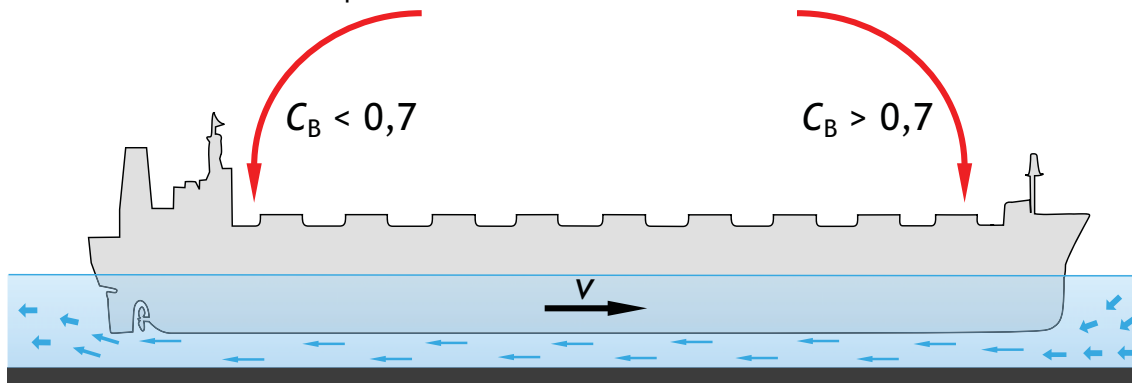
The effect of increased draft and squat in ships sailing through narrow channels in shallow water has been known for centuries. This effect, already observed in 1835 by Scott Russell, results from changes in hydrodynamic pressure on the hull of the ship as it moves through water of any depth, but is more pronounced in shallow waters. The shape of the hull also influences the effect: ships with a block coefficient close to one (fuller shapes) tend to sink more at the bow, while those with narrower shapes tend to sink at the stern.

Figure 7. Influence of the block coefficient on dynamic trim.

Using this formula and the characteristics of both the ship and the port, the squat effect can be estimated. In this case, it would cause the bow to sink approximately one centimeter, which is completely negligible and played no role in the accident.
