# TECHNICAL REPORT A-15/2010

Investigation of the sinking of F/V ROSAMAR,  
24 miles from Burela on the 5th of December, 2008

# Technical report

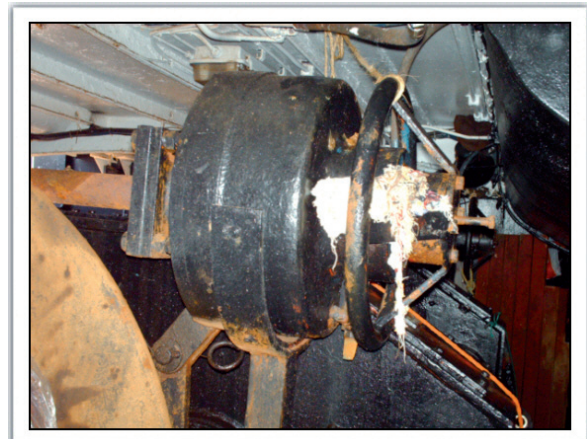
**Figure 11.** Trawling machine brake wheel with its actuator

The brakes could be operated manually by means of a wheel, or from a distance by means of a pneumatic actuator. The actuating system on board F/V ROSAMAR can be seen in figure 11.

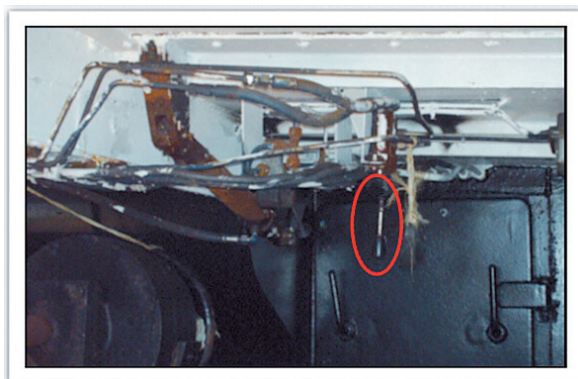
**Figure 12.** Trawling machines manual operating lever

On the main deck, aft of each trawling machine there was a manual actuation lever, which can be seen in figure 12. The lever allowed for releasing and hoisting the machine cable by operating the clutch. When the lever was pulled out, the machine would begin to hoist in the cable and when the lever was pushed in, the machine began to release the cable; upon letting go of the lever, which was spring loaded to the neutral

When the machine levers were in the hoisting position, traction tension was generated on the cables through the clutches. However, if this manual system was used during trawling to correct the location of the gear, the winding of the cables did not necessarily occur because when you added these tensions to those generated by the resistance of the moving gear, the resulting tension could change its direction. Since the tension was transmitted through the clutches, which allowed the reel to slide according to the direction of the resulting force, the cable reel could either wind or unwind the cable.

This operation was designed to require the person operating the machine to always be present when the machines were operating in manual mode. The levers were located on the ceiling to prevent a shifting of weights from accidentally moving them.

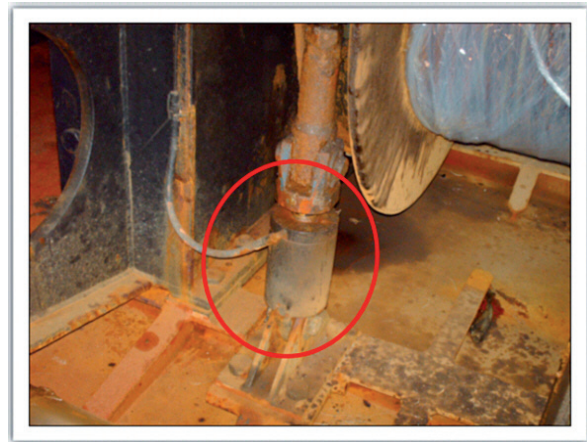
**Figure 13.** Trawling machine tension measurement force sensor

F/V ROSAMAR's trawling machines included a constant tension control system. The system measured the signal of the force exerted by each machine on one of its anchoring points to the deck. For this, it used a sensor that consisted in a traction/compression load cell, which can be seen in figure 13.

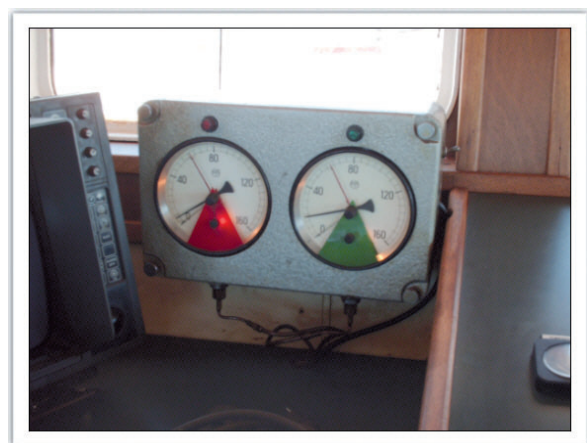
**Figure 14.** Tension indicators on the trawling machines, with adjustable alarm

Two indicators were located forward of the wheelhouse on the port side, where the Skipper could read the tension exerted by each machine on the trawling cable. These indicators, which can be seen in figure 14, included alarms that provided a warning when the reference tension, which was adjustable, was exceeded.
