Report ULM A-013/2016

Accident involving an Evektor
EV-97 Eurostar aircraft, registration
EC-KTF, in San Ignacio del Viar
(Seville, Spain) on 20 May 2016

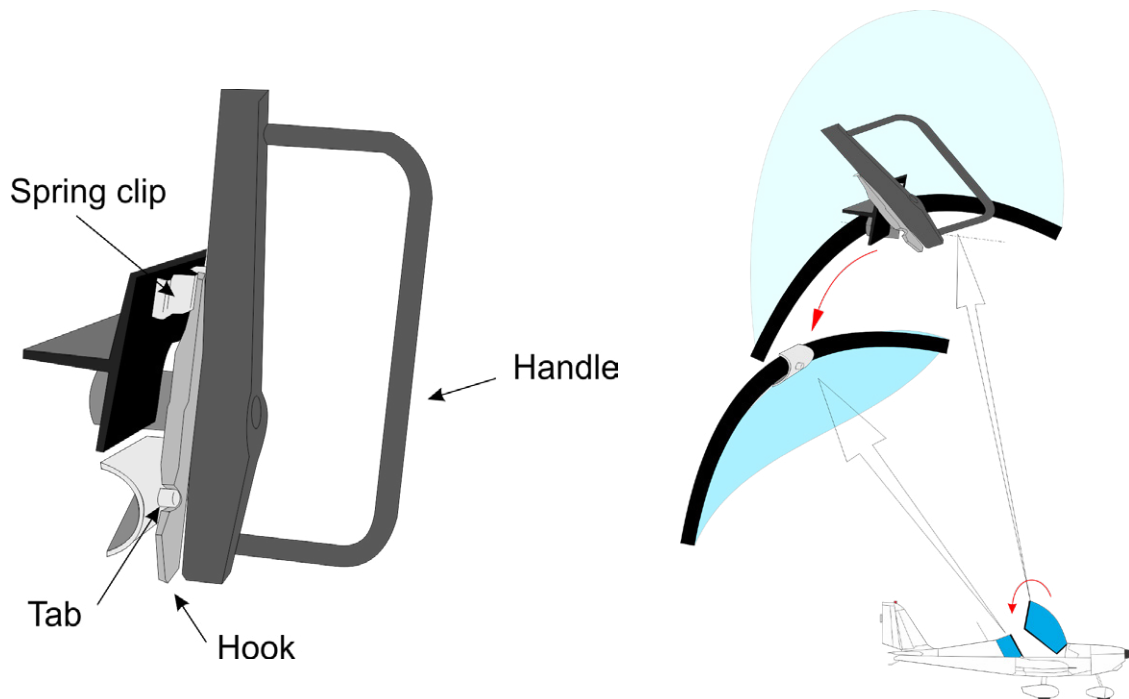
Figure 8. Parts and location of the canopy locking mechanism

At the rear of the canopy is the locking mechanism, as shown in Figure 8. It consists of a handle with a hook that locks into a small tab at the rear of the cockpit. The handle is secured with a spring clip system that keeps it from opening accidentally. To lock and unlock the system, some force must be applied when turning the handle (Figure 9).
